Victoria Estates HOA Queen Creek, AZ

Report #: 15113-1
Beginning: January 1, 2022
Expires: December 31, 2022

RESERVE STUDY Update "With-Site-Visit"

September 11, 2021

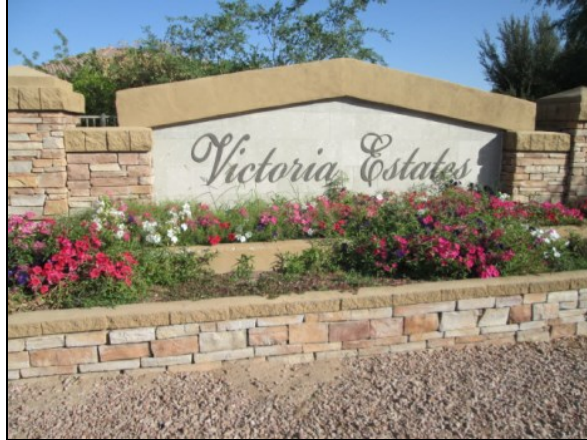
Comments: Monuments consists of a tile wall surface with plastic lettering attached that spells out "Victoria Estates". Still in decent shape. This component funds to eventually replace the lettering and tile, plus improve landscaping in front of the monuments.

Useful Life:
20 yearsRemaining Life:
6 years

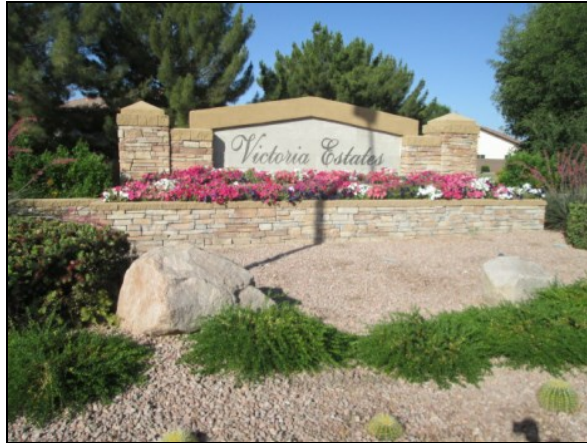
Comp #: 110 Entry Walls - Repair/Paint**Quantity: Approx 2,240 Sq Ft**

Comments: HOA approved a proposal to repair and paint monument stucco in 2021. Project will also include painting just the entry portion of the perimeter walls to match the monuments. Due to high visibility, we recommend planning to repaint this area more frequently than the other community walls.

Useful Life:
5 yearsRemaining Life:
4 years

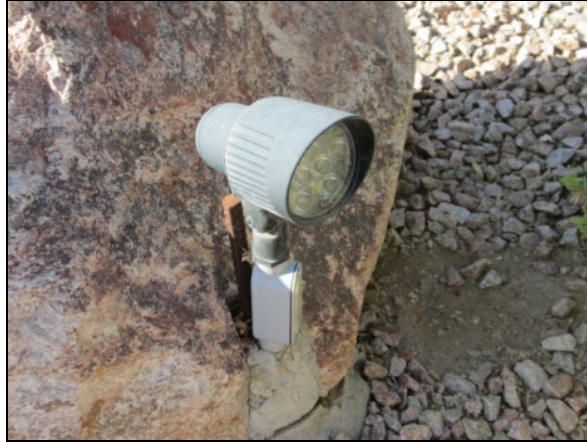
Comp #: 120 Entry Lights - Replace

Comments: Quantity includes (6) spot lights for the monuments and (10) well lights at the palm trees in the entry island. There is (1) Unique transformer for the lights too. The original monument lights were replaced with these LED spot lights, but the timing and cost is unknown. They do not appear newer though, but still in fair condition. Repair or replace individual fixtures as a maintenance expense. This component funds to replace all of the lights and transformer together.

Useful Life:
10 years

Remaining Life:
6 years

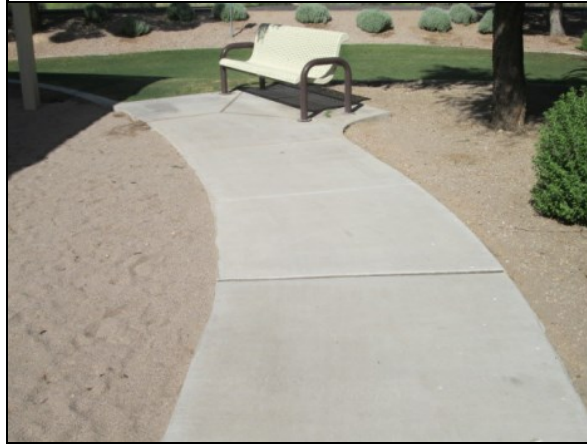
Comp #: 220 Concrete - Repair

Funded?: No. There is a limited amount of HOA owned concrete. There is no expectancy to completely replace the concrete. HOA plans to repair or replace as needed with Operating funds, so no Reserve funding has been allocated.

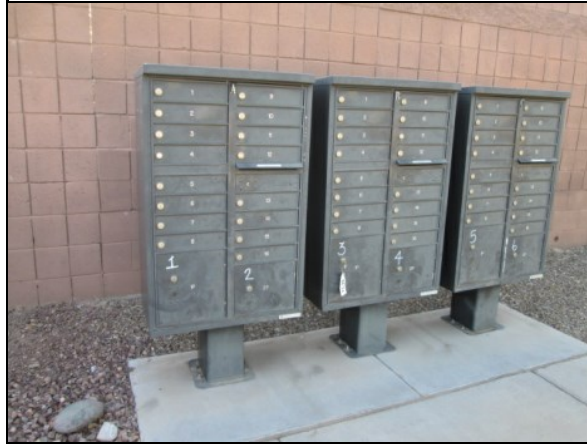
Comp #: 380 Mailboxes - Replace

Useful Life:
18 years

Remaining Life:
8 years

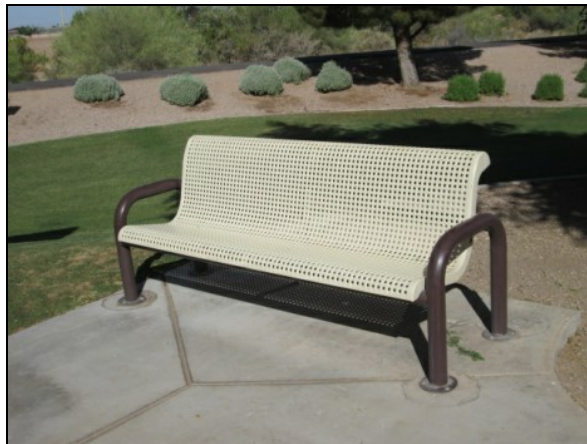
Comp #: 404 Park Benches - Replace

Comments: Park benches have been replaced in the recent past, but actual timing and cost are currently unknown. They still look newer and are in good condition.

Useful Life:
15 years

Remaining Life:
12 years

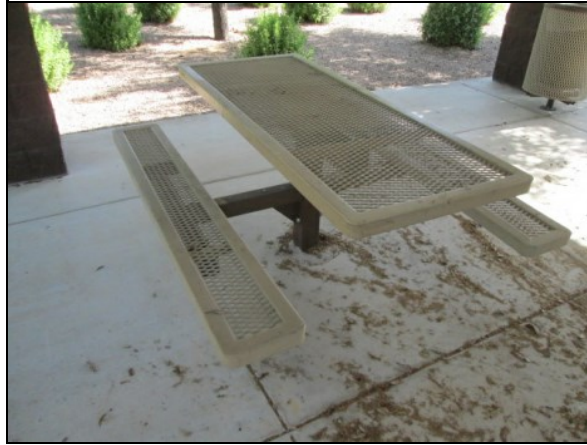
Comp #: 405 Park Furniture - Replace

Comments: Pieces include (2) picnic tables, (1) trash can, and (2) Iron Mountain Forge barbecue grills. Furniture is still original and looks older and dirty. Still intact, functional, and in fair condition.

Useful Life:
18 years

Remaining Life:
4 years

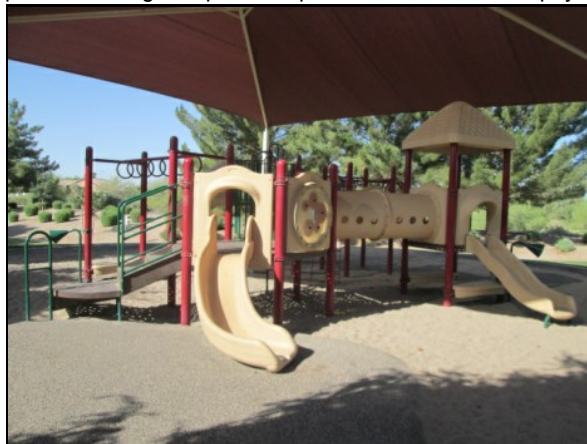
Comp #: 410 Play Structure - Replace

Useful Life:
20 years

Remaining Life:
6 years

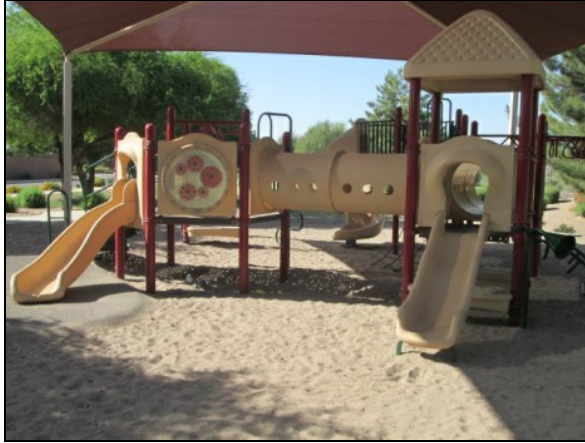
Comp #: 411 Play Structure - Repair

Useful Life:
5 years

Remaining Life:
2 years

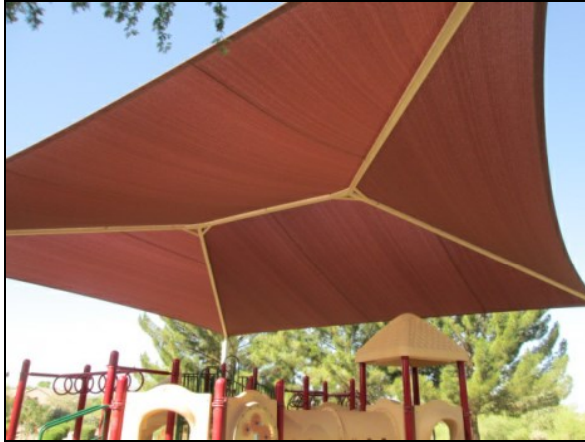
Comp #: 418 Shade Screen - Replace

Useful Life:
15 years

Remaining Life:
14 years

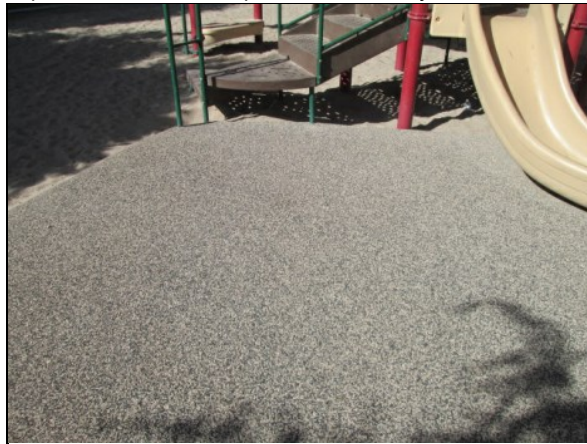
Comp #: 422 Playground Turf - Replace

Useful Life:
20 years

Remaining Life:
6 years
