## Belmont at Triple Crown Scottsdale, AZ

Report #: 47163-0  
Beginning: January 1, 2024  
Expires: December 31, 2024

# RESERVE STUDY "Full"

October 19, 2023

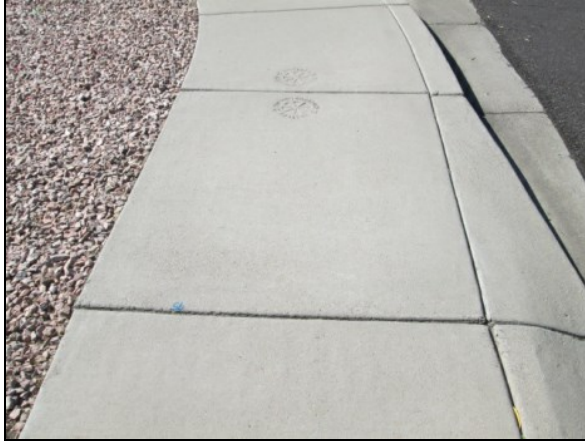
### Comp #: 103 Concrete - Repair

History: Installed in 1996. ~\$3,500 will be spent in 2023 for (23) trip hazard repairs.

Useful Life:  
4 years

Remaining Life:  
3 years

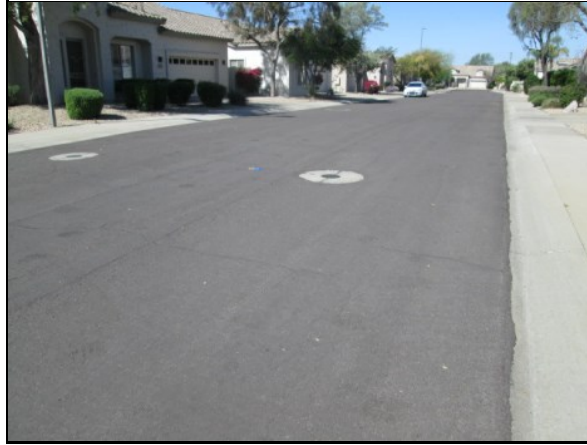
**Comp #: 218 Asphalt - Seal/Repair**

Useful Life:  
4 years

Remaining Life:  
0 years
