**CAPITAL RESERVE ANALYSTS**

Palomino Pointe Association

Regarding: FY2016 - Level I Capital Replacement Reserve Study

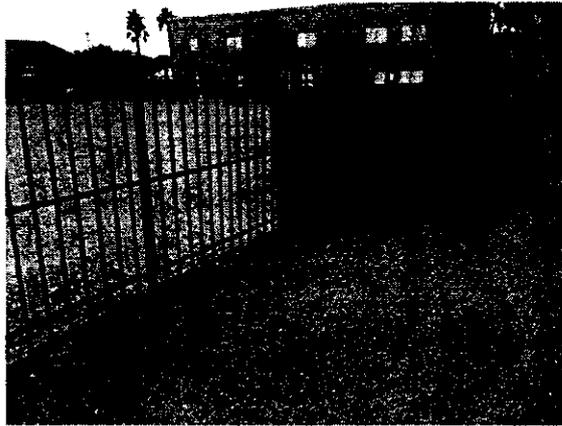
Perimeter Fence - Replace

Age: Actual install date unknown at this time. In-service date based on observed conditions.

Current Condition: Fencing appears sturdy and in fair condition.

Maintenance Requirements: Repaint every 4-5 years to prevent rust and prolong useful life expectancy.

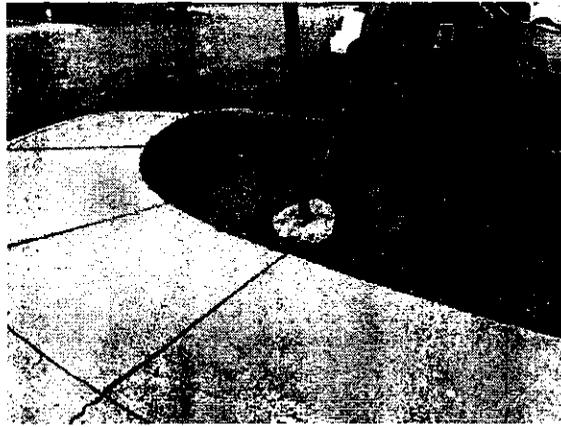
Age: Installation dates vary.

Current Condition: Some areas noted to be full and in good condition while other areas were observed to be thin and in need of replenishment.

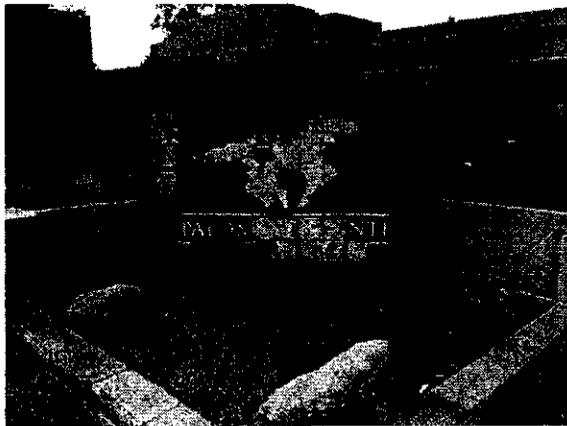
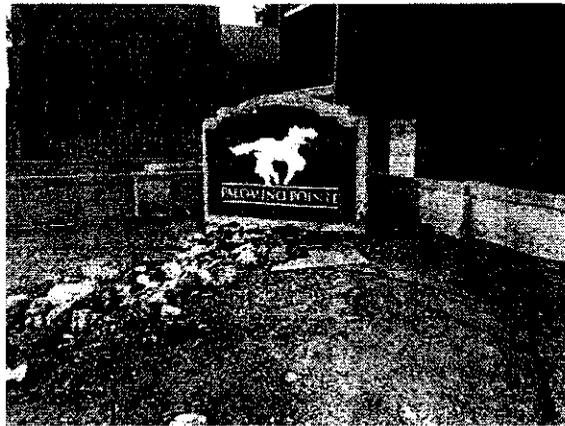
Age: Install date unknown.

Current Condition: Missing tiles noted.

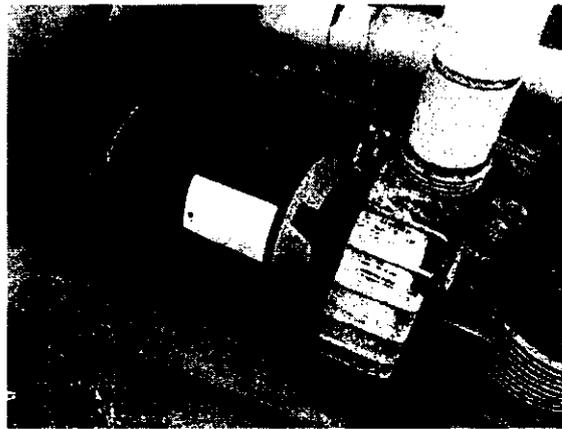
Current Condition: Functional and in decent condition.

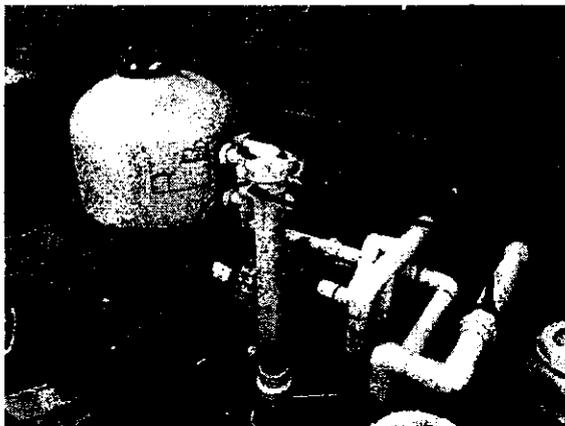
Current Condition: Functional and in decent condition.

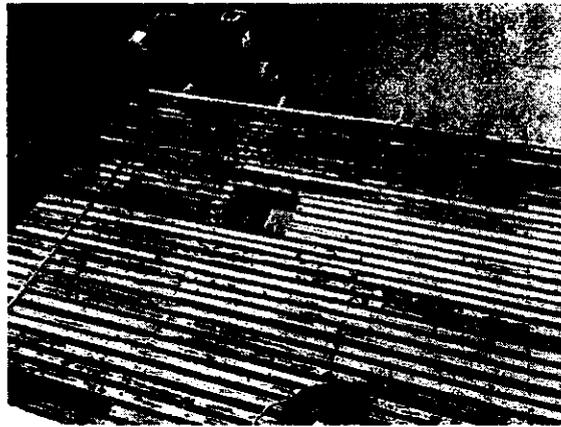
Age: Actual install date unknown at this time. In-service date based on observed conditions.

Current Condition: Wood beams intact and in fair condition.
