**Property: SOUTHERN ENCLAVE HOMEOWNERS ASSOCIATION
PHOENIX, ARIZONA**

Service: PROPERTY EVALUATION AND RESERVE FUND ANALYSIS

FULL RESERVE STUDY

**Southern Enclave Homeowners Association
Phoenix, Arizona**

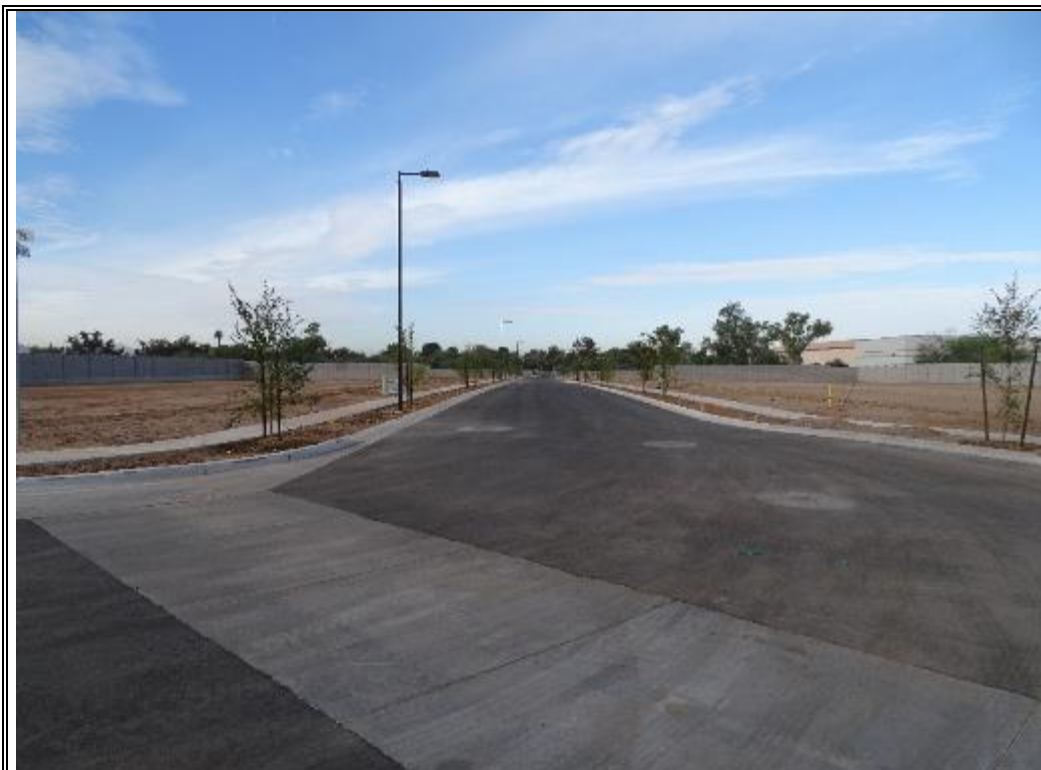
- ✓ Private asphalt streets are in new condition. See Photo 2.
- ✓ Stamped asphalt simulates brickwork at the main entrance. See Photo 3.
- ✓ CMU block walls surround the perimeter of the property and each individual home. The HOA is responsible for the walls around the common areas. See Photo 4.

Description:
Private Streets

- ✓ Private streets are scheduled for crack seal and sealcoat in five years, and then repaired every 12 years. The schedule is adjusted at years 30 to restart the crack seal, sealcoat, and repair cycle after the street is resurfaced. Before developer turnover to the HOA, it is assumed the street will be crack sealed and seal coated to extend asphalt lifespan. Many products with different qualities are available and many may have higher associated costs.

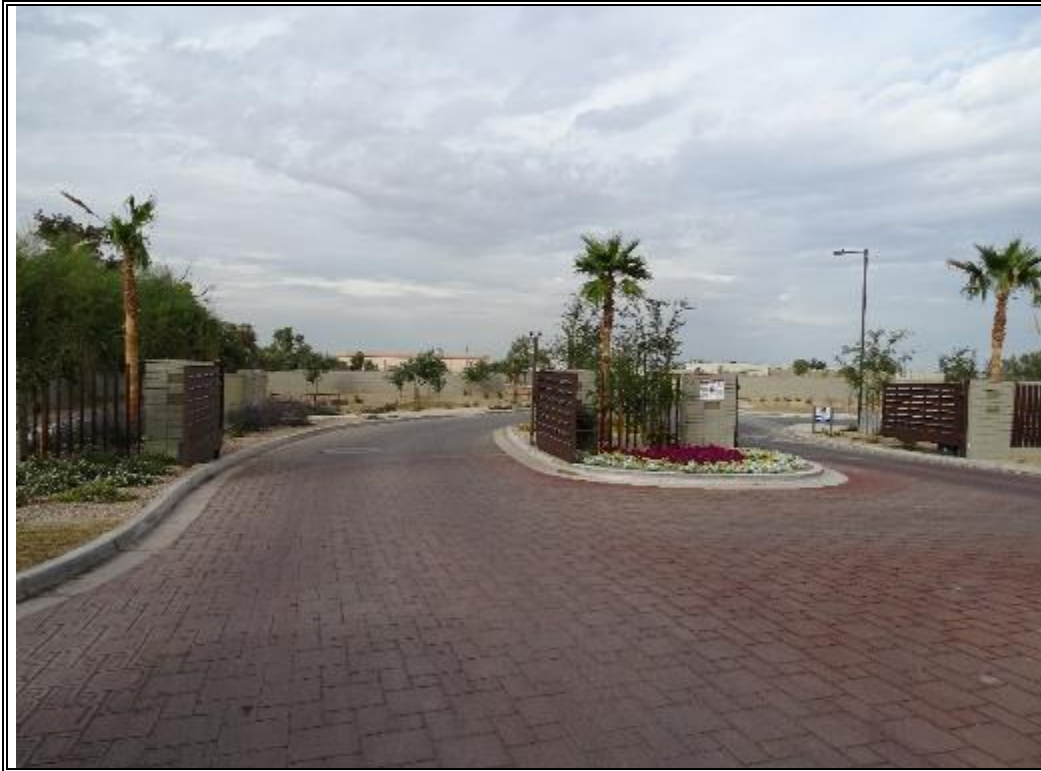
Photo Number
3

Description:
Stamped asphalt
at main entry
gates

- ✓ The stamped asphalt area at the entry way is scheduled for minor repairs every six years and resurfacing/restamping every 30 years.
- ✓ The block walls are scheduled for repairs of 2.5% of the wall every 10 years. They are scheduled for painting every 8 years.

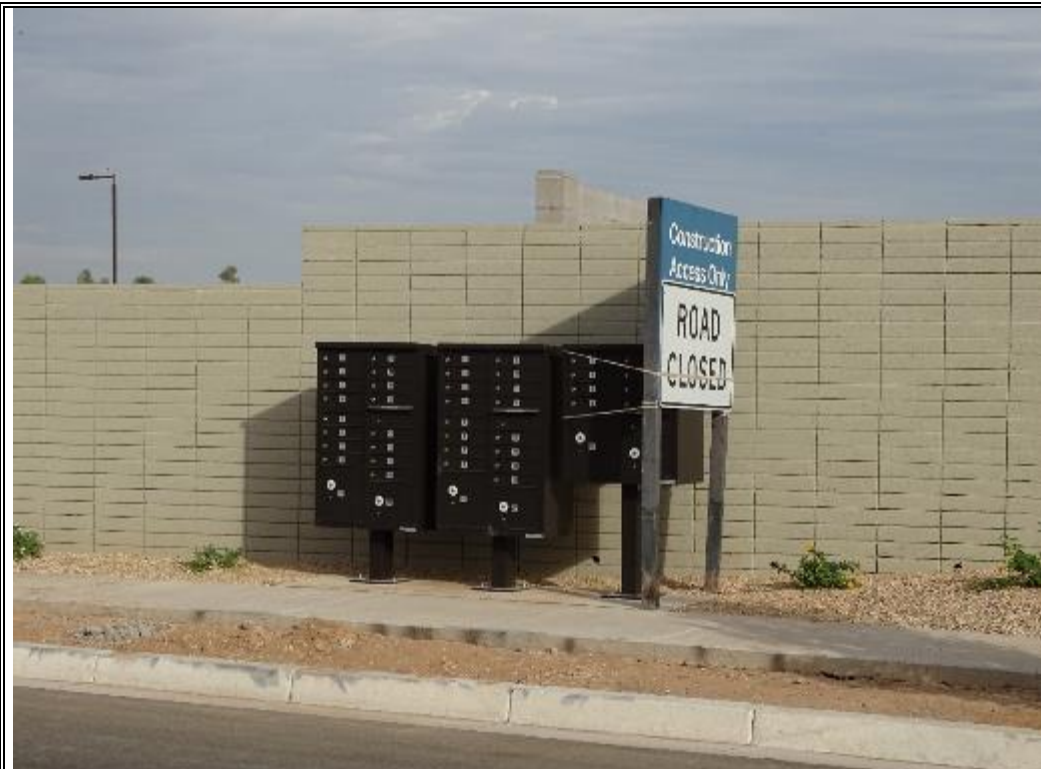
Description:
Common CMU
walls

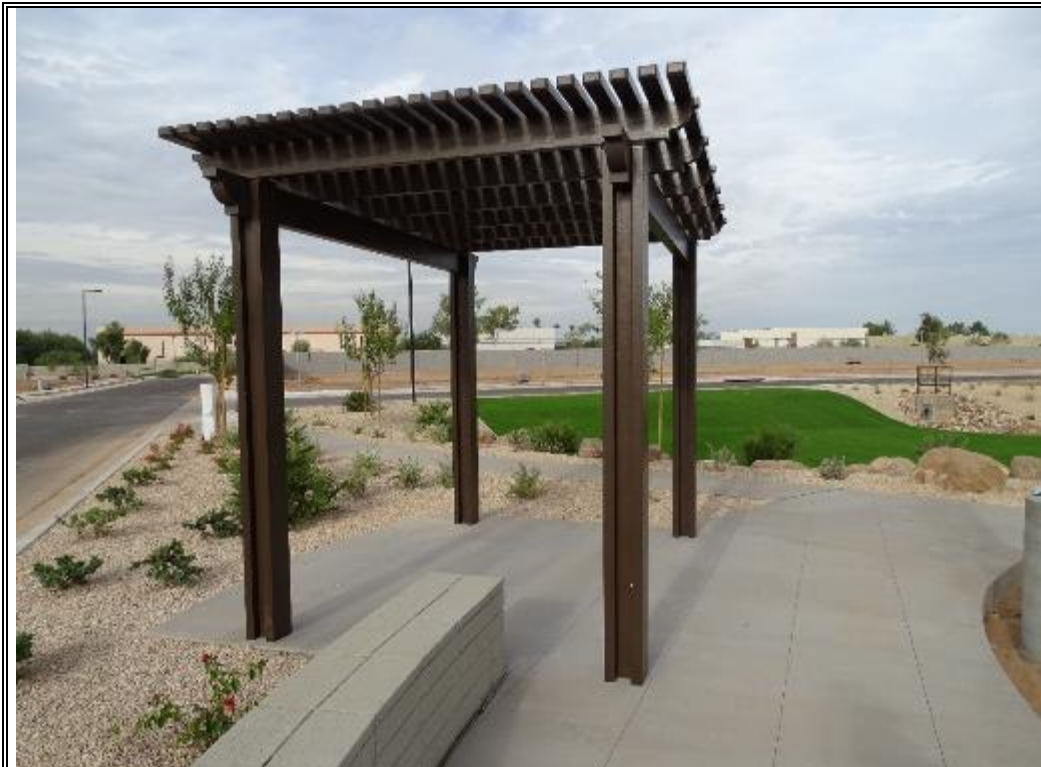
Photo Number
5

Description:
Small aluminum
pergola at Tot
Lot – West

- ✓ The two small aluminum pergolas are scheduled for repainting every 8 years and replacement every 30 years. The painting schedule should be modified after year 30 to restart with the installation of a new structure. The aluminum structures come with a 15-year warranty and are more susceptible to damage than similar concrete wood-frame pergola structures. A recommended application of a protective coating would come from the operations and maintenance budget.

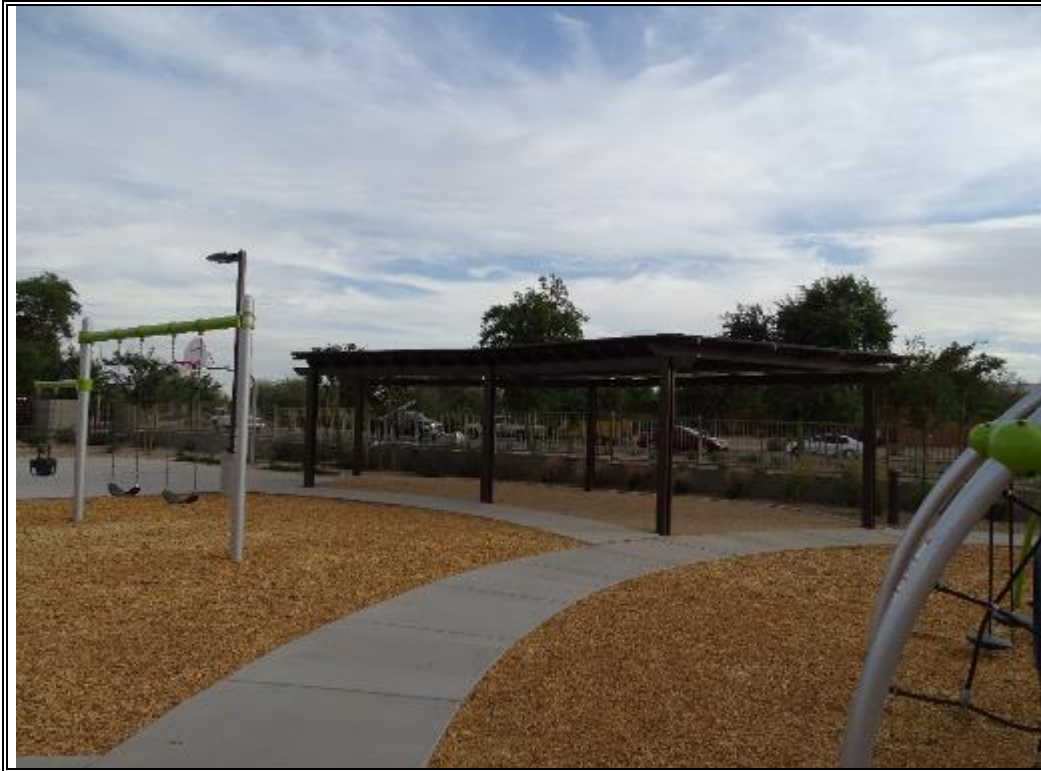
Description:
Large aluminum
pergola at Tot
Lot – South

- ✓ The large aluminum pergola is scheduled for repainting every 8 years and replacement every 30 years. The painting schedule should be modified after year 30 to restart with the installation of a new structure. The aluminum structure comes with a 15-year warranty and may be more susceptible to incidental damage than similar wood-frame pergola structures. Application of a protective coating (recommended) would come from the operations and maintenance budget.

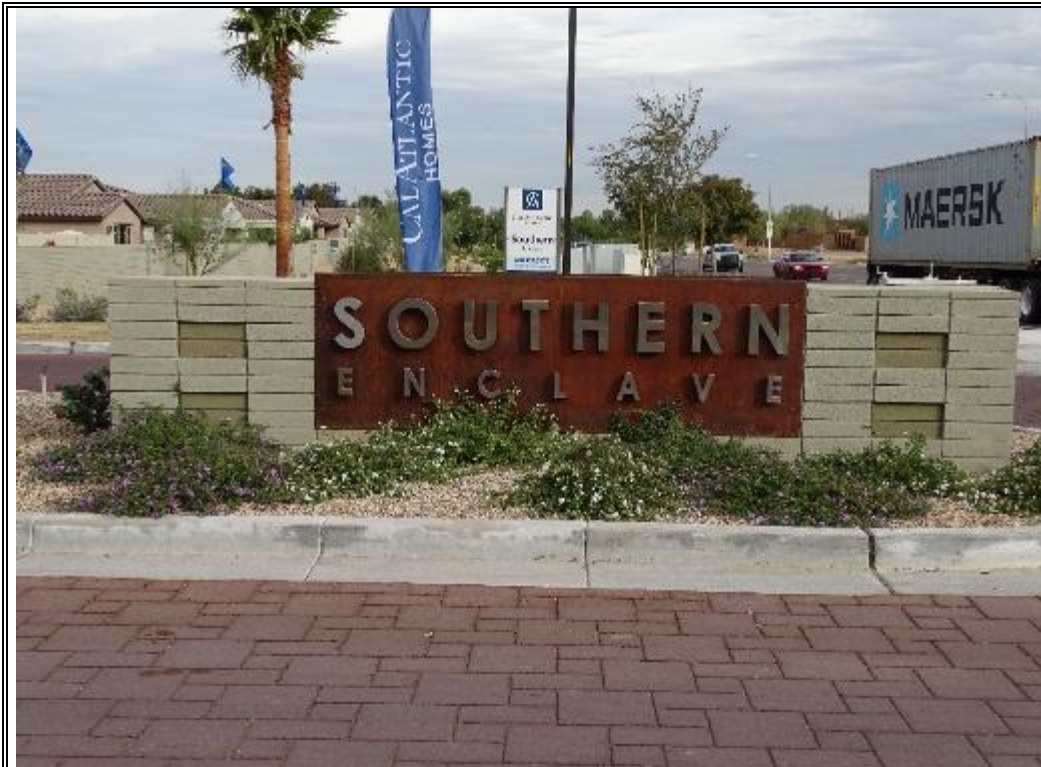
Photo Number
7

Description:
Monument Sign

- ✓ The monument sign is scheduled for refurbishment every 20 years.

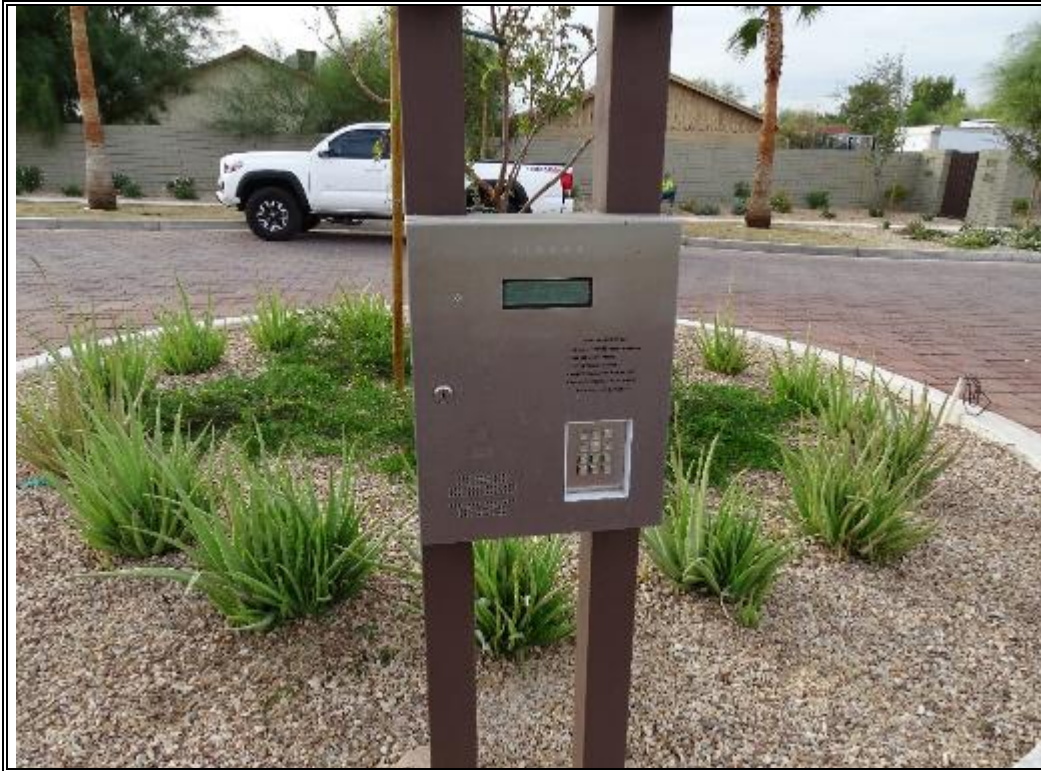
- ✓ The access panel telephone is located at the main entrance in the southwest corner. The system is a Linear telephone access system with a limited two-year warranty. See Photo 19.
- ✓ The vehicle gates are operated by Maximum Megatron swing-arm controllers with one controller per gate. See Photo 20.

Description:
Entry access
control and
telephone
system

- ✓ The access panel telephone is scheduled for replacement after 15 years and includes removal and disposal of the old panel.
- ✓ The vehicle gate actuators are scheduled for replacement after 14 years and are recommended to be replaced in pairs. The expense includes removal and disposal of the existing units.
- ✓ The vehicle gates are scheduled for replacement after 30 years. They are likely to be replaced earlier due to an accident. The hinges and pivots will require regular maintenance in the operations budget.
- ✓ The pedestrian gates are scheduled for replacement after 30 years. The security access readers may require replacement during that time, which will fall under the operations budget.
- ✓ The irrigation controllers are expected to be replaced between eight to ten years. Other irrigation maintenance will be covered by the landscaping budget.

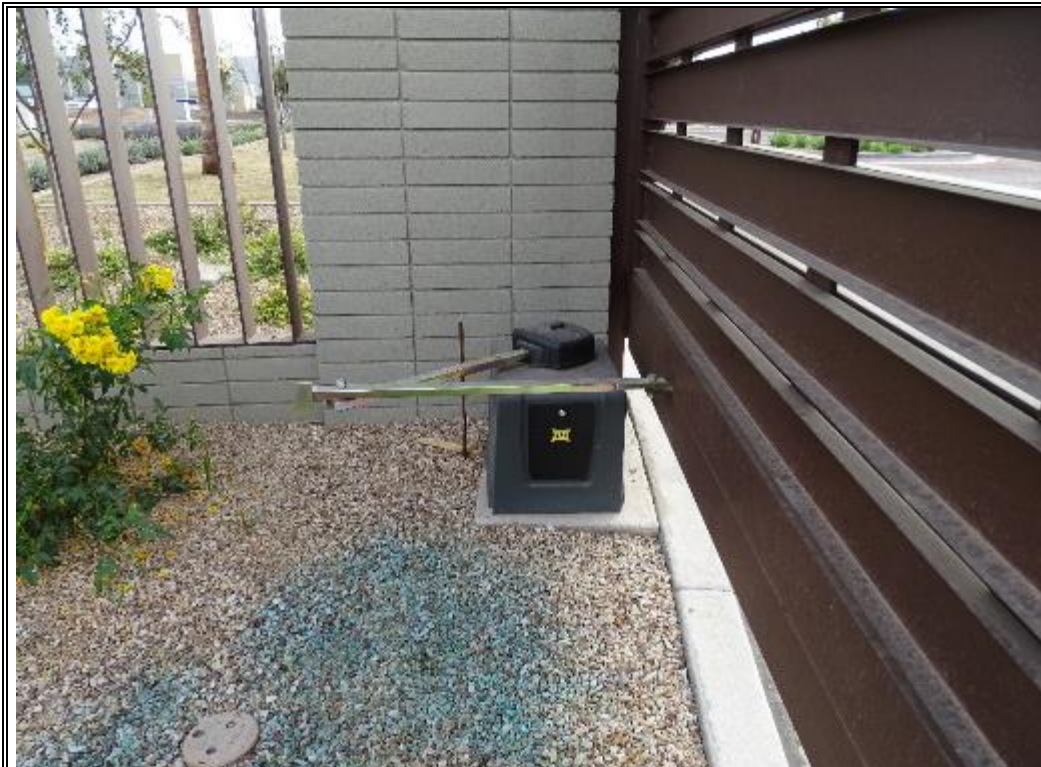
Photo Number
19

Description:
Maximum
Megatron Gate
actuators

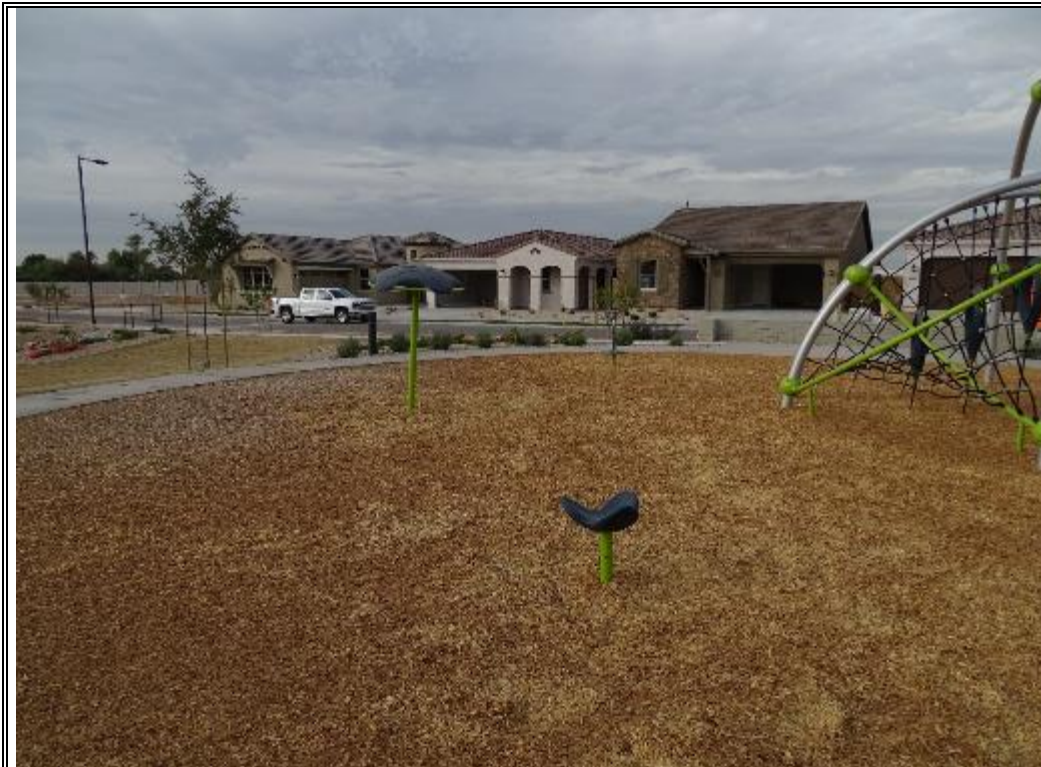
Photo Number
29

Description:
Tot Lot – East,
seat and hanging
shell

- The swing is scheduled for replacement at 20 years. It may require replacement of the individual swings under the operations budget.
 - The seat and spinning structure are scheduled for replacement at 20 years.

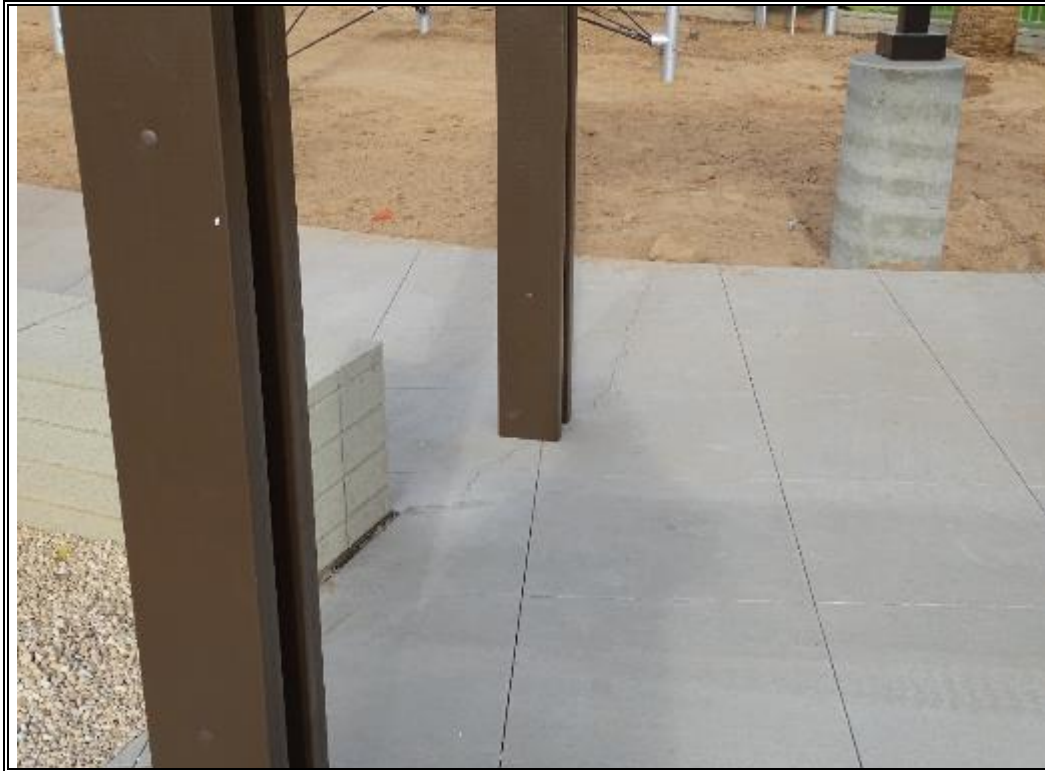
- ✓ At the Tot Lot – South, the small spinning structure is installed at an angle, see Photo 30.
- ✓ At the Tot Lot – West, the concrete between the small pergola and the play area has a significant crack, see Photo 31.

Description:
Cracking
concrete
observed under
the small
aluminum
pergola at Tot
Lot – West
