"Full" Reserve Study

Meadows East HOA San Tan Valley, AZ

Report #: 37418-0
For Period Beginning: January 1, 2020
Expires: December 31, 2020

Date Prepared: September 18, 2019

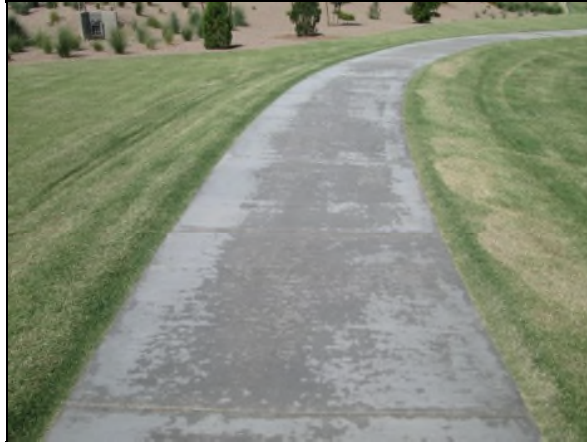
Comp #: 220 Concrete - Repair

Comments: There is no expectancy to completely replace the concrete. This component funds an allowance for periodic repairs and/or partial replacements as needed.

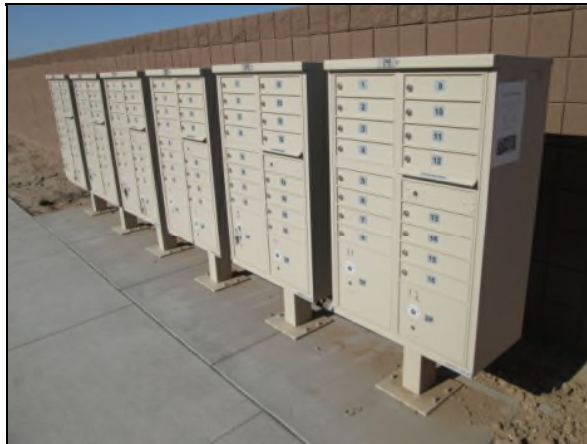
Comp #: 380 Mailboxes - Replace

Comments: There are 16-box clusters. Observed to be newer and in good condition. Future replacement should be anticipated.

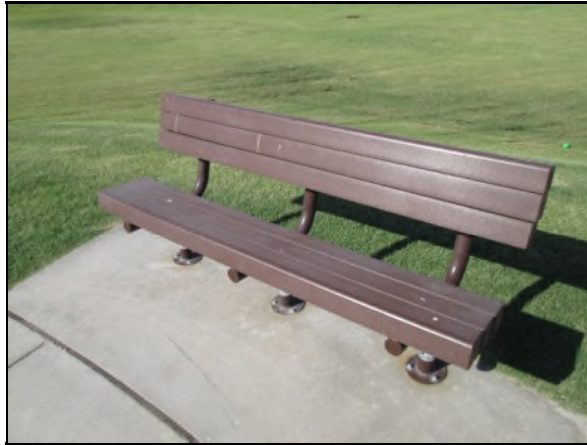
Comp #: 405 Park Furniture - Replace

Comments: Pieces include (13) 6' benches, (1) 6' picnic table and (1) trash can. Furniture is constructed of recycled plastic manufactured by PW Athletics. Observed to be newer and in good shape.

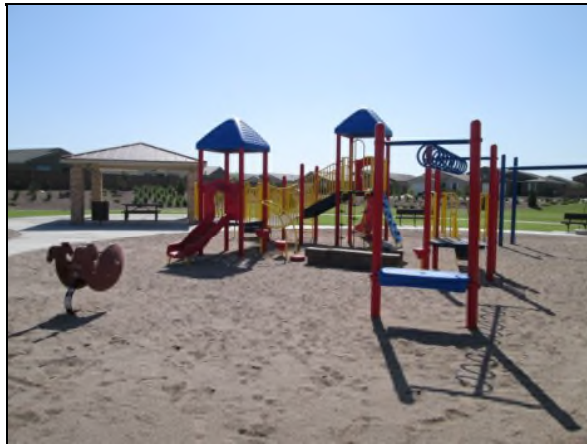
Comp #: 410 Playground Equipment - Replace

Comments: Pieces include (1) Little Tikes large play structure with multiple attachments, (2) Playworld large play structures, (1) tire swing, (1) 4-seat swing-set and (4) spring riders. Observed to be newer and in good condition.

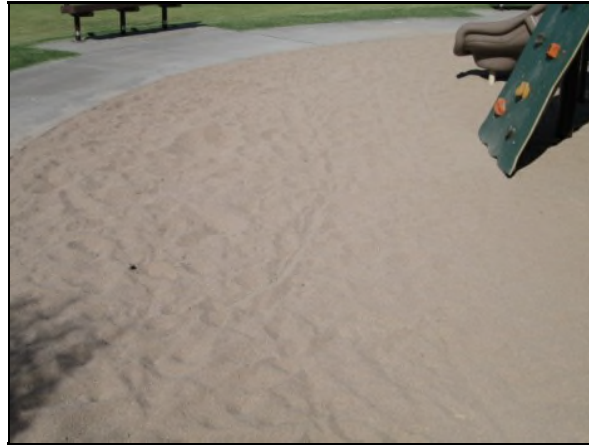
Comments: There is no expectancy to completely replace the sand. This component provides funding to replenish the sand with a 2" layer, which is approximately 95 tons. Observed to be soft and full.

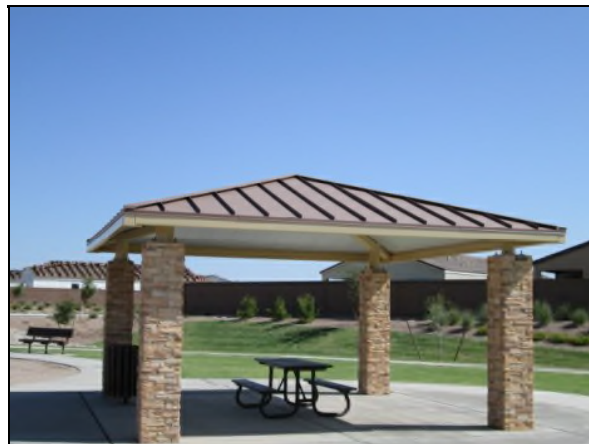
Comp #: 420 Ramada Roof - Replace

Comments: Long life expectancy under normal circumstances. It would still be prudent to plan for replacement eventually, even if just for aesthetic purposes. Observed to be intact and in good condition.

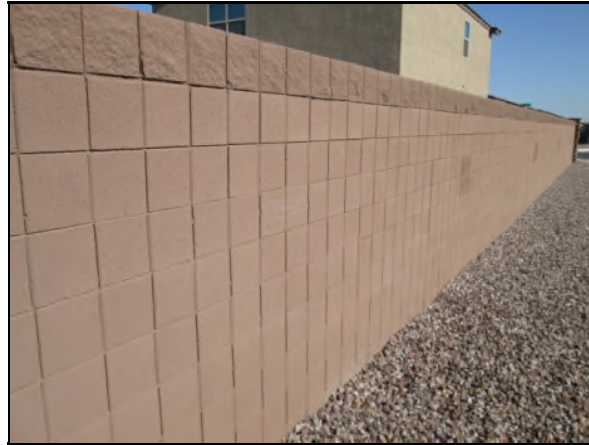
Comp #: 501 Block Walls - Repair

Comments: Walls are expected to last the life of the community under normal circumstances. This component funds an allowance for repairs and/or partial replacement due to excessive settling or other sources of damage.

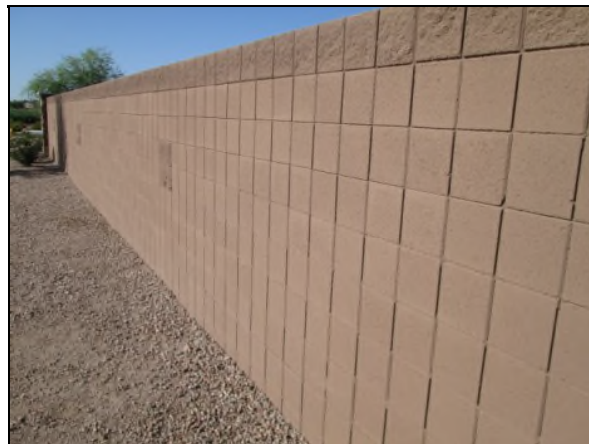
Comments: Surfaces were observed to be uniform and in good shape.

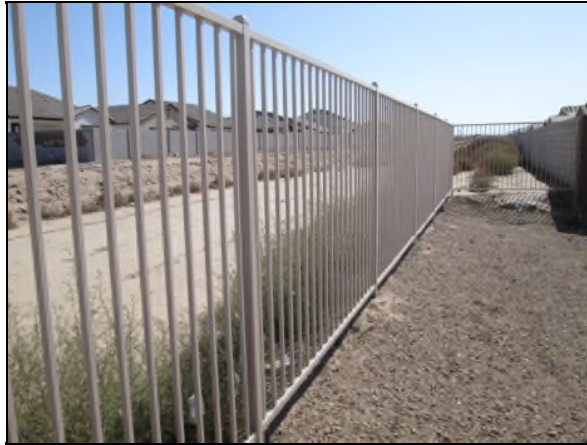
Comp #: 505 Metal Fence - Replace

Comments: Observed to be intact and secure. Future replacement should be anticipated.

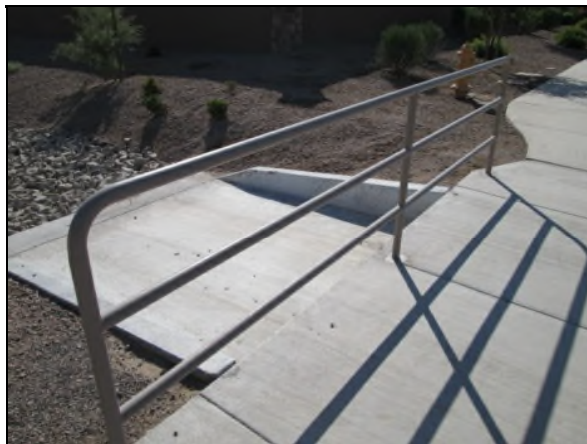
Comp #: 507 Culvert Rails - Replace

Funded?: No. These are iron pipe rails mounted on top of concrete culverts. They have an extended life span with no expectancy to replace in the foreseeable future. Inspections and repairs should be addressed as a maintenance expense when needed.

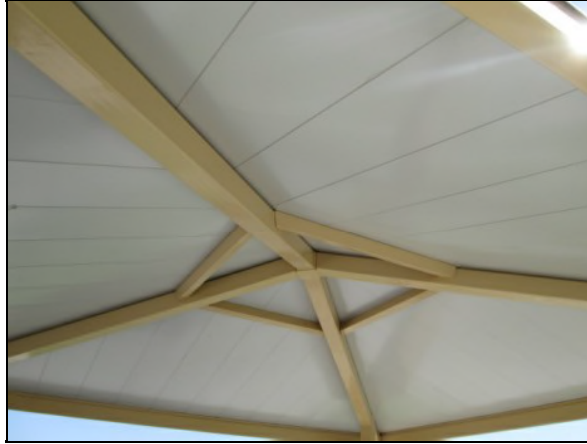
Comments: Surfaces were observed to be uniform and in good shape. This component funds to periodically repaint approximately 500 LF of metal fencing, 210 LF of culvert rails and the ramada roof. Repainting of metal surfaces has been scheduled to coincide with the block walls repainting projects.

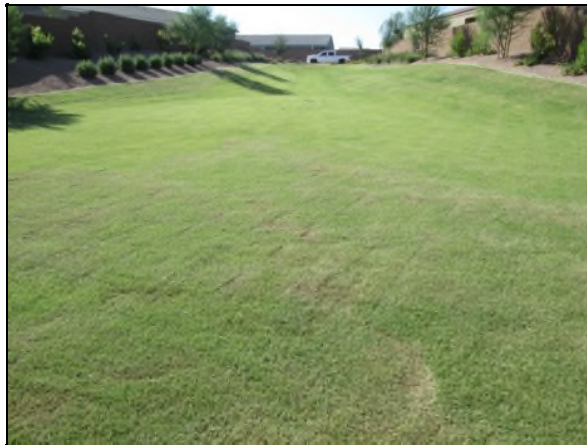
Comp #: 600 Irrigation System - Replace

Funded?: No. It is beyond the scope of this Reserve Study to quantify and assess conditions of the irrigation system. Funding can be provided for future replacement at the client's request, but we would need to be provided with cost and life expectancy estimates. Repairs and partial replacements should be included in the annual landscape maintenance budget.

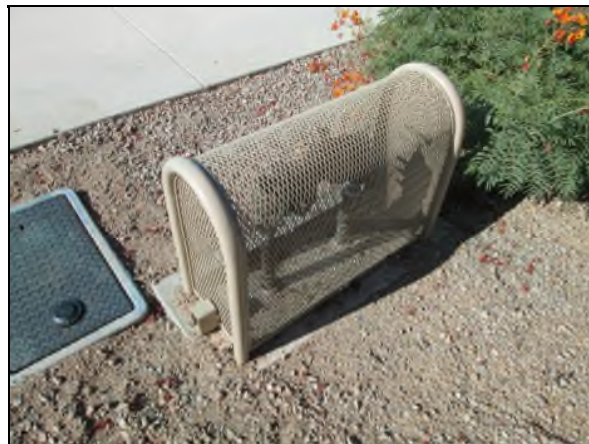
Comp #: 630 Backflow Valves - Replace

Funded?: No. Backflow valves typically last a long time. They can often be repaired and rebuilt rather than replaced. Recommend repairing or replacing as needed with Operating funds.

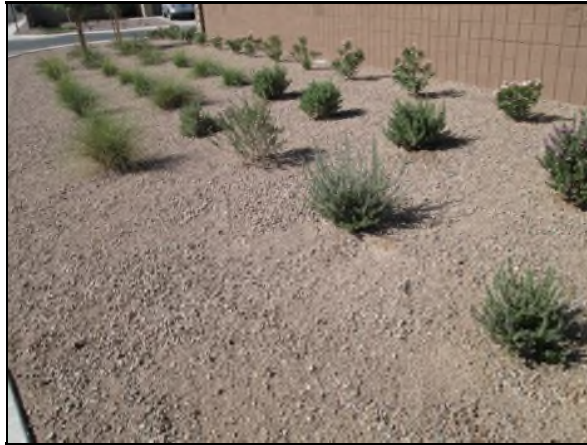
Comments: Complete replacement of the landscape granite is not anticipated. Coverage will deplete over time, so this component funds an allowance to top dress the existing granite with a new 1" layer, which is approximately 4,510 tons.

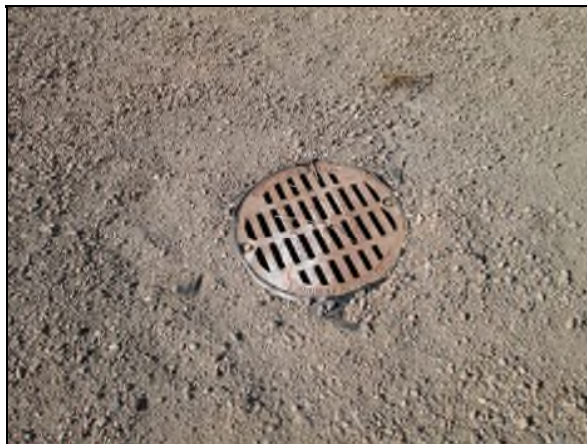
Comments: Drywells need to be inspected and cleaned out periodically to ensure proper operation and to prevent failure.

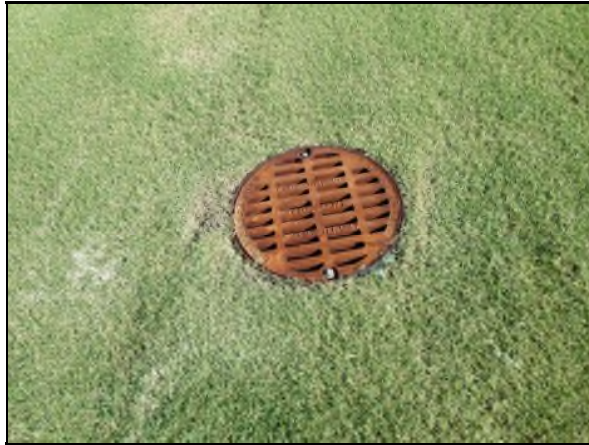
Comp #: 662 Drywells - Partial Replace

Comments: There is no expectancy to replace all drywells under normal circumstances. This component funds a long-term allowance for partial replacement in the event some do fail.

Allowance to replace (1) drywell
