Starling Madison Lofquist, Inc.  
*Consulting Structural and Forensic Engineers*

Subject: Roof Damage – Preliminary Structural Review  
Lake Park Villas  
5609 S. Hurricane Ct  
Tempe, Arizona 85283  
SML No. 006-22

Roof Damage – Preliminary Structural Review  
Lake Park Villas  
5609 S. Hurricane Ct  
Tempe, Arizona 85283  
SML No. 006-22

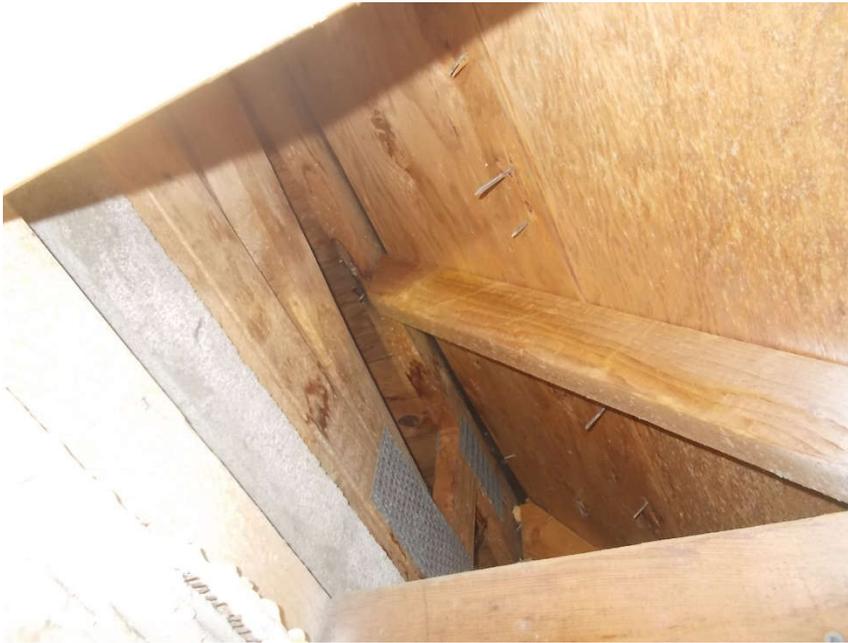
Basically, from what I saw looking at a very limited number of buildings, the structural damage to the mansard roofs is limited to the north and south sides of each unit.

Photo 1:  
View of typical mansard framing at north/south sides of units. Connections do not have appropriate framing hardware. **MODIFICATIONS ARE REQUIRED.**

I recommend removing the roof tile and sheathing from the north and south side of each unit, and then I would perform a follow up inspection. I believe that much of the existing wood framing can be re-used. We just need to add appropriate metal hardware/straps. The mansards would then receive new roof sheathing, and a lighter weight roof material. I also recommend removing the heavy stucco soffit material.

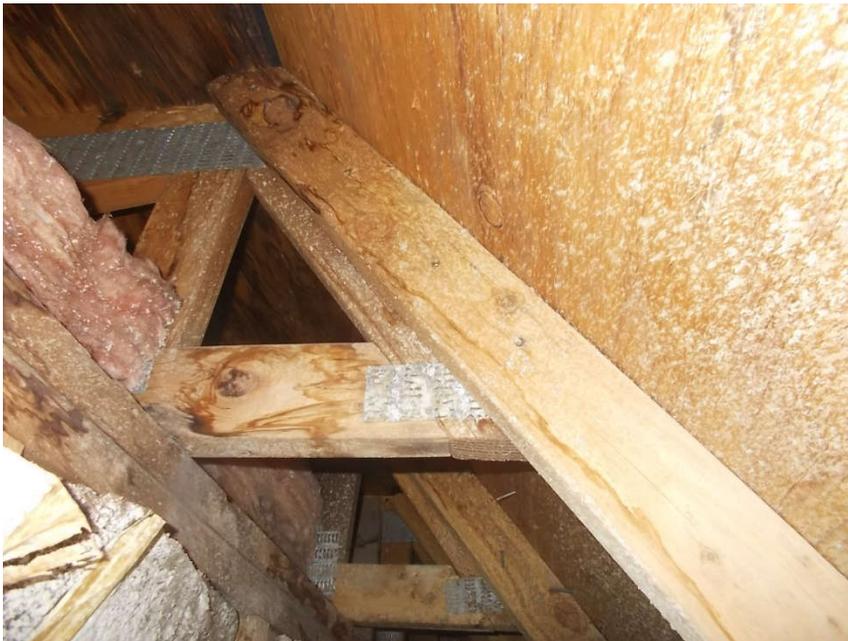
For the east and west side of each unit, and again based on my limited observations, I believe these

sections of roof are structurally sound. I would have to do some additional onsite inspections to verify this.

Photo 2:  
View of typical mansard framing at east/west sides of units. Mansard framing is "sistered" to side of roof trusses and appears to be stable and code compliant. **NO MODIFICATIONS REQUIRED.**
