Turtle Rock III

Pavement Field Assessment

October 2015

Evaluation of existing pavement
Including maintenance and replacement cost projections

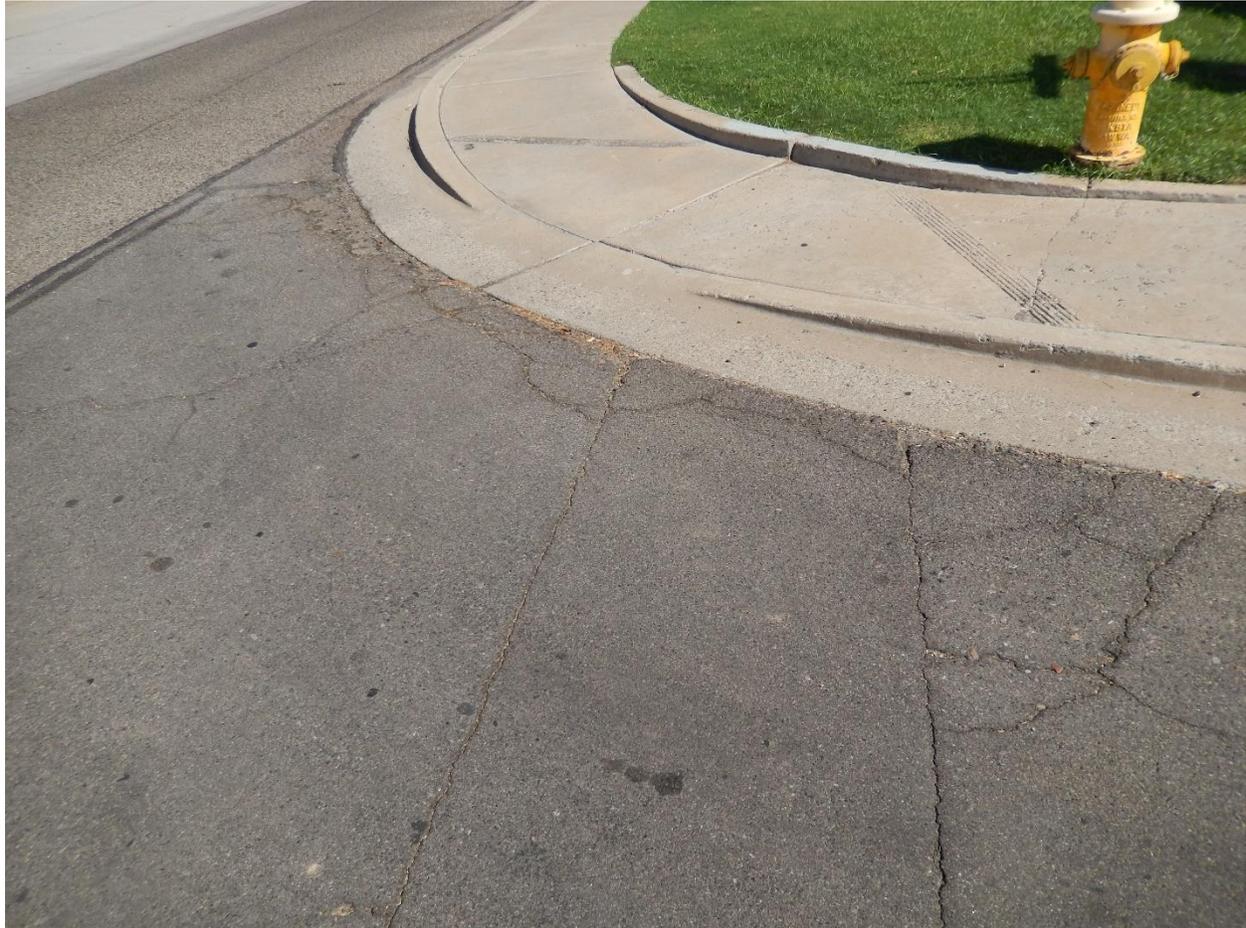
Traffic volume damage

Caused by site specific traffic volume ranging from standard passenger vehicles to heavy commercial and municipal trucks and buses. May apply to all or limited sections of the roadways

- a) Status: Present in limited areas
- b) Severity: Low
- c) Recommendation: Where applicable, require agencies, jurisdictions or entities imparting significant heavy loading to pay into a fund to offset the cost associated with the inevitable accelerated pavement deterioration

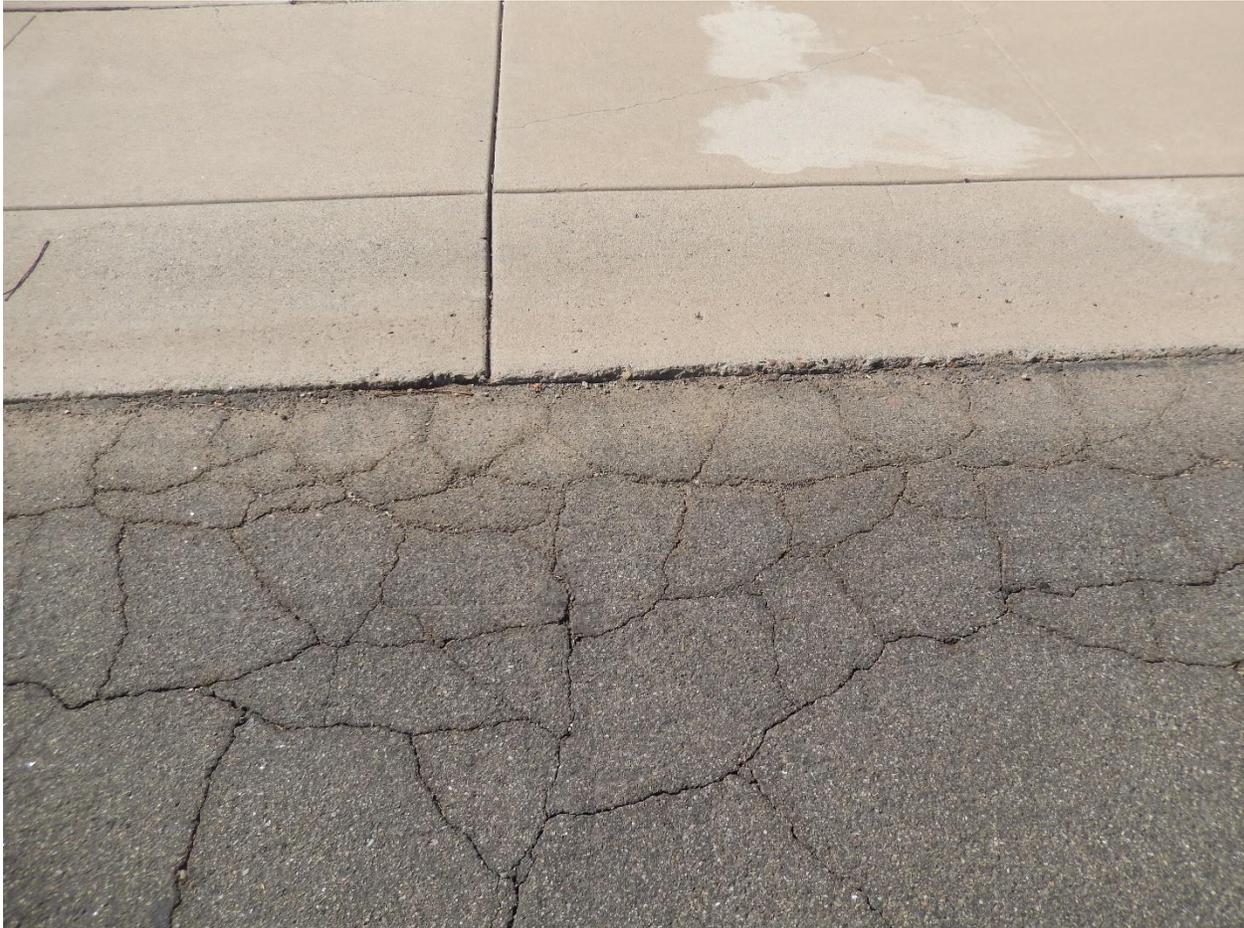
Water damage

Caused by overspray or runoff from improperly adjusted water systems and standing water due to improper drainage

- d) Status: Present throughout the property due to improper drainage
- e) Severity: High
- f) Recommendation: Reduce runoff, raise pavement surface 1/4" above concrete curbing

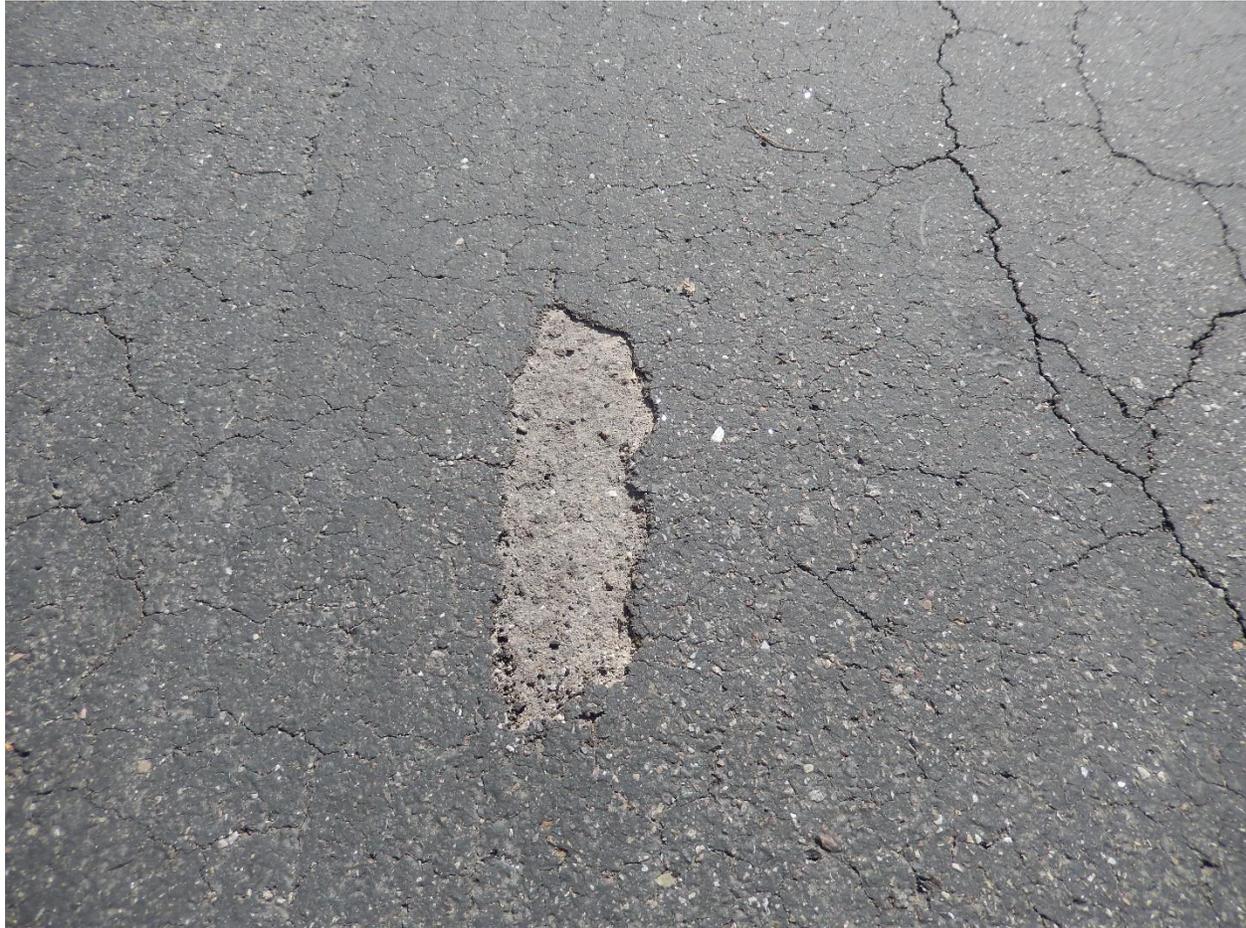
Existing overlay failures

Caused by improper installation techniques, thin overlay, inadequate compaction, improper materials, failure of surrounding or underlying pavement

- a) Status: Present in limited areas
- b) Severity: Low
- c) Recommendation: Full-depth removal of specified areas and 3" replacement with hot asphaltic concrete

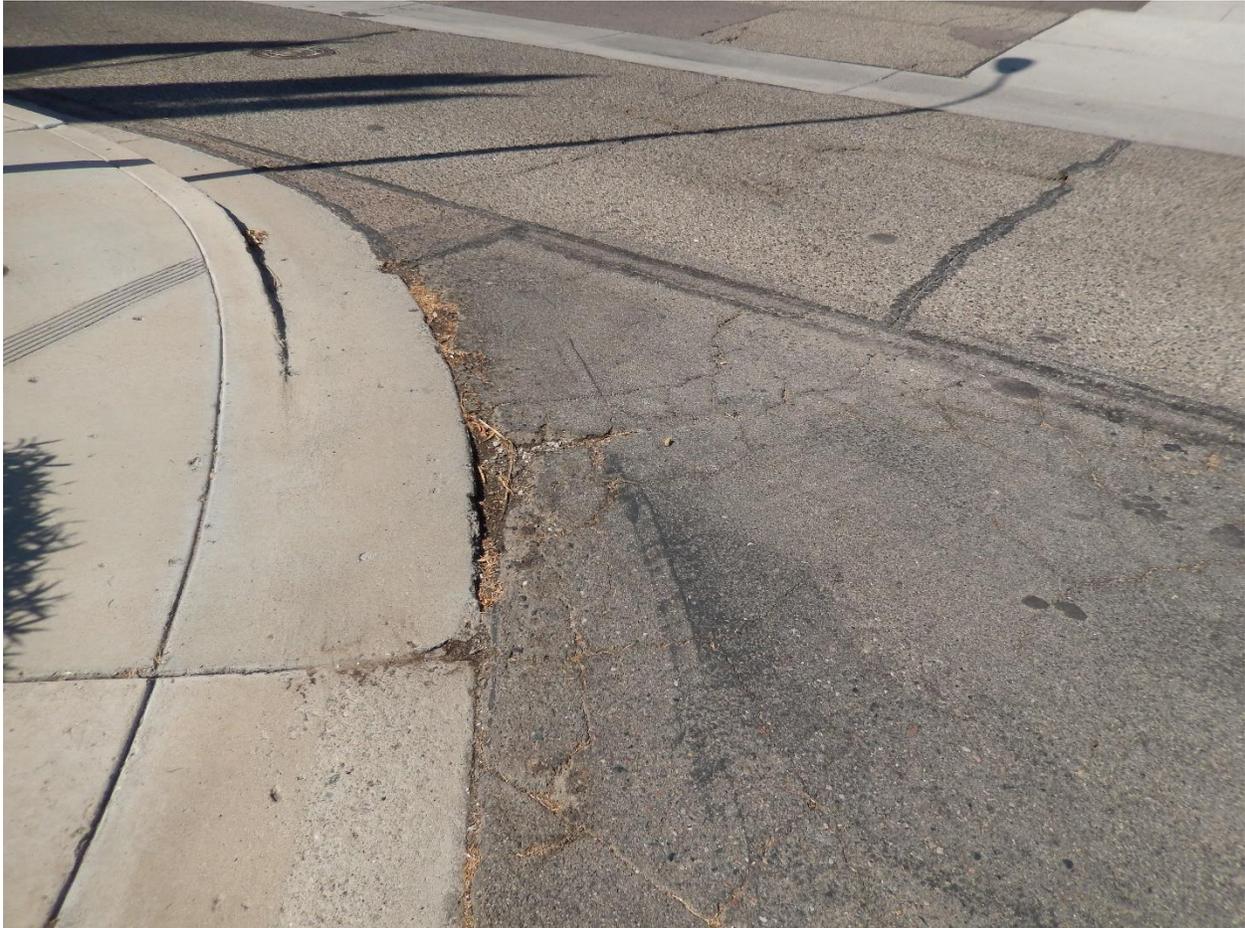
Potholes

Caused by poor surface mix, base/subgrade deficiencies, poor drainage, chemical and oil residue

- a) Status: Present in limited areas. Small, shallow, 1st-stage
- b) Severity: Medium – due to location and depth creating trip hazard liabilities
- c) Recommendation: Full-depth removal of specified areas and 3" replacement with hot asphaltic concrete

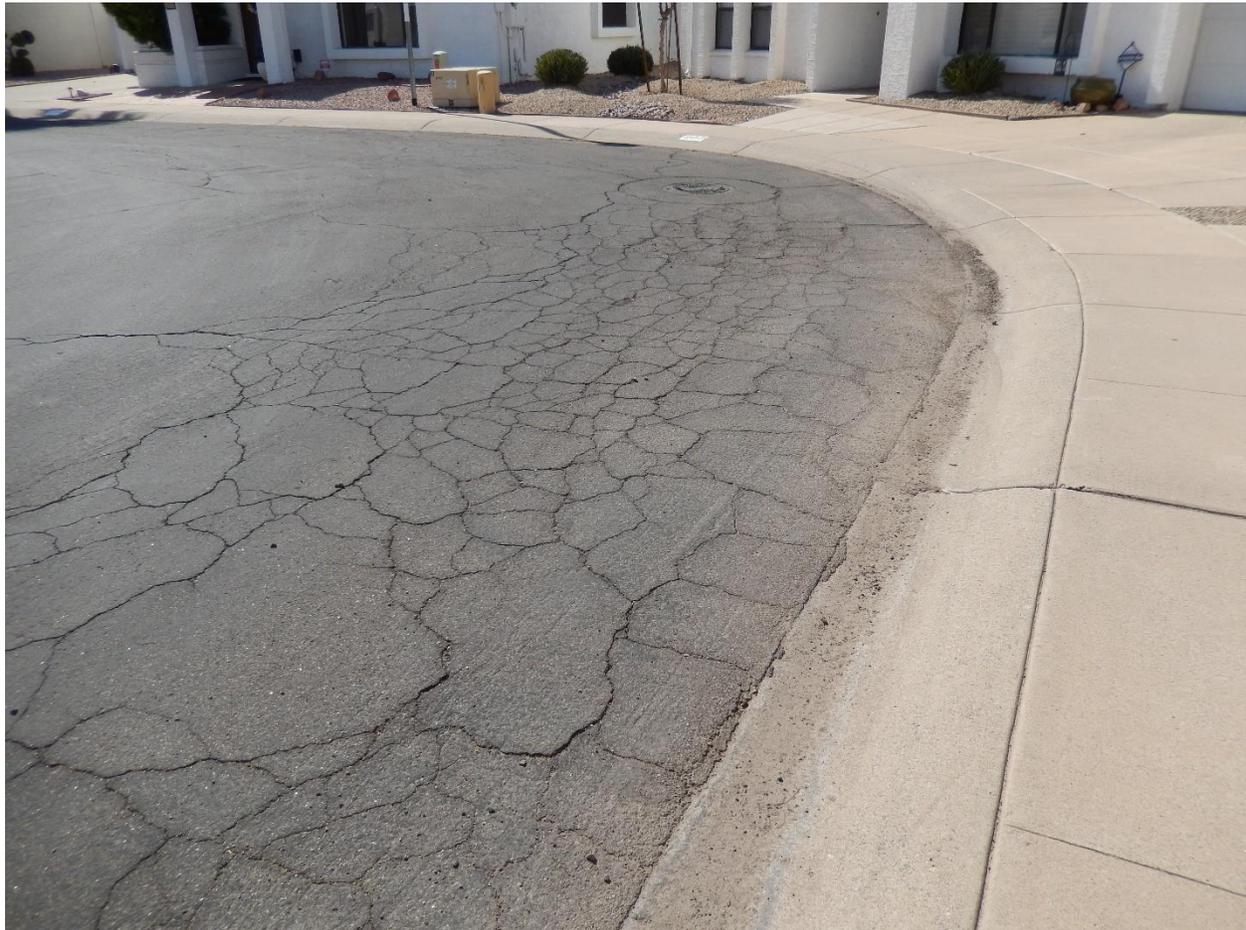
Raveling/weathering

Caused by poor compaction or improper temperature during pavement installation, lack of protective sealcoat, frequent exposure to water

- a) Status: Present in limited areas
- b) Severity: Low
- c) Recommendation: Clean and remove raveling surface fines and apply surface coat

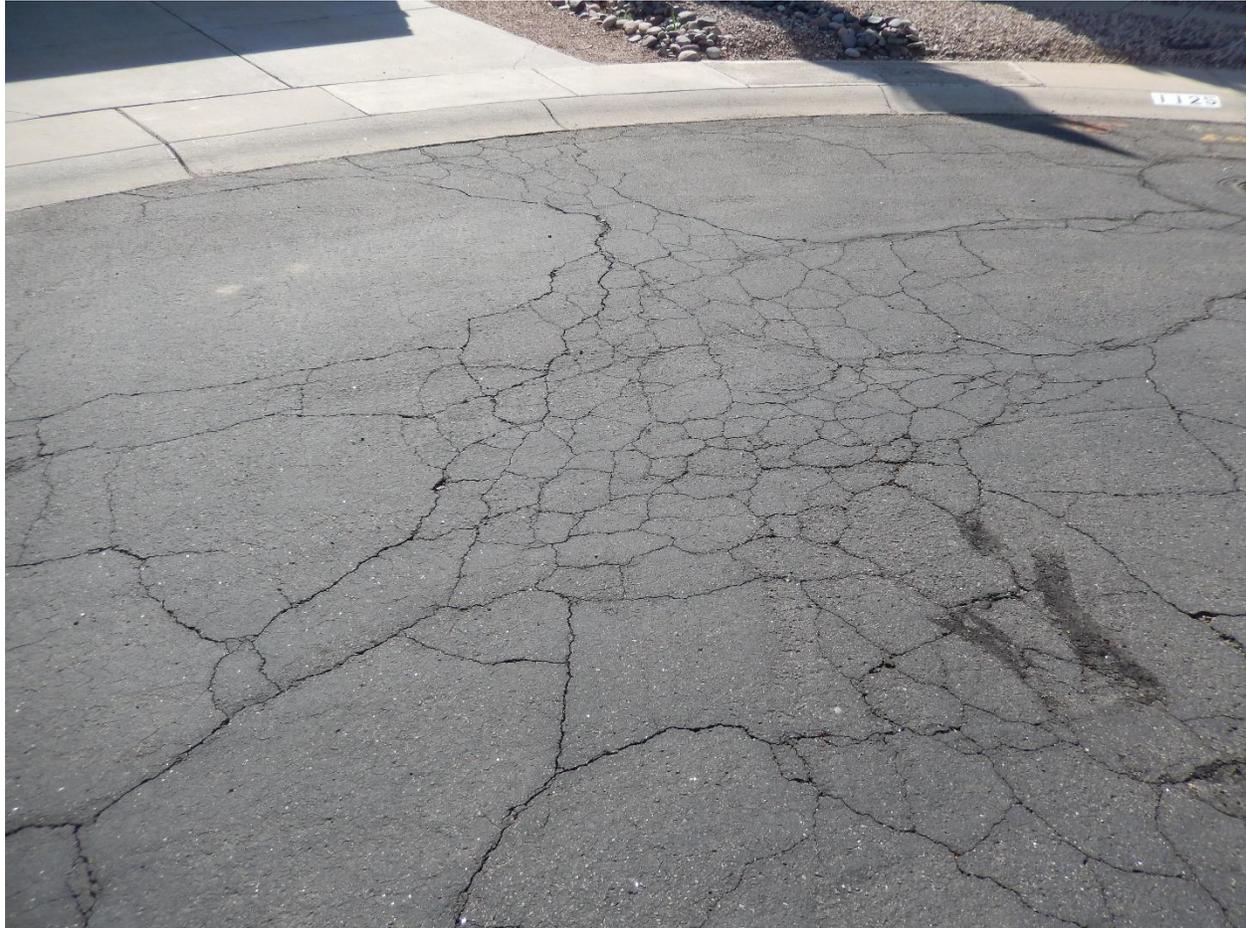
Fatigue cracking

Extreme fatigue cracking throughout the property suggests existing base/subgrade issues which can only be addressed through partial or complete removal and replacement. The wider cracks and sunken utilities constitute trip hazard liabilities and will require immediate attention.

Caused by excessive loading, thin surface, base/subgrade deficiencies, poor drainage

- a) Status: Present throughout property
- b) Severity: High, large areas of severe cracking with spalled edges
- c) Recommendation: Full-depth removal of specified areas and 3" replacement with hot asphaltic concrete

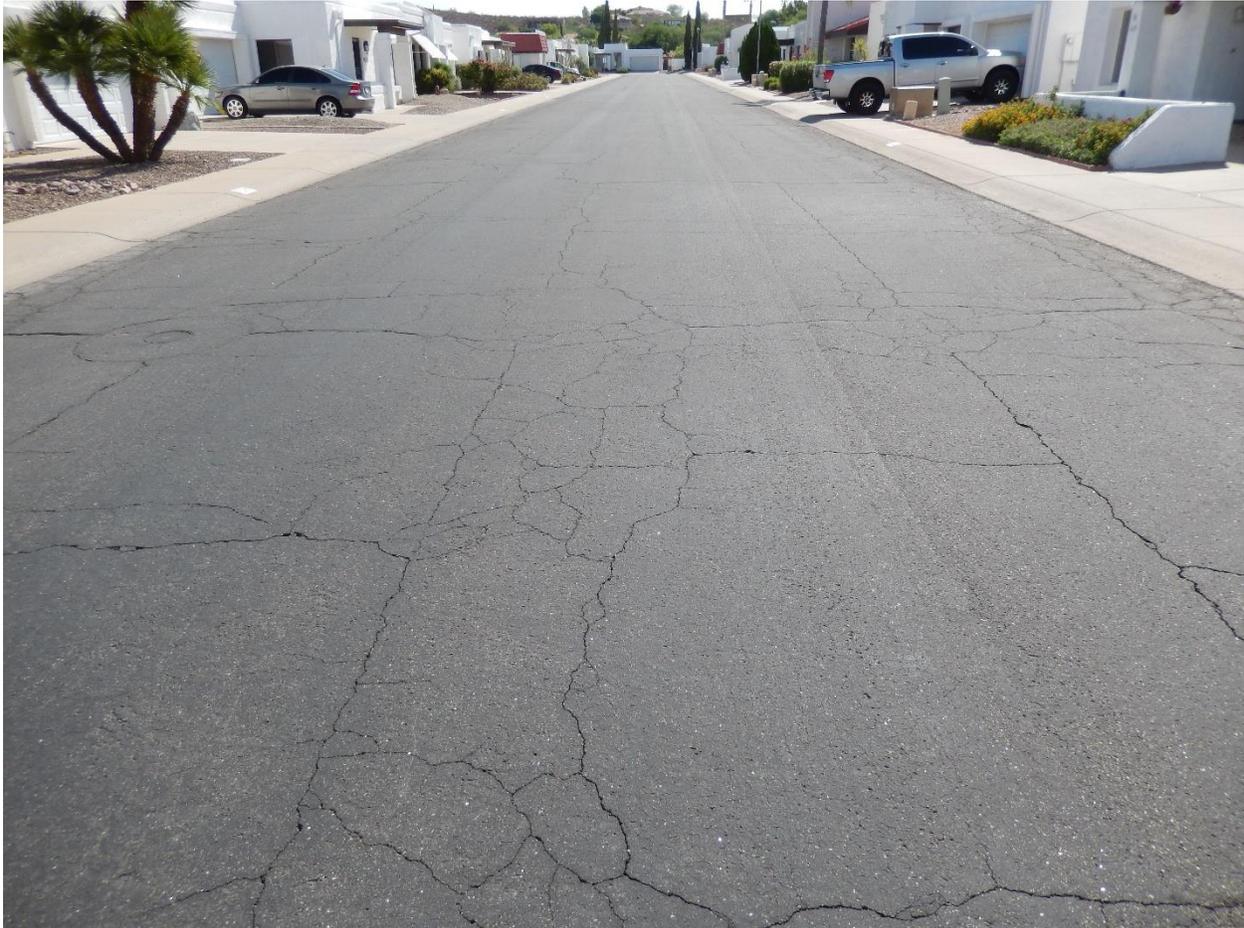
Longitudinal and transverse cracking

Caused by poorly constructed joint cracks, shrinkage of asphalt layer, operation of paver

- a) Status: Present throughout property
- b) Severity: High, 1" and 2" in width, spalled edges
- c) Recommendation: Treatment of cracks outside of fatigued areas with hot-applied sealant

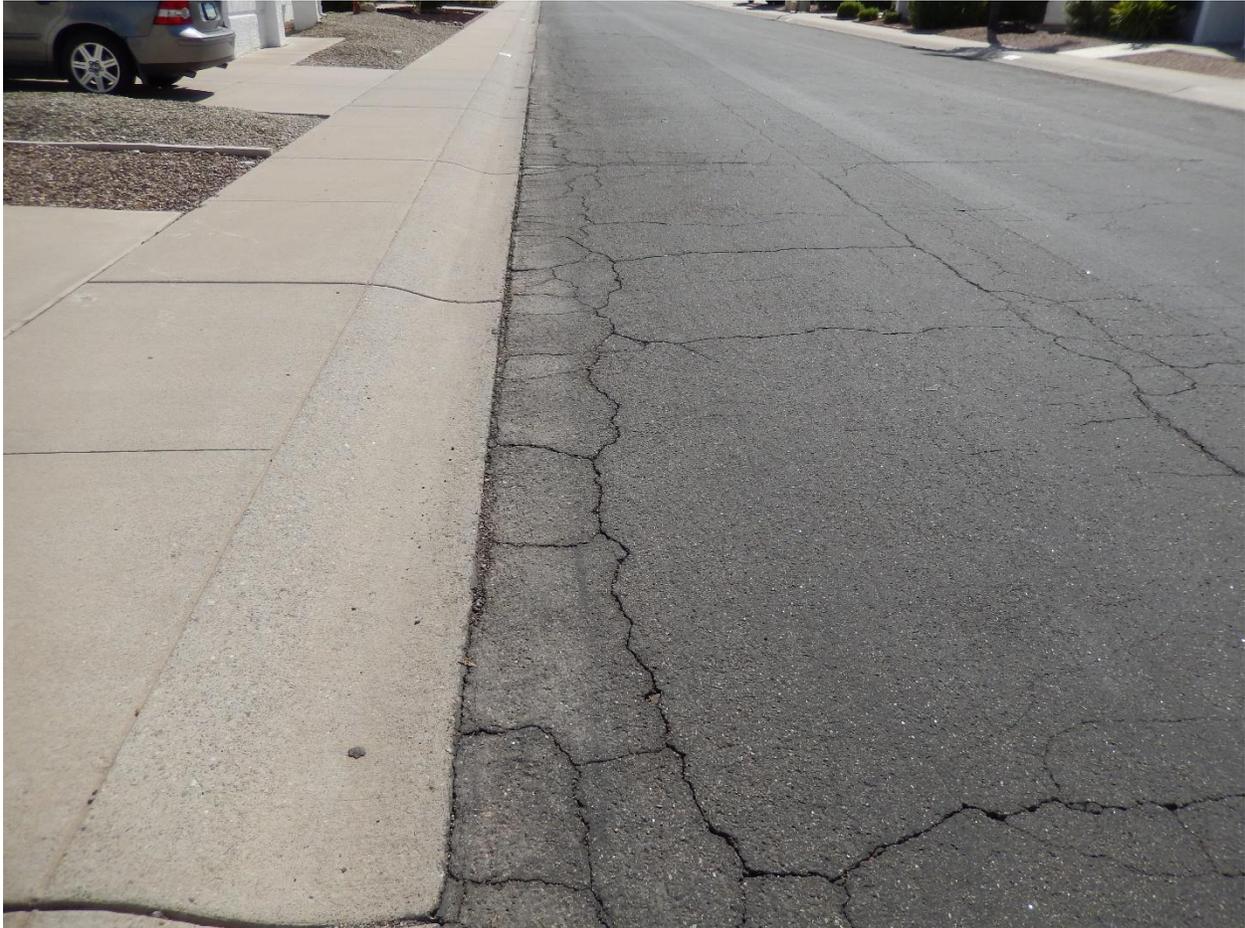
Edge cracks

Caused by lack of lateral support, thinning of pavement near edges

- a) Status: See "Settlement/grade depressions" below
- b) Severity: n/a
- c) Recommendation: Full-depth removal of specified areas and 3" replacement with hot asphaltic concrete

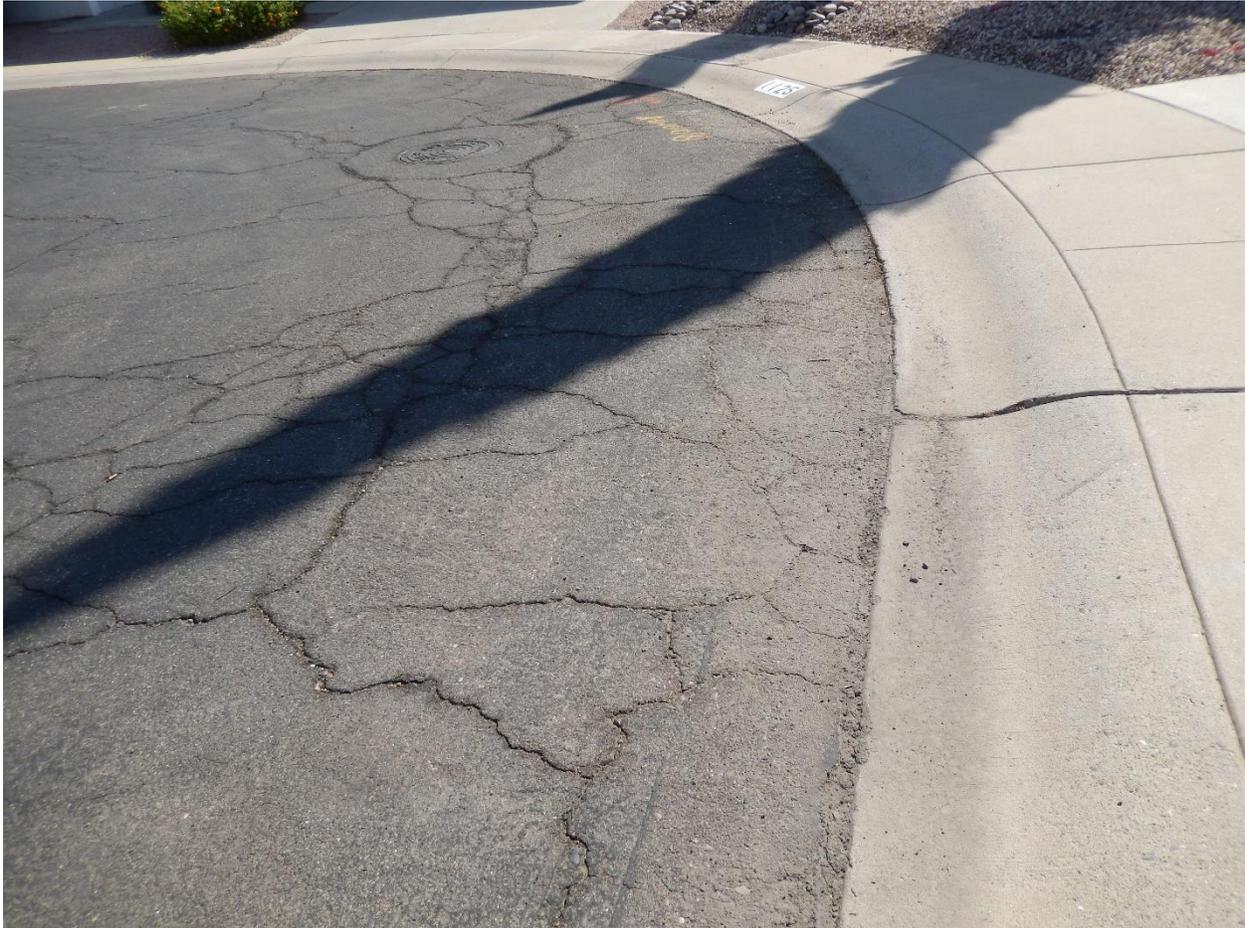
Settlement/grade depressions

Caused by settlement or failure in the lower pavement layers, base/subgrade deficiencies

- a) Status: Present throughout property along roadway edges
- b) Severity: High, due to quantity, 1/2" to 1" in depth, retaining water
- c) Recommendation: Full-depth removal of specified areas and 3" replacement with hot asphaltic concrete

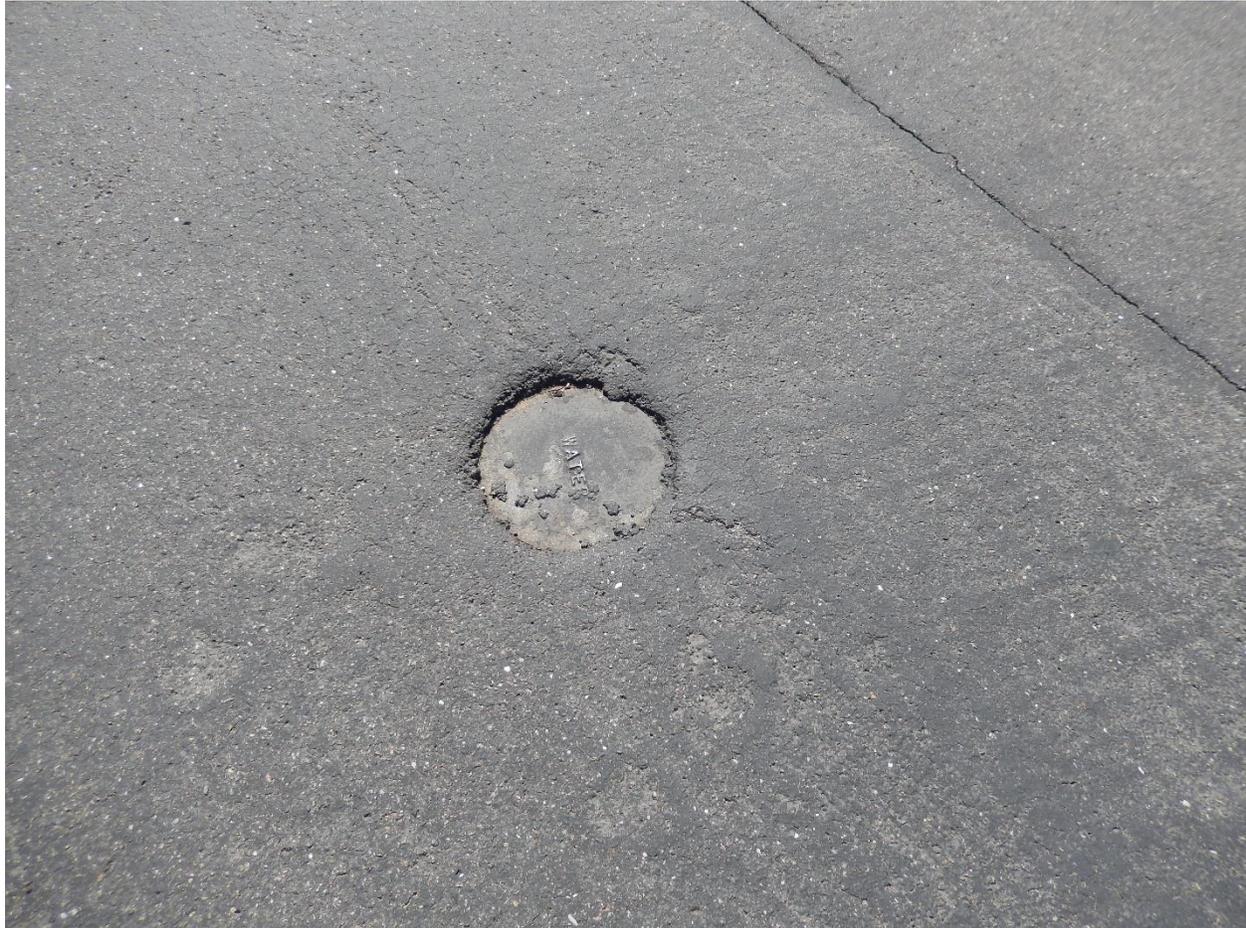
Sunken utilities

Caused by failure to adjust height of existing utilities to match surface treatment grade and level

- a) Status: Present in limited areas
- b) Severity: Medium, due to trip hazard liability
- c) Recommendation: Height adjustments after any grade or elevation changes

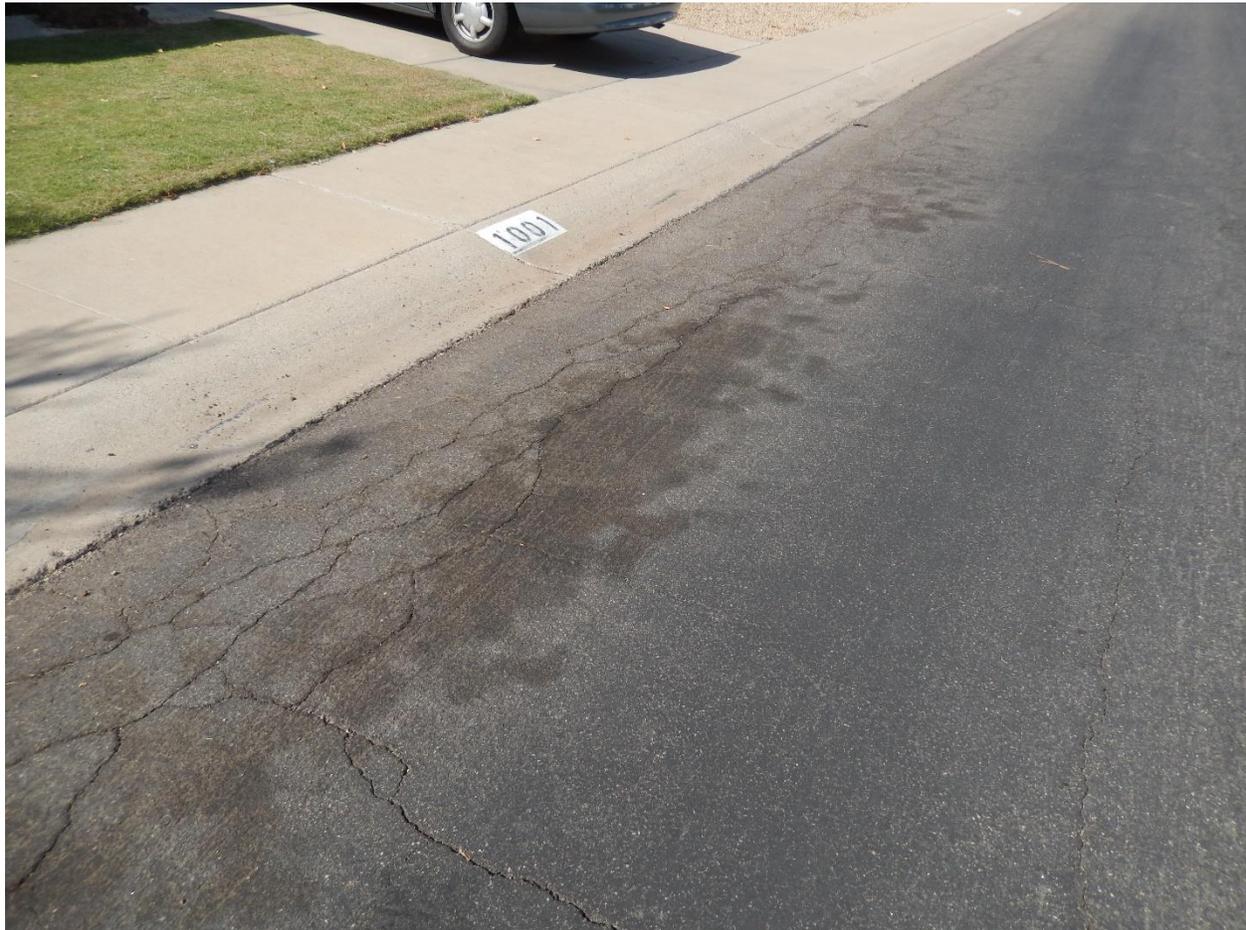
Oil or chemical residue

Caused by runoff from existing structures, leaking vehicles, spillage

- a) Status: Present in limited areas
- b) Severity: Low
- c) Recommendation: Thorough cleaning followed by treatment with poly bonding material prior to sealcoating
