**Palm Valley Phases II/III**  
**Cortile - P15/16**  
**Goodyear, AZ**

Report #: 9457-9  
Beginning: January 1, 2026  
Expires: December 31, 2026

**RESERVE STUDY**  
**Update "With-Site-Visit"**

August 26, 2025

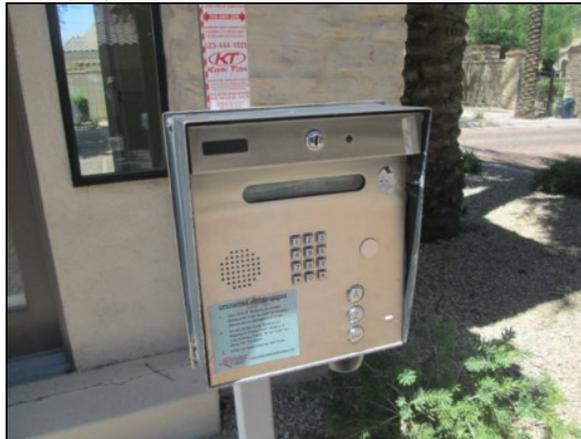
**Comp #: 110 Entry System - Replace**

**Useful Life:**  
15 years

**Remaining Life:**  
7 years

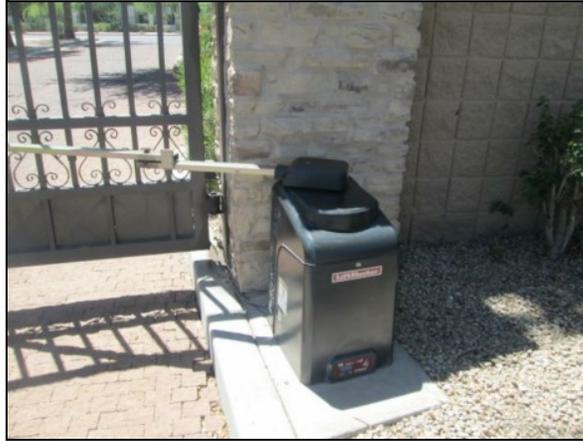
**Comp #: 114 Gate Operators - Replace**

**Useful Life:**  
15 years

**Remaining Life:**  
6 years
