Palm Valley Phases II/III
The Preserve - P8
Goodyear, AZ

Report #: 9457-9
Beginning: January 1, 2026
Expires: December 31, 2026

RESERVE STUDY
Update "With-Site-Visit"

August 26, 2025

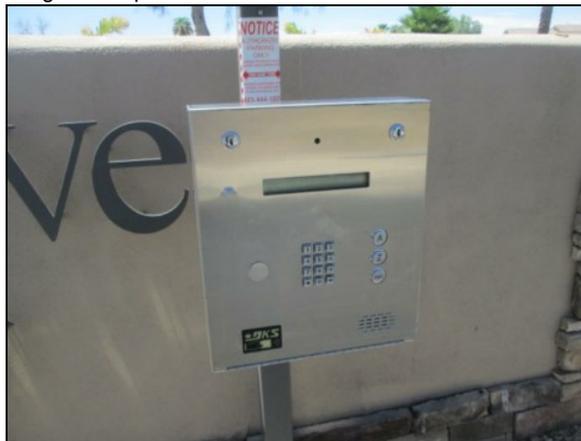
Comp #: 110 Entry System - Replace

History: Replaced in 2023 for \$7,641. Previously repaired in 2016 and installed in 2006.
