## Scottsdale Springs Condominiums

### *Scottsdale, AZ*

## RESERVE STUDY

### Update "With-Site-Visit"

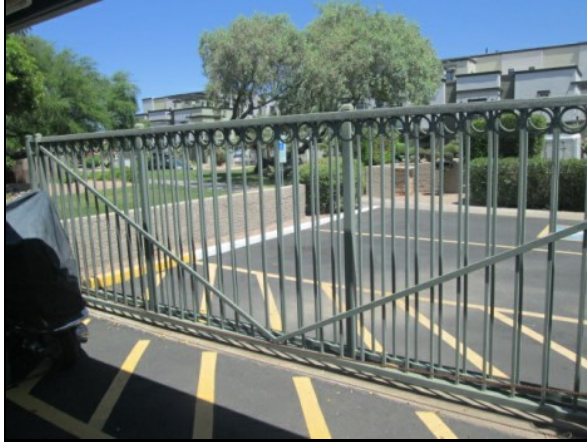
Comments: Useful Life and Remaining Useful Life have been extended per the client's request. Fence/gates are older and worn. Based on age, replacement should be anticipated soon.

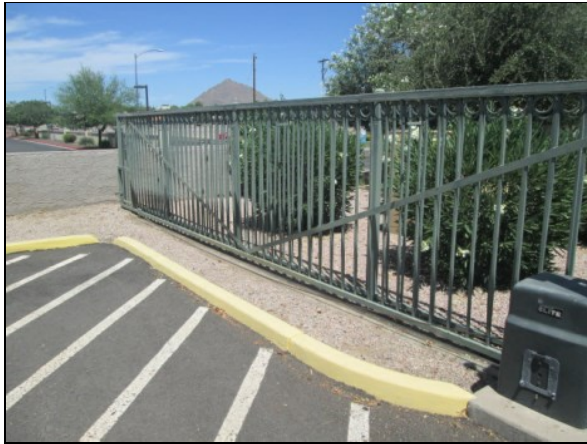
Comments: Surfaces appear to be oxidized and faded. Recommend planning to repaint in the near future to restore the appearance and to inhibit rust.

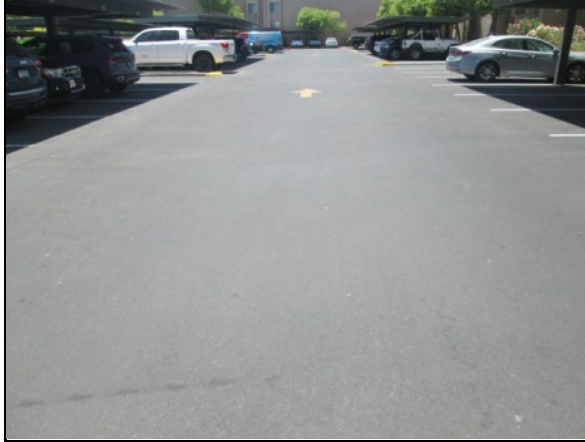
Comments: Asphalt is smooth and in good condition. This component funds to remove and repave the asphalt. Life span is based on periodically seal coating and maintaining the surface.

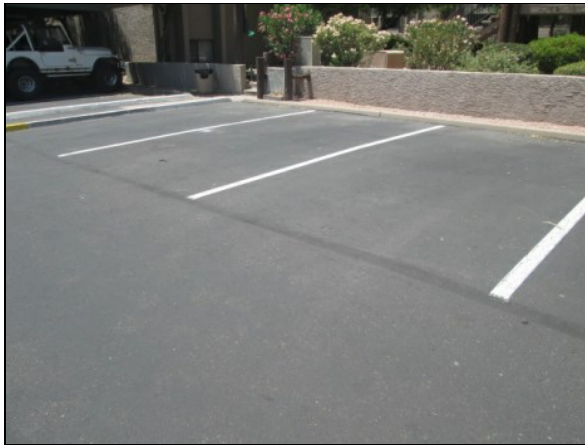
Comments: Seal appears to be in good shape with no problems reported. Seal coat asphalt surfaces periodically to prevent premature cracking and deterioration.

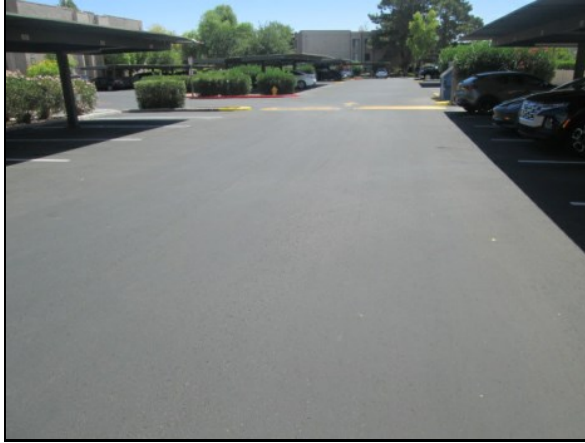
Comments: Asphalt is smooth and in good condition with some minor cracking starting to form. This component funds to remove and repave the asphalt. Life span is based on periodically seal coating and maintaining the surface.

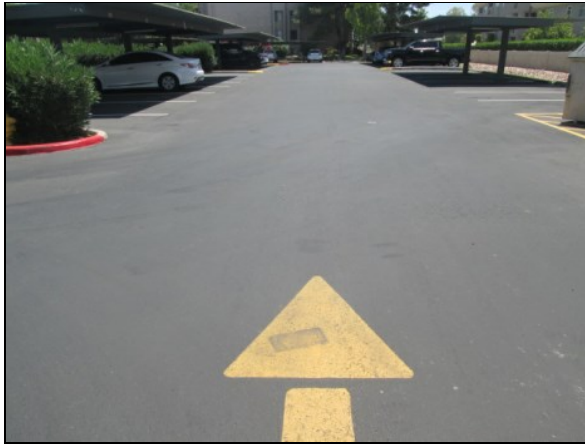
Comments: Seal appears in good shape with no problems reported. Seal coat asphalt surfaces periodically to prevent premature cracking and deterioration.

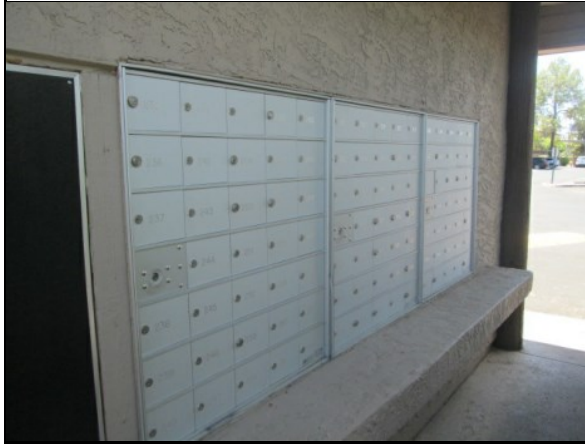
Comments: Quantity includes (10) 2-parcel lockers and (6) 5x7 clusters. Long life component under normal circumstances. Future replacement should be anticipated.

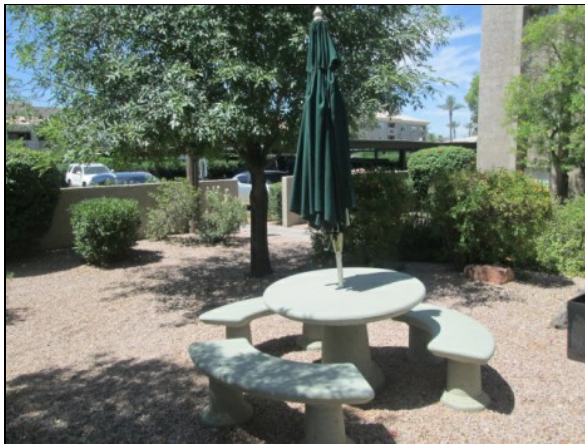
Comments: Concrete pieces include approximately (8) tables, (30) benches, and (19) trash/ash urns. Long life components under normal circumstances. It would still be prudent to plan for replacement eventually. Remaining Useful Life has been extended per the client's request.

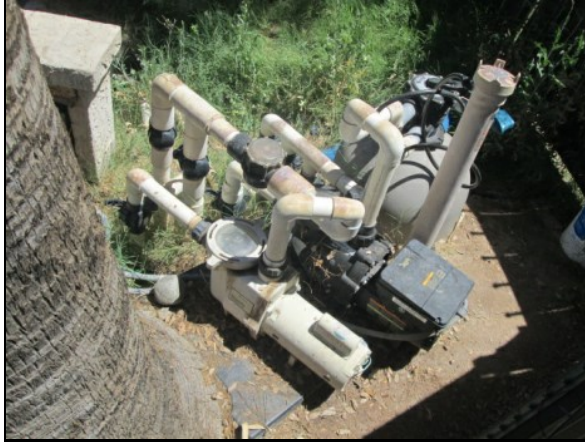
Comments: Appears functional with no problems reported. Periodic repair and motor replacement should be addressed as a maintenance issue. This component funds for replacement of the pump and motor assembly.

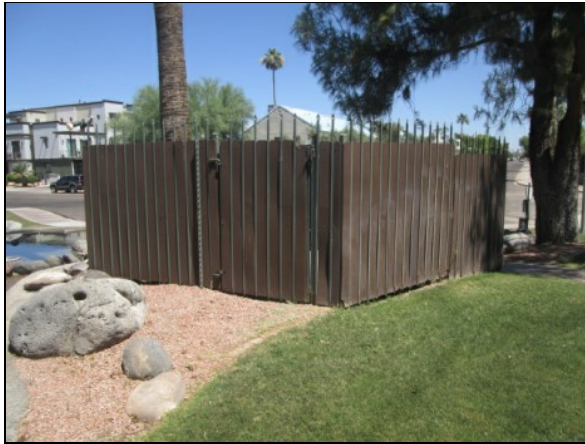
Comments: Fence appears older but still sturdy and intact. The water feature equipment fence also has composite slats that will require replacement. Repaint as an Operating expense to maintain the appearance and to inhibit rust.

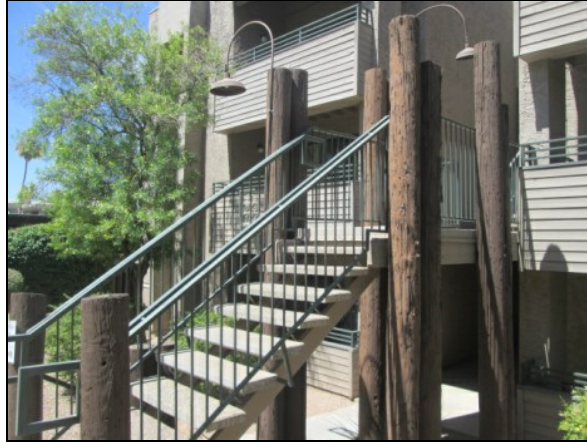
Comments: This component funds to repaint the balcony rails, stair handrails and unit numbers of buildings 5, 6, 9, 10 and 11. Repaint periodically to maintain the appearance and to inhibit rusting.

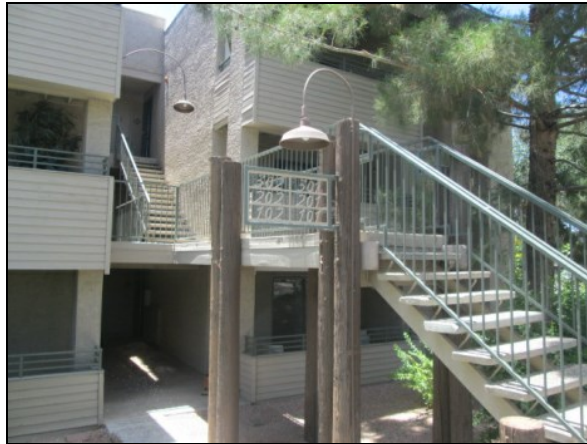
Comments: This component funds to repaint the balcony rails, stair handrails and unit numbers of buildings 4, 7, 8 and 12. Repaint periodically to maintain the appearance and to inhibit rusting.
