## **Turtle Rock III**

## **Pavement Field Assessment**

## **October 2015**

## **Field assessment**

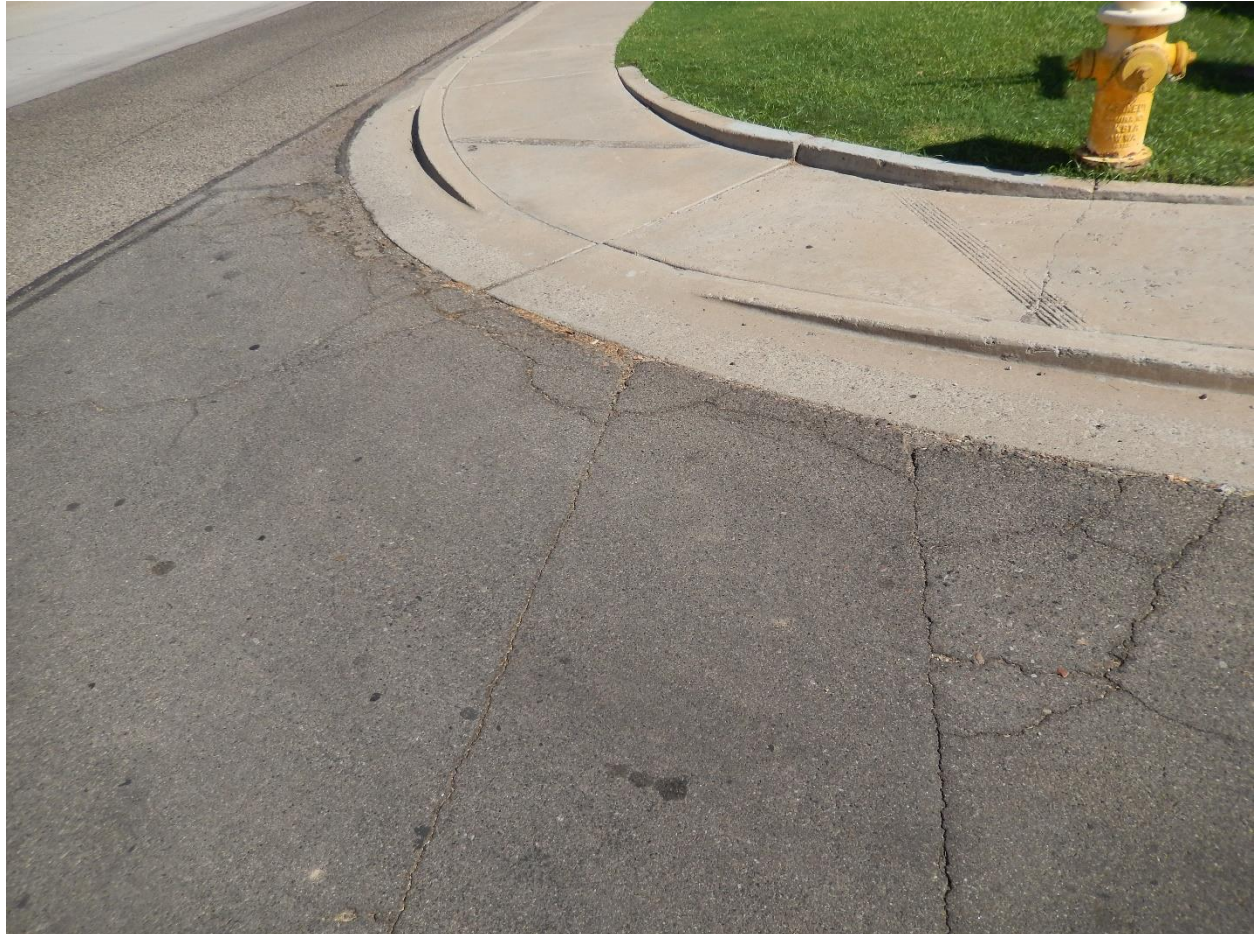
**Traffic volume damage**

**Caused by site specific traffic volume ranging from standard passenger vehicles to heavy commercial and municipal trucks and buses. May apply to all or limited sections of the roadways**

- a) Status: Present in limited areas
- b) Severity: Low
- c) Recommendation: Where applicable, require agencies, jurisdictions or entities imparting significant heavy loading to pay into a fund to offset the cost associated with the inevitable accelerated pavement deterioration

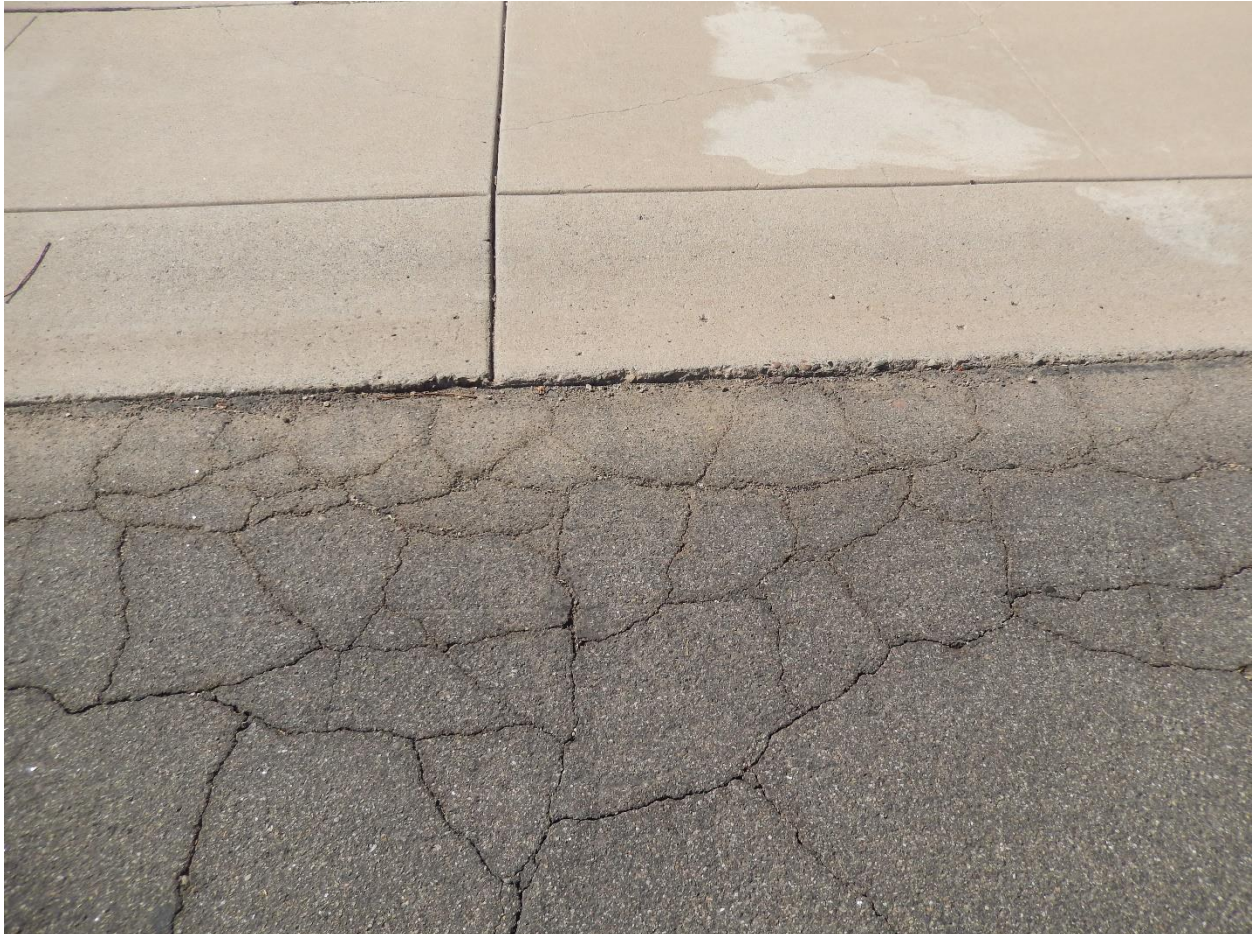
**Water damage**

**Caused by overspray or runoff from improperly adjusted water systems and standing water due to improper drainage**

- d) Status: Present throughout the property due to improper drainage
- e) Severity: High
- f) Recommendation: Reduce runoff, raise pavement surface 1/4" above concrete curbing

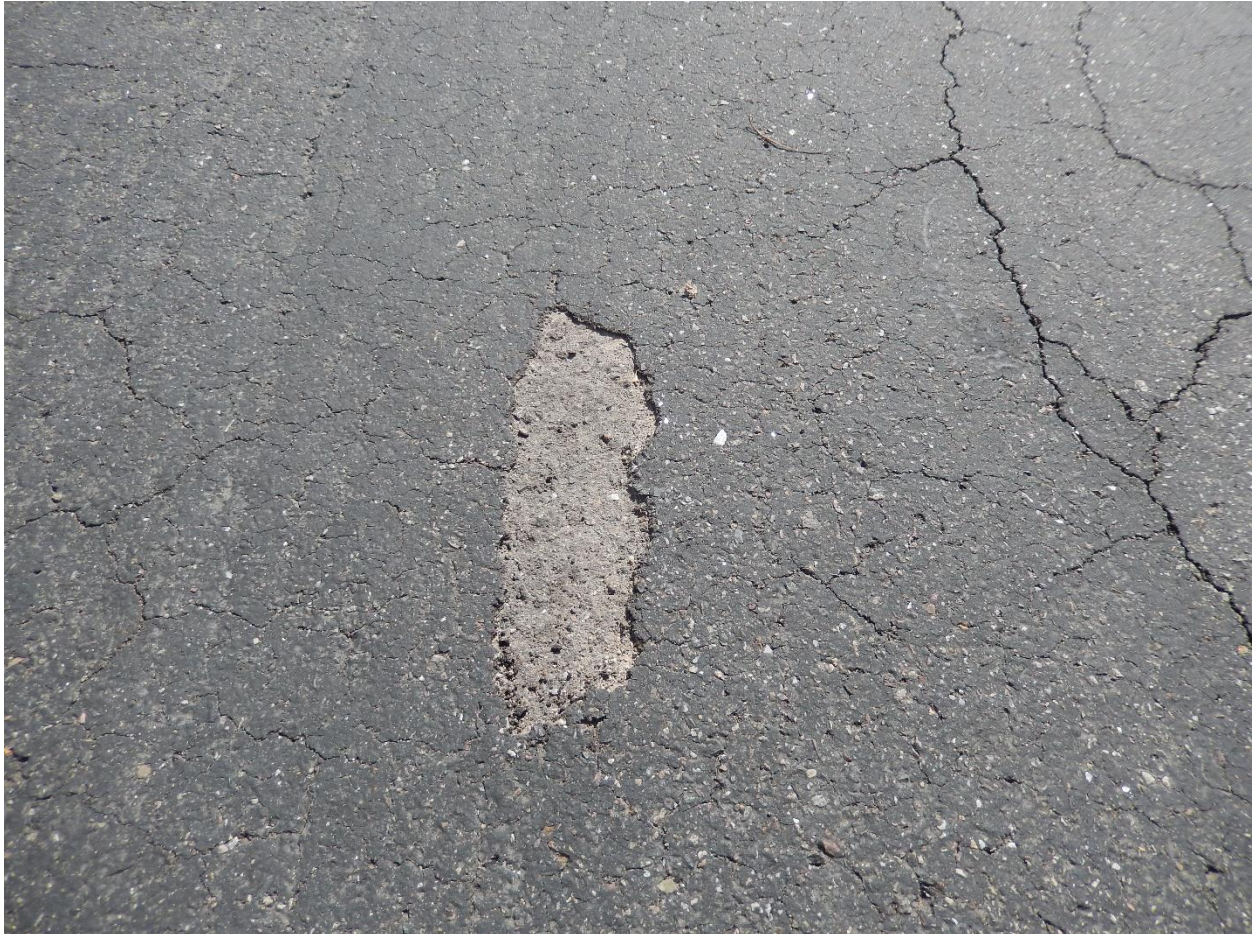
## **Existing overlay failures**

**Caused by improper installation techniques, thin overlay, inadequate compaction, improper materials, failure of surrounding or underlying pavement**

- a) Status: Present in limited areas
- b) Severity: Low
- c) Recommendation: Full-depth removal of specified areas and 3" replacement with hot asphaltic concrete

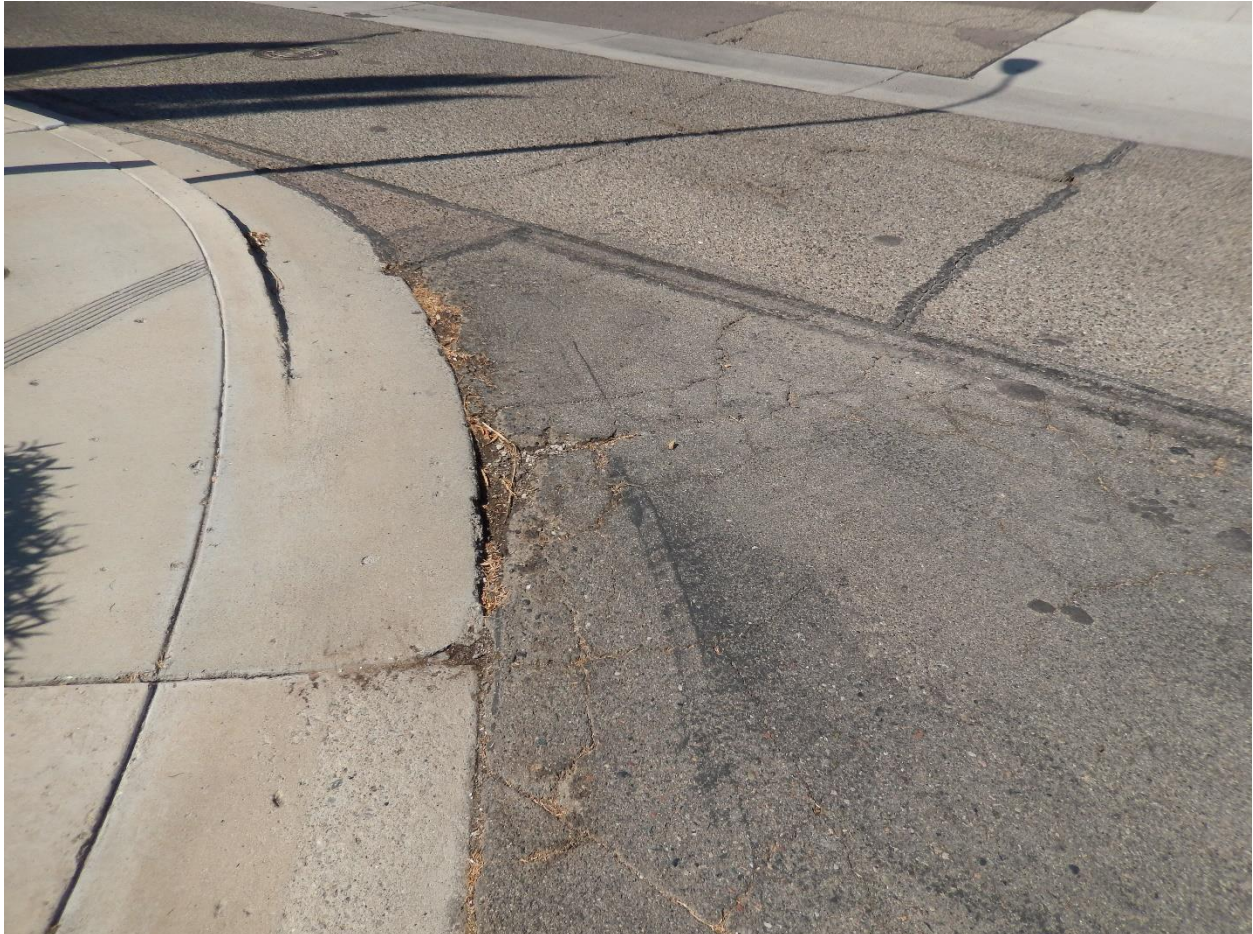
## Potholes

**Caused by poor surface mix, base/subgrade deficiencies, poor drainage, chemical and oil residue**

- a) Status: Present in limited areas. Small, shallow, 1st-stage
- b) Severity: Medium – due to location and depth creating trip hazard liabilities
- c) Recommendation: Full-depth removal of specified areas and 3" replacement with hot asphaltic concrete

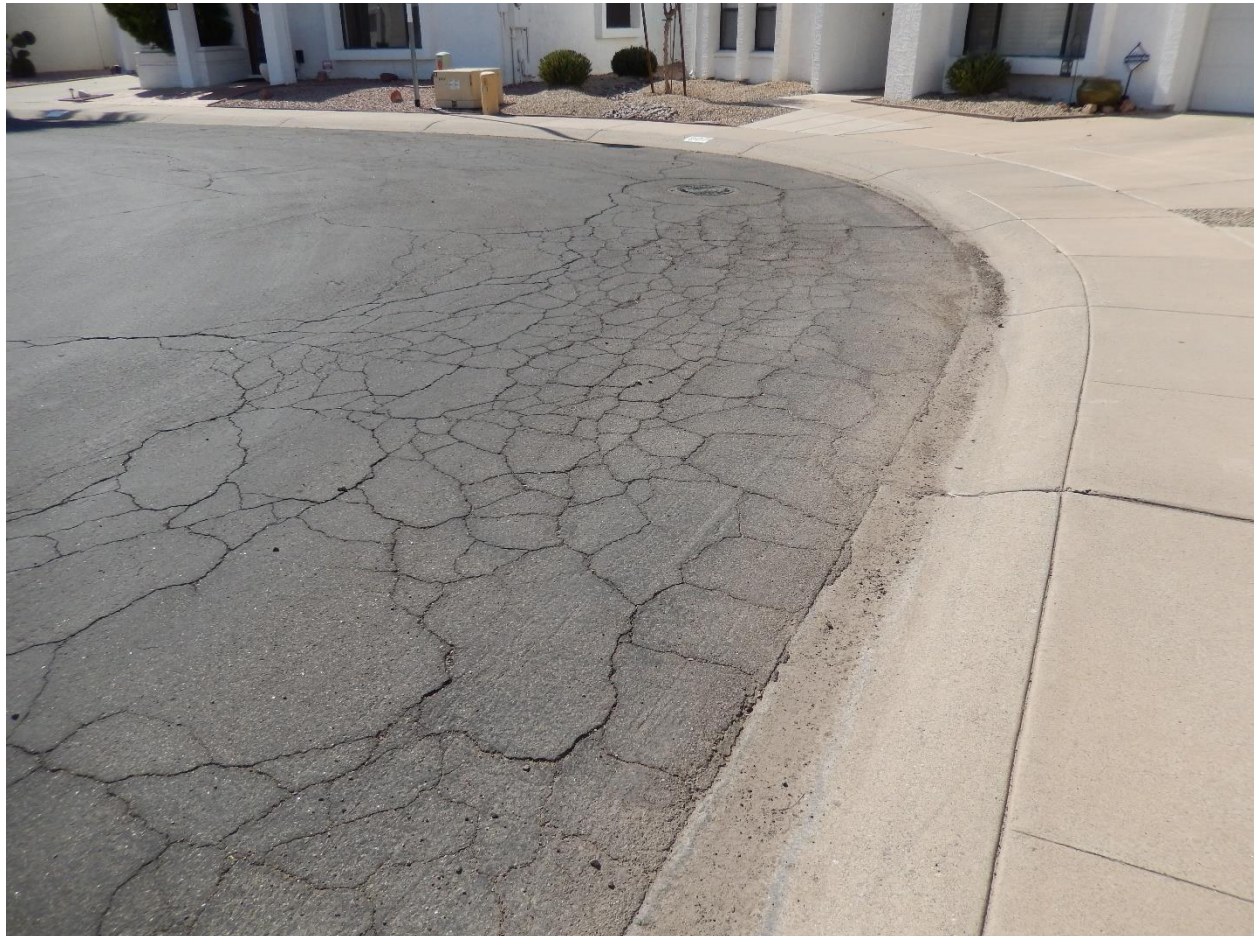
**Raveling/weathering**

**Caused by poor compaction or improper temperature during pavement installation, lack of protective sealcoat, frequent exposure to water**

- a) Status: Present in limited areas
- b) Severity: Low
- c) Recommendation: Clean and remove raveling surface fines and apply surface coat

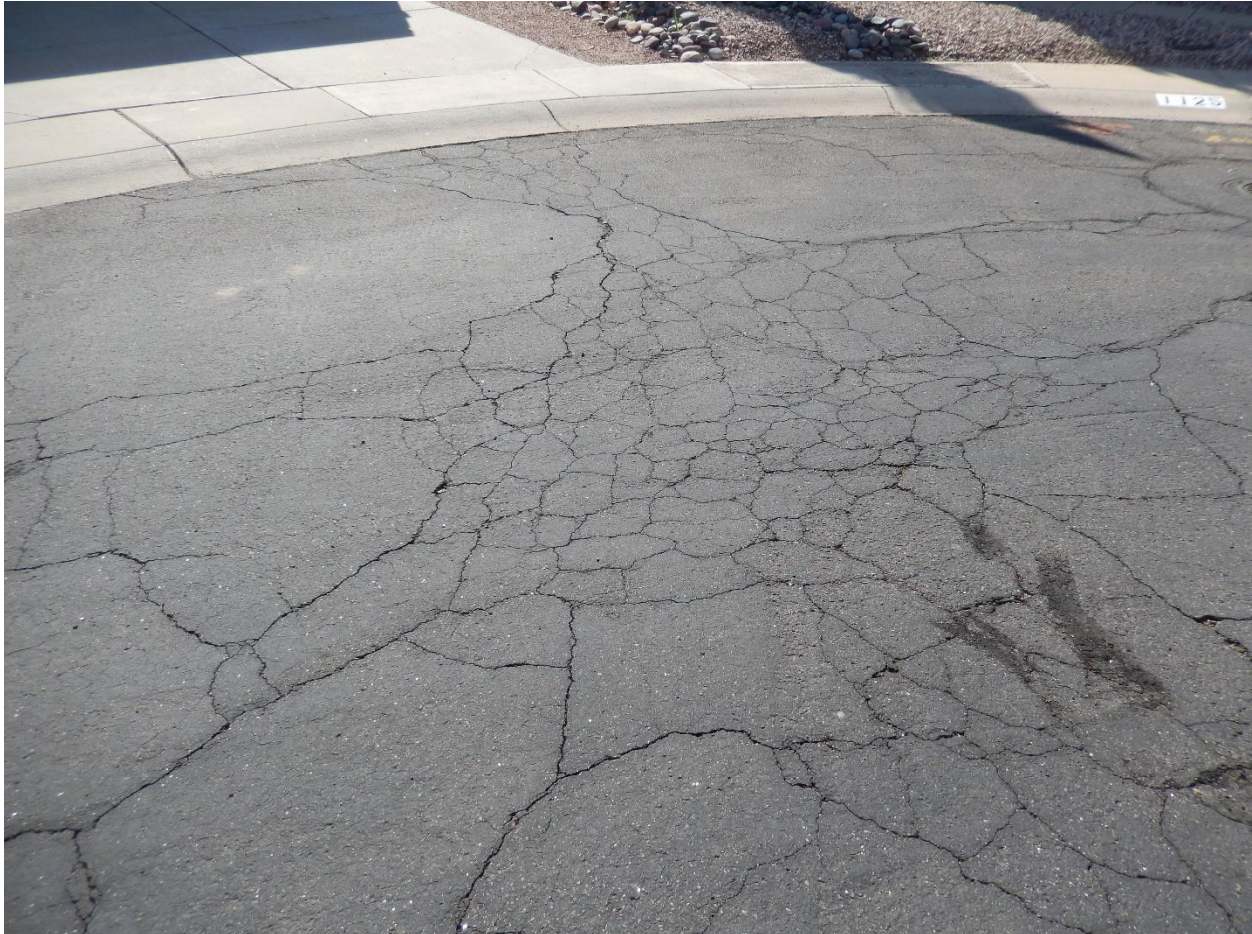
**Fatigue cracking**

**Caused by excessive loading, thin surface, base/subgrade deficiencies, poor drainage**

- a) Status: Present throughout property
- b) Severity: High, large areas of severe cracking with spalled edges
- c) Recommendation: Full-depth removal of specified areas and 3" replacement with hot asphaltic concrete

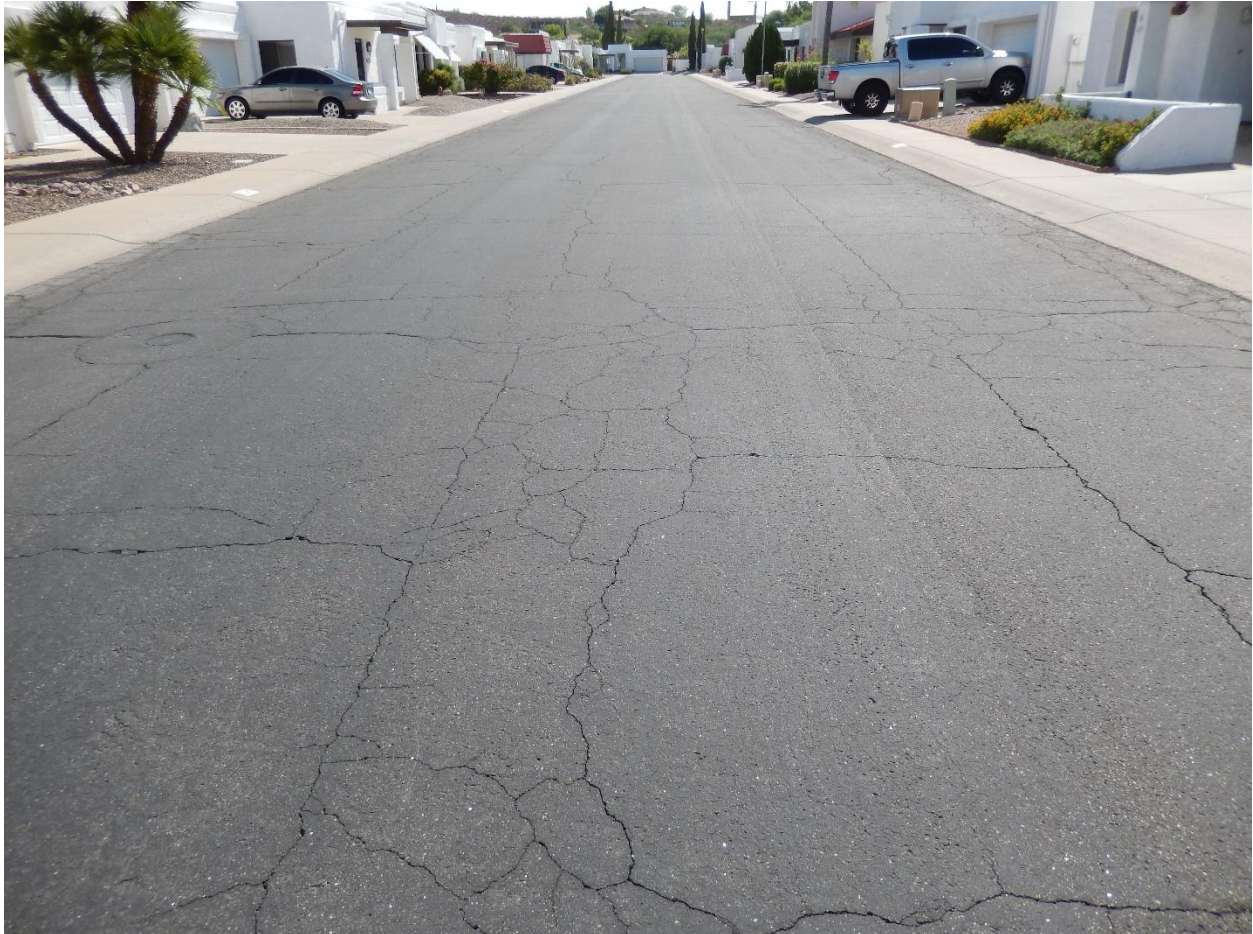
## **Longitudinal and transverse cracking**

**Caused by poorly constructed joint cracks, shrinkage of asphalt layer, operation of paver**

- a) Status: Present throughout property
- b) Severity: High, 1" and 2" in width, spalled edges
- c) Recommendation: Treatment of cracks outside of fatigued areas with hot-applied sealant

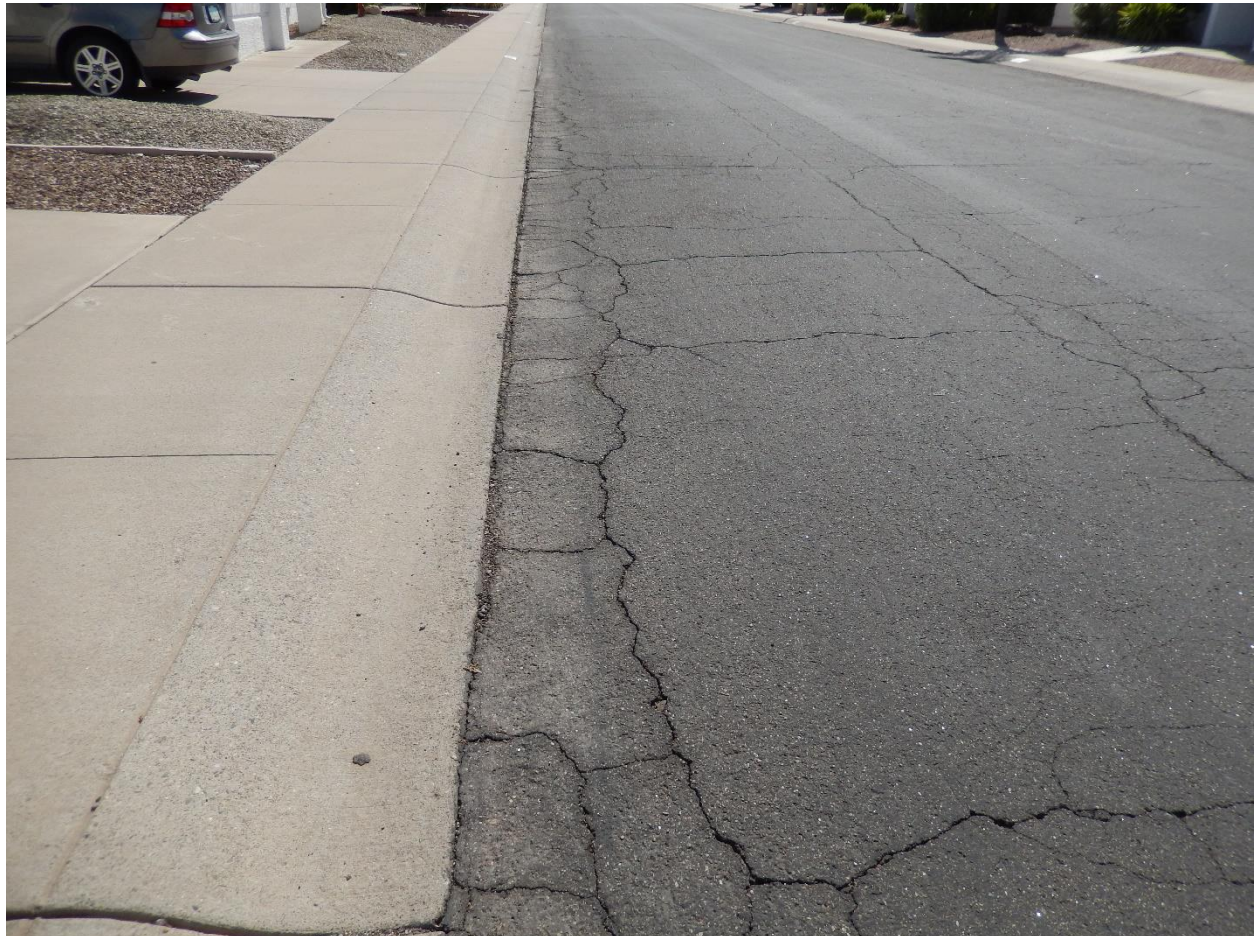
**Edge cracks**

**Caused by lack of lateral support, thinning of pavement near edges**

- a) Status: See "Settlement/grade depressions" below
- b) Severity: n/a
- c) Recommendation: Full-depth removal of specified areas and 3" replacement with hot asphaltic concrete

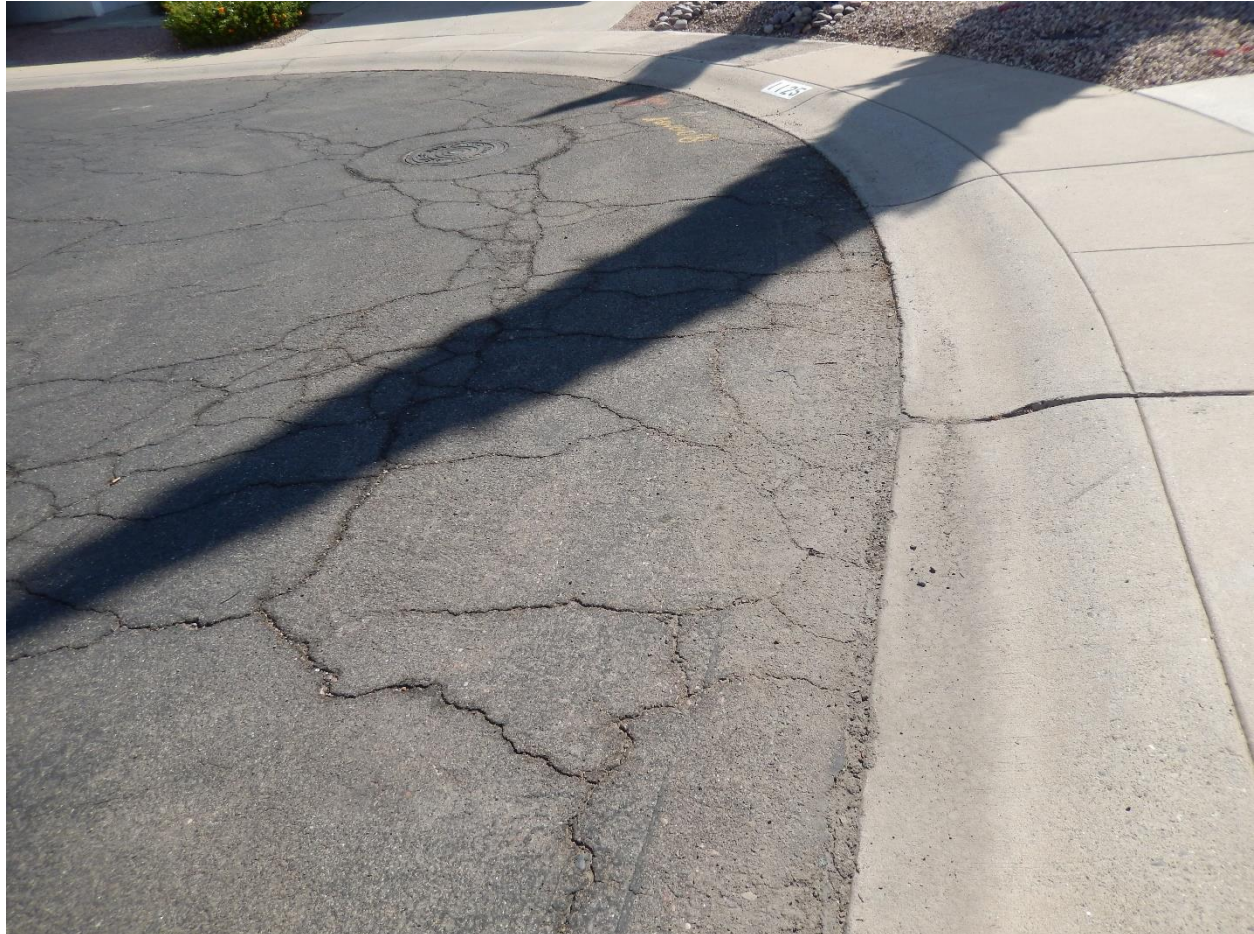
**Settlement/grade depressions**

### **Caused by settlement or failure in the lower pavement layers, base/subgrade deficiencies**

- a) Status: Present throughout property along roadway edges
- b) Severity: High, due to quantity, 1/2" to 1" in depth, retaining water
- c) Recommendation: Full-depth removal of specified areas and 3" replacement with hot asphaltic concrete

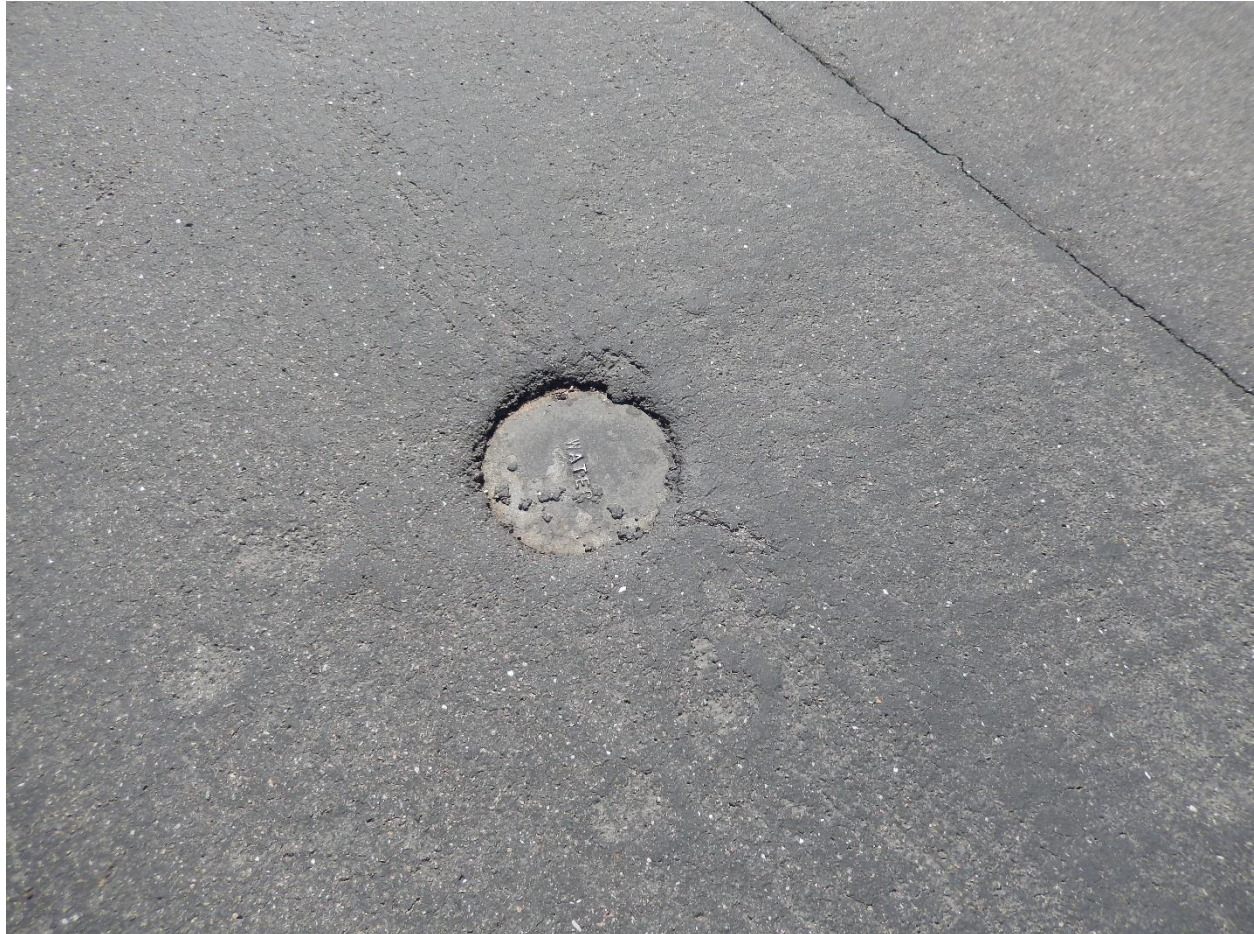
**Sunken utilities**

### **Caused by failure to adjust height of existing utilities to match surface treatment grade and level**

- a) Status: Present in limited areas
- b) Severity: Medium, due to trip hazard liability
- c) Recommendation: Height adjustments after any grade or elevation changes

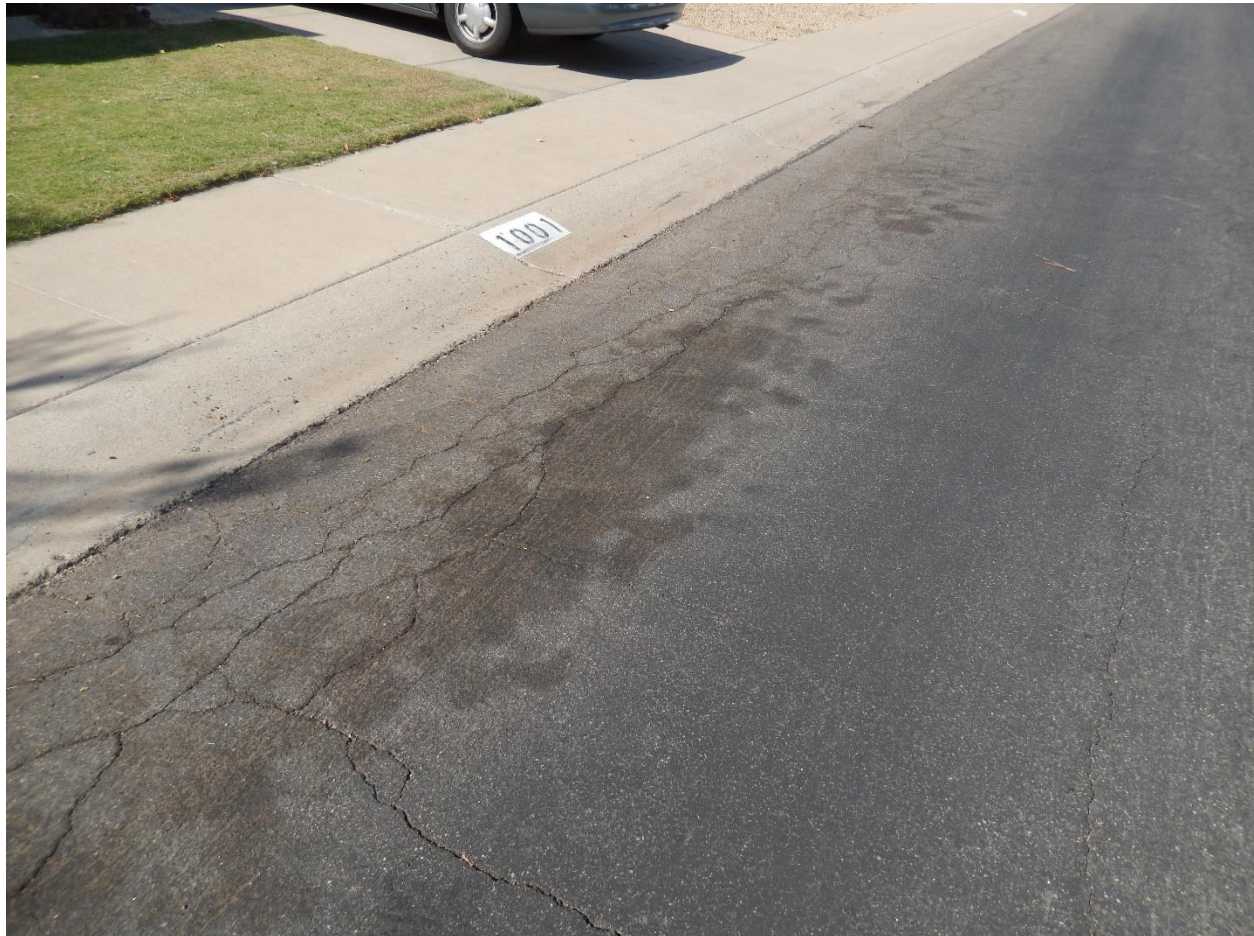
**Oil or chemical residue**

**Caused by runoff from existing structures, leaking vehicles, spillage**

- a) Status: Present in limited areas
- b) Severity: Low
- c) Recommendation: Thorough cleaning followed by treatment with poly bonding material prior to sealcoating
