# Report of Findings

## Woodland Park Homeowners Association

Frank Civil Consulting

February 29, 2016

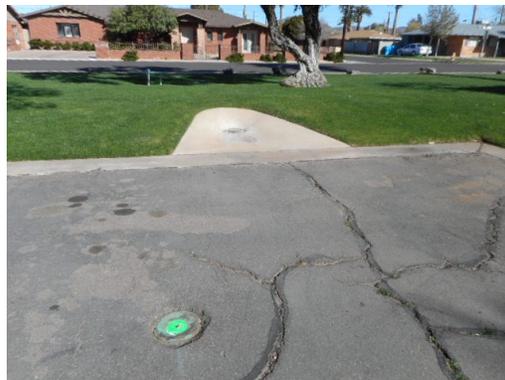
Exhibit 1

The first location identified was a "wet well" located at approximately the mid-point of the property at the north end of the Community in a common element just north of the Hazelwood Street cul-de-sac (Exhibit 1). This drainage component is made of brick and mortar and appears to receive a portion of the storm water generated at the east end of Hazelwood Street and all storm water within the cul-de-sac. The well grate was grouted in place; therefore, we were unable to determine its performance ability (Exhibit 2). We are not sure if this was truly a part of the original design and construction; however, "wet wells" of this nature will fill with sediment and eventually lose the ability to percolate storm water.

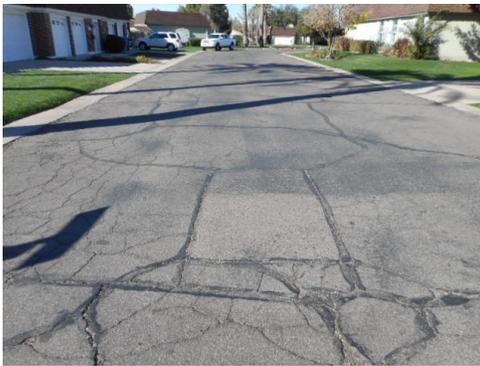
Exhibit 4

The surface condition of Hazelwood Street is extremely dry and brittle and instability of the original pavement is reflecting through the surface of the slurry seal (Exhibit 4). There is considerable structural and finite cracking occurring throughout the pavement surface (Exhibit 5). Thermal shrinkage and pavement structural failure cracks exist from approximately hairline to ½” in width (Exhibit 6). Some of this cracking is the result of moisture intrusion into the sub terrain creating instability that impacts the structural stability of the pavement above while other cracking is related to the age and brittle nature of the pavement section. Asphalt failure was exhibited throughout this street.

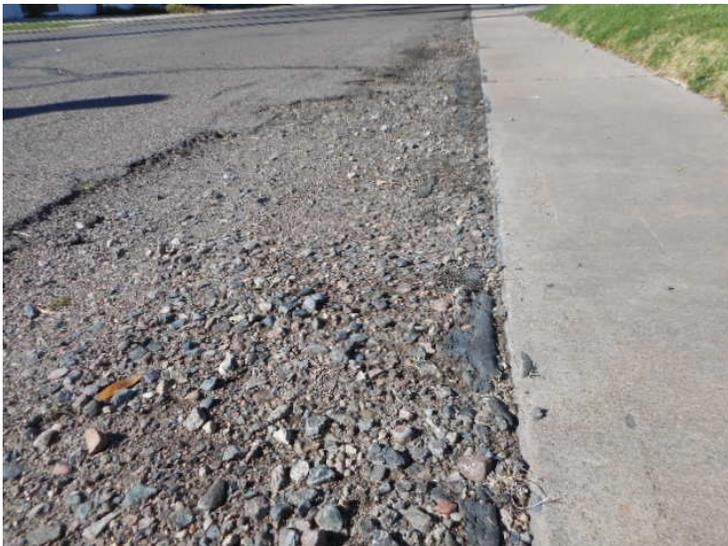
Exhibit 7

Irrigation overspray has dramatically impacted the amount of asphalt deterioration adjacent to sod locations (Exhibit 7). Oils and surface fines have been washed out of the pavement surface at these locations exposing the coarse structural aggregates beneath. The pavement is now displacing even the coarse aggregates at the time of this investigation. Consideration should be given for the installation of a riparian barrier between grass and pavement or installation of “stream head” sprinklers once reclamation is completed to minimize water contact with the new pavement surface maximizing its life expectancy (Exhibit 8).

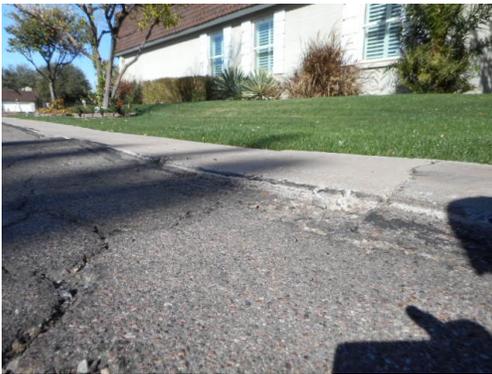
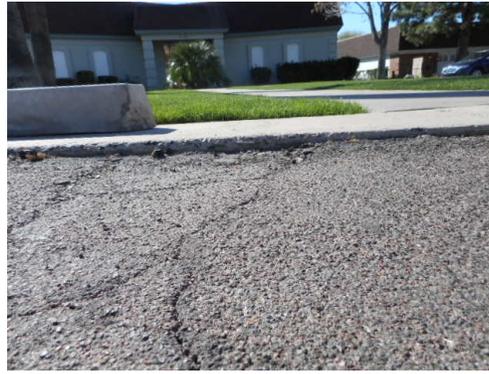
Undulation (ground movement that is creating both heaving and settlement) of the pavement and concrete is occurring at multiple locations where asphalt along the ribbon curb has settled up to 2" (Exhibits 9 & 10). Ground movement of this nature was also identified at isolated locations between the curb and the resident's driveways (Exhibit 11). This geographic region historically has exhibited highly expansive clay soils which promotes earth movement when moisture intrusion occurs. Storm and irrigation water permeation into the pavement surface where water stores, thermal cracks and the void between concrete and pavement has created this condition throughout the property.

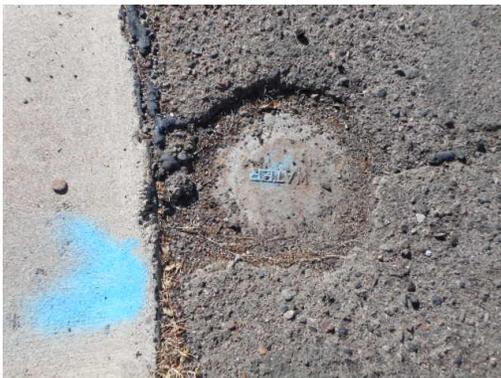
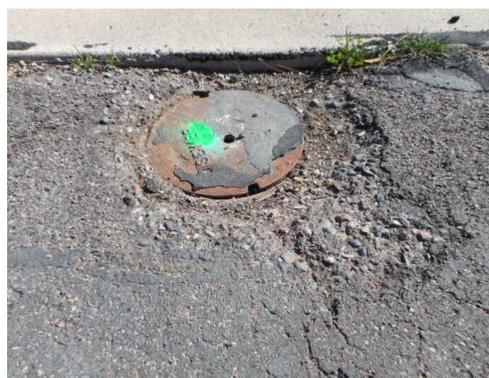
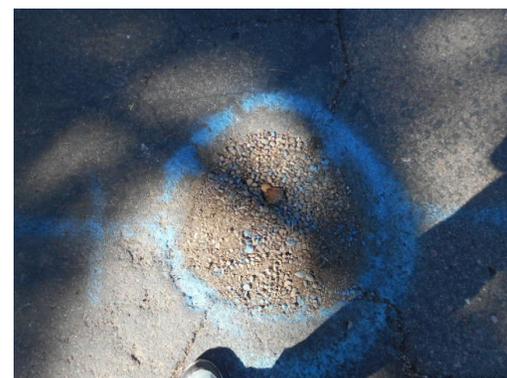
During previous asphalt renovation projects, public utilities were not adjusted to the new finish elevation of the pavement surface (Exhibits 12, 13 & 14). This practice is frowned upon by the public agencies that are required to maintain them. During reconstruction, all utilities will be lowered to avoid damage during grading and paving operations. Once completed, all utilities will be readjusted to finished pavement elevation utilizing a concrete adjustment/subsidence collar.

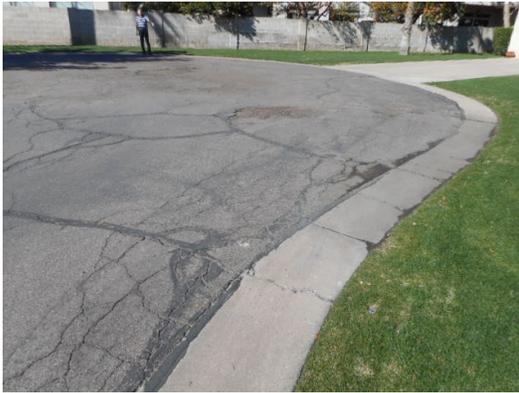
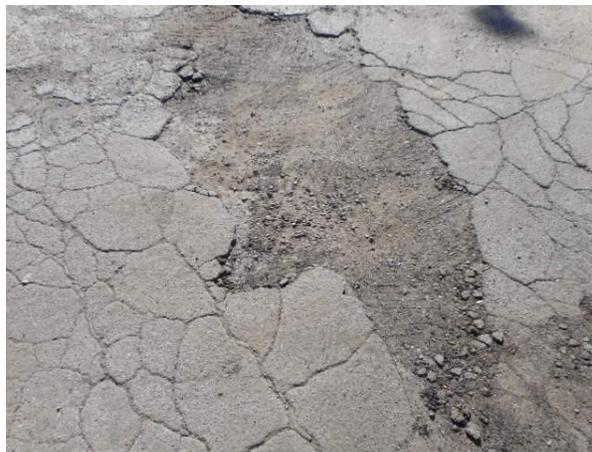
Water storage in the west cul-de-sac as defined in the “General Observations” of this report has resulted in moisture intrusion into the sub terrain and subsequent severe pavement failure (Exhibits 15 & 16). Removal and replacement of the asphalt is recommended for this property as a whole; however, as stated previously in this report, storm and nuisance water release off of the asphalt is extremely important to prevent pre-mature degradation of the pavement and sub terrain.

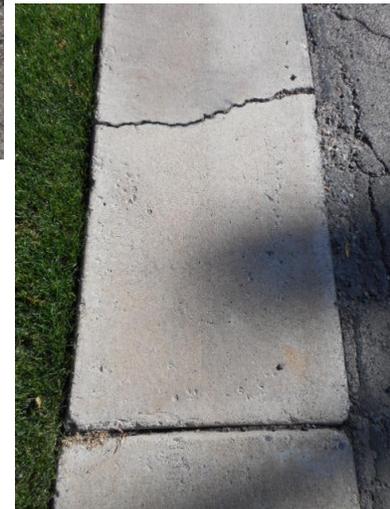
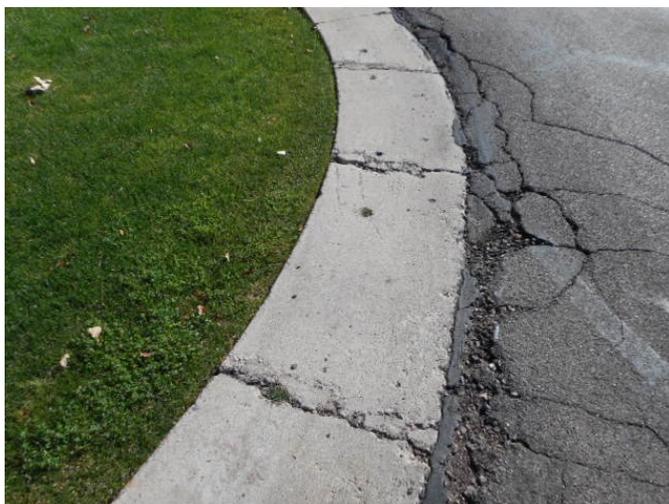
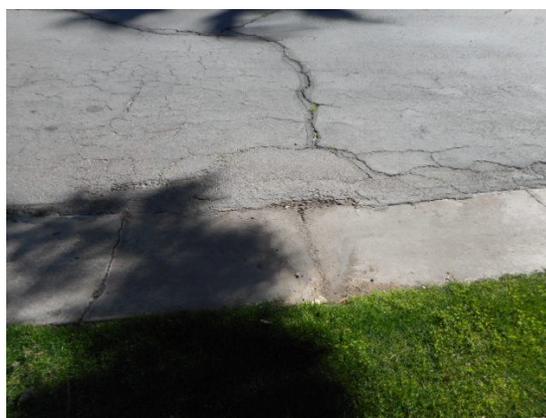
Ribbon curb throughout the street was exhibiting structural failure at isolated locations as a result of unstable sub terrain and the load of the concrete or traffic above (Exhibits 17, 18 & 19). These structurally failed curb locations warrant removal and replacement as a part of the asphalt reclamation project.

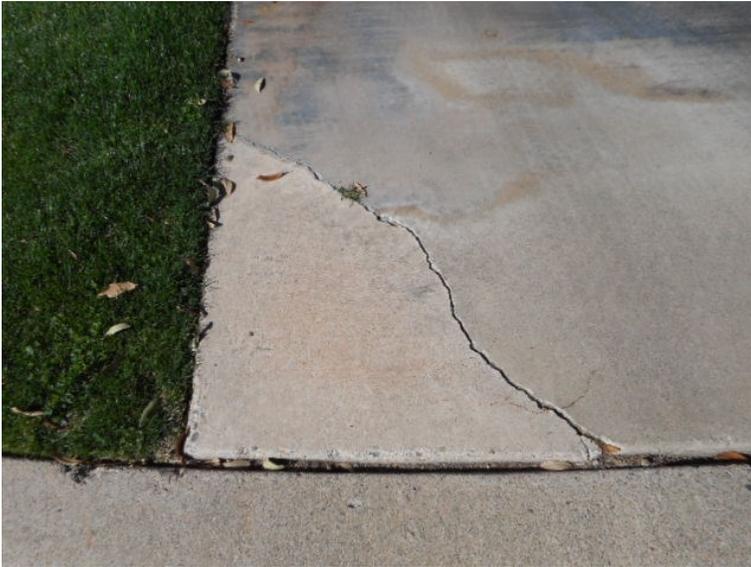
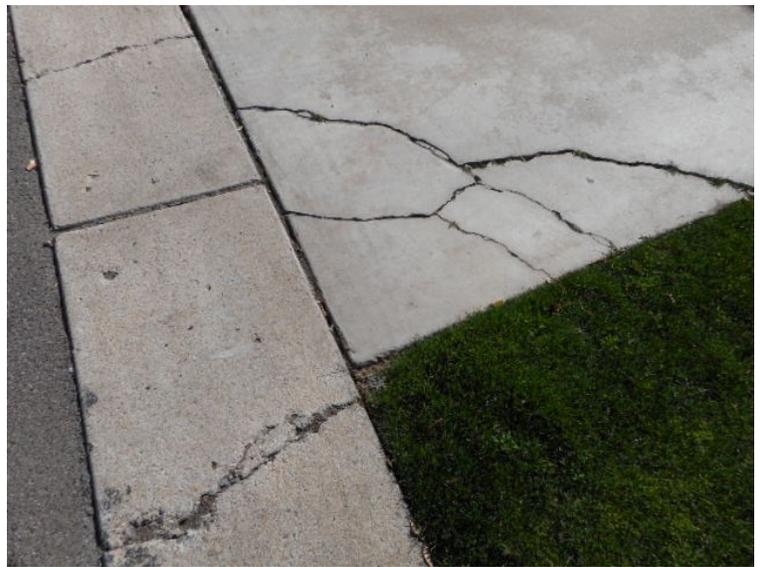
It is our understanding that the association owns and maintains the driveways throughout this community. At multiple isolated locations structural cracking and concrete failure was identified (Exhibits 20 & 21). Several minor previous repairs have been completed throughout that were performing acceptably at the time of this investigation (Exhibits 22 & 23). All locations exhibiting excessive structural fatigue (ground movement, severe concrete damage) are recommended for reconstruction. The degree that these area are corrected should be evaluated by the Board.

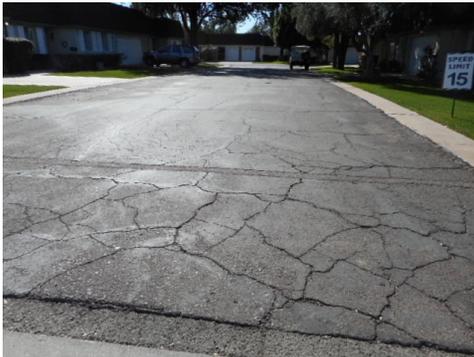
Exhibit 24

31st Place connects Coolidge Street and Hazelwood Street. It is a crowned street with storm and nuisance water draining along the ribbon curb edges to the south for release onto Hazelwood Street for further conveyance to the west (Exhibit 24).

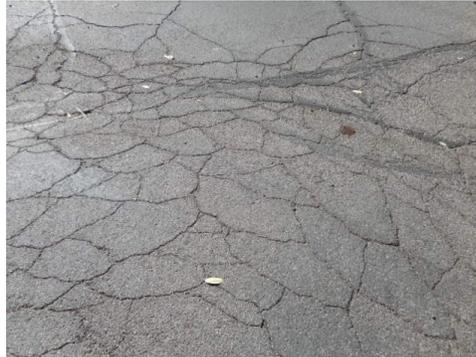
Exhibit 25

The surface condition of the pavement is commensurate with Hazelwood Street. The condition of the slurry is very fatigued and brittle (Exhibit 25). Irrigation overspray has increased pavement failure along the curbside edge which should be corrected prior to reconstruction (Exhibit 26). Instability of the sub terrain has reflected through the surface of the pavement and slurry seal throughout this drive.

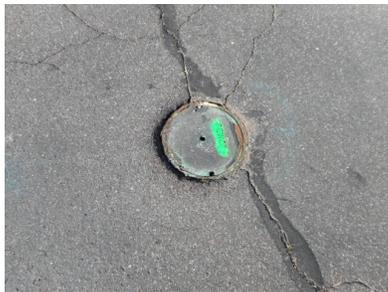
Exhibit 27

As identified on Hazelwood, utilities were never adjusted to the finish surface elevation of the pavement after the prior asphalt overlay and slurry application (Exhibit 27). Some of these utilities were over an inch below the surface elevation of the pavement.

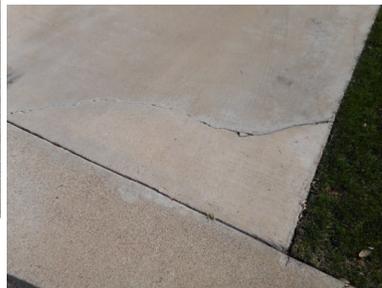
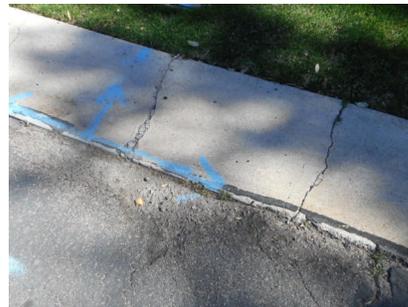
Concrete curb and resident driveway cracking and structural failure were identified at multiple locations throughout this street (Exhibits 28 & 29). Removal and replacement during asphalt reclamation is warranted and recommended. Specifically regarding the resident's driveways, the Community's Board of Directors should discuss the limits of repair for cost versus the aesthetic appeal of those limits.

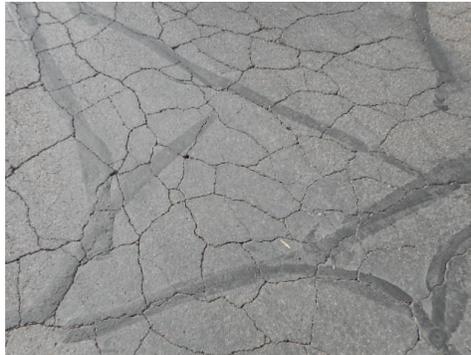
Exhibit 32

31st Way connects Coolidge Street with Hazelwood Street at the east side of the community (Exhibit 31). 31st Way exhibits the same asphalt conditions structurally and from a subterranean perspective with regard to instability and pavement failure (Exhibit 32).

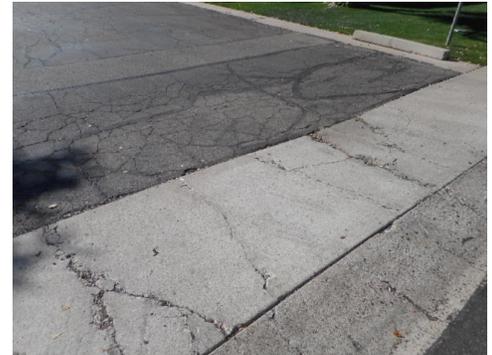
Exhibit 33

The structurally failed concrete driveway entrance at the north end of this street is maintained by the City of Phoenix and cannot be replaced by the Community without a permit (Exhibit 33). When reclamation is planned a meeting with the City should be arranged to discuss potential municipal repairs at this location.

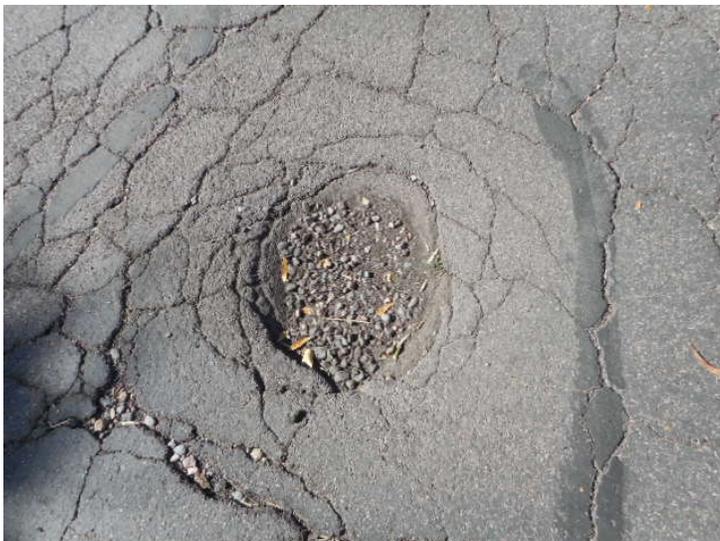
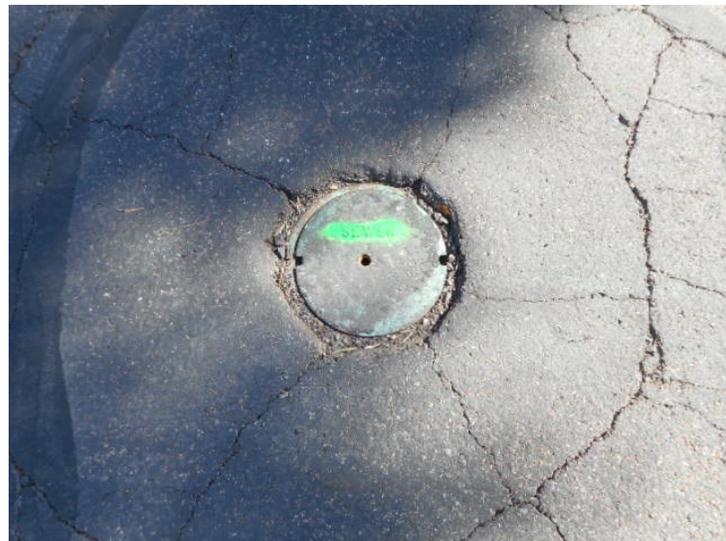
As was identified throughout the community, public utilities were never adjusted up to the finish elevation of the pavement surface and should be during the planned reclamation project (Exhibits 34 & 35).

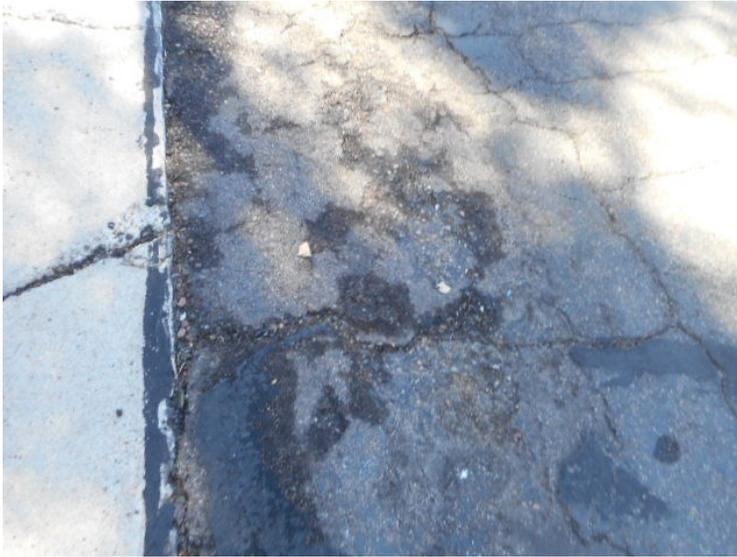
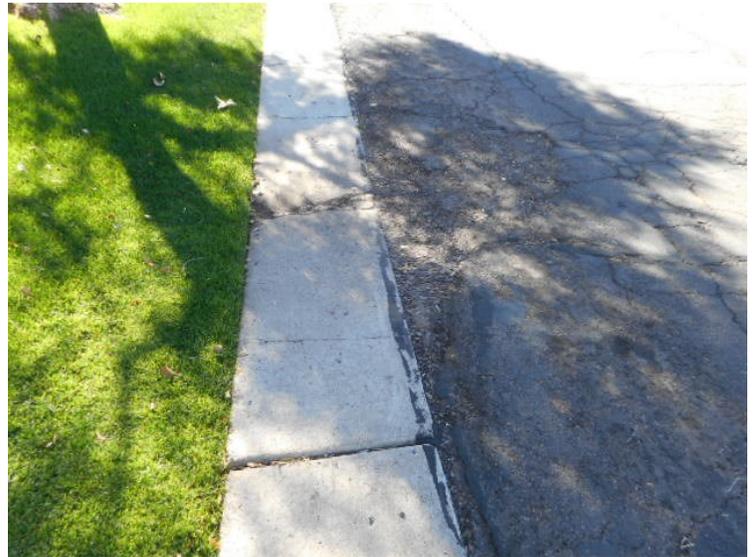
Irrigation water has negatively impacted the structural condition of the pavement adjacent to sod areas on this street as it has on all other streets within the Community (Exhibits 36 & 37).

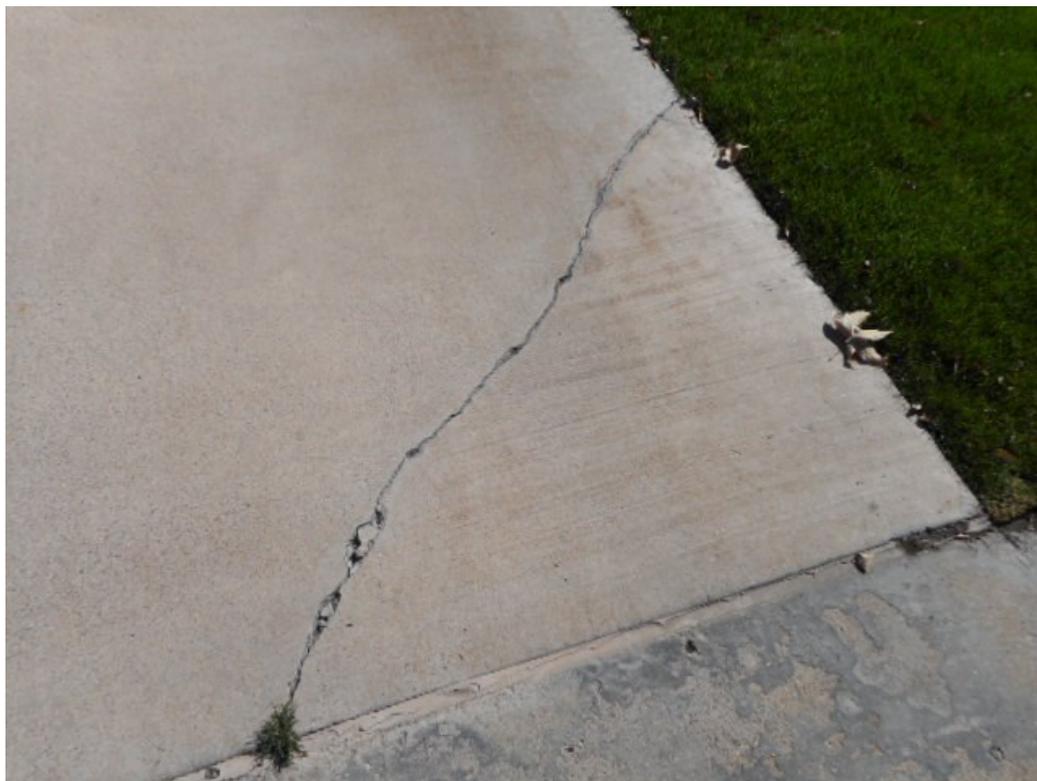
Exhibit 38

Concrete cracking and structural failure of the ribbon curb and resident's driveways were identified at multiple locations throughout this street (Exhibit 38). Ribbon curb at one location of this street has settled up to 4" in depth as a result of moisture permeation and subsequent ground movement. Removal and replacement of these severely fatigued concrete areas are recommended and warranted during the reclamation of the streets. Again, the Community's Board of Directors should discuss the limits of repair for cost versus the aesthetic appeal of those limits.
