## Update “With Site-Visit” Reserve Study

### **Papago Ridge Condominiums** **Phoenix, AZ**

**Report #: 14506-1**  
**For Period Beginning: January 1, 2016**  
**Expires: December 31, 2016**

**Date Prepared: January 7, 2016**

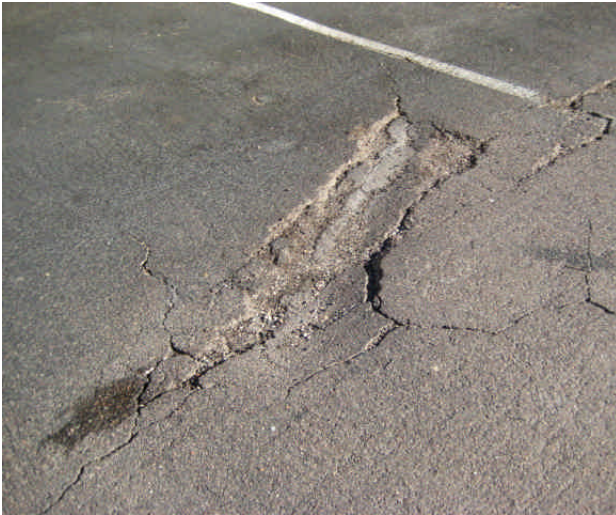
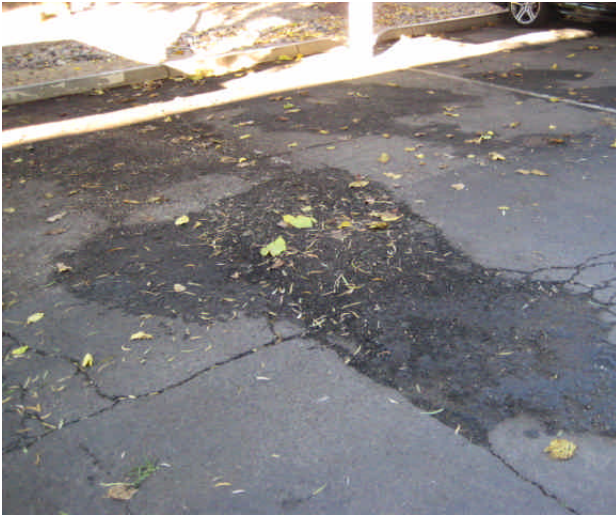
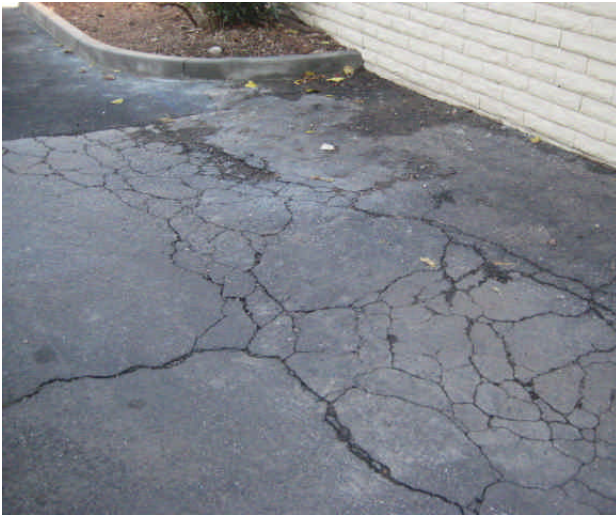
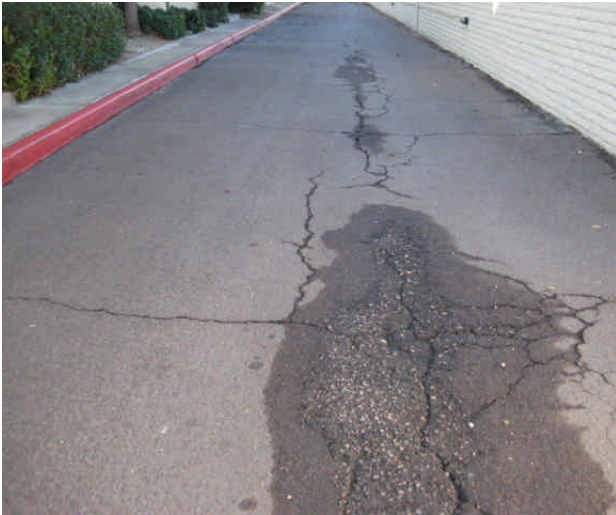
During our site inspection we learned the pool and spa are planned to be resurfaced in 2016. We noticed that the asphalt was in poor condition (see photos below).

- We also recommend a special assessment of \$270,000 (\$3,000/Unit) in 2016 primarily to help fund the scheduled asphalt resurfacing and painting projects.

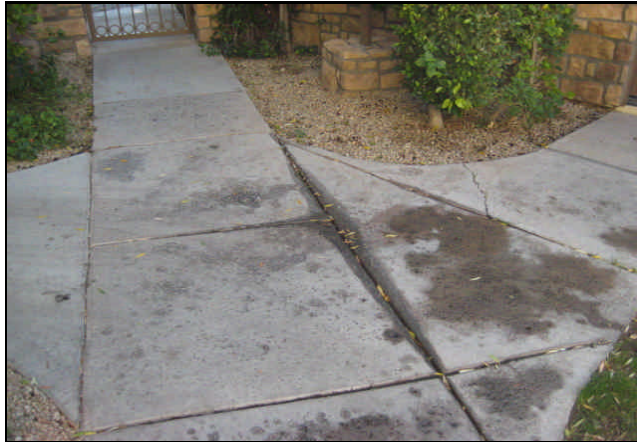
**Comp # : 103      Concrete - Repair**      Quantity: Numerous Sq Ft

History : Some curb repair was reportedly completed in 2015.

Useful Life:  
5 years

Remaining Life:  
3 years

Best Case: \$1,700

Worst Case: \$2,300

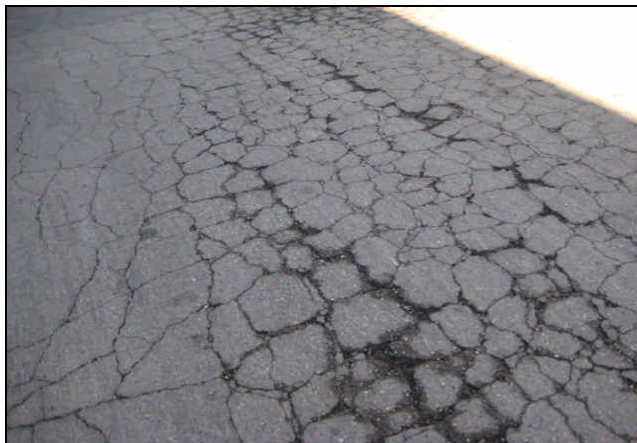
Useful Life:  
24 years

Remaining Life:  
0 years

Best Case: \$115,000

Worst Case: \$145,000
