July 01, 2015

COMMUNITY ASSET EVALUATION

Miramonte

Glendale, Arizona

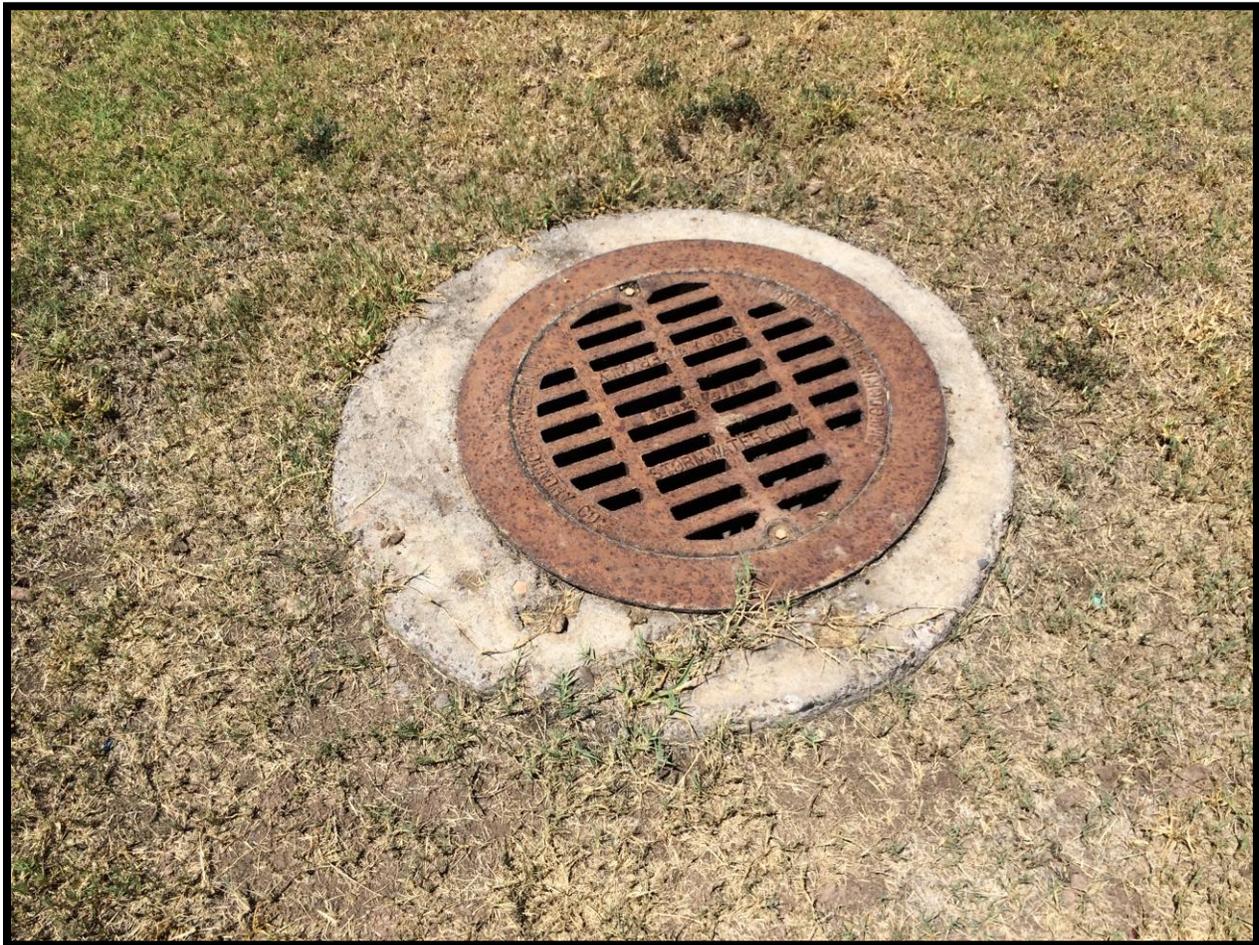
| Asset #101 | Dry Wells | Quantity | 3 |

The Maxwell Single Chamber system that are in your community should last the life of your community and not need replacement. It was designed and installed by Torrent Resources, 602-268-0785. Torrent Resources is currently offering free inspections, Per Neva Andrada at Torrent Resources. It is recommended that the drywells be inspected annually and cleaned/ repaired as needed. The maintenance funding provided is estimated at a need of \$3,000.00 every 5 years starting in 2020. To allow the association enough time to fund the maintenance

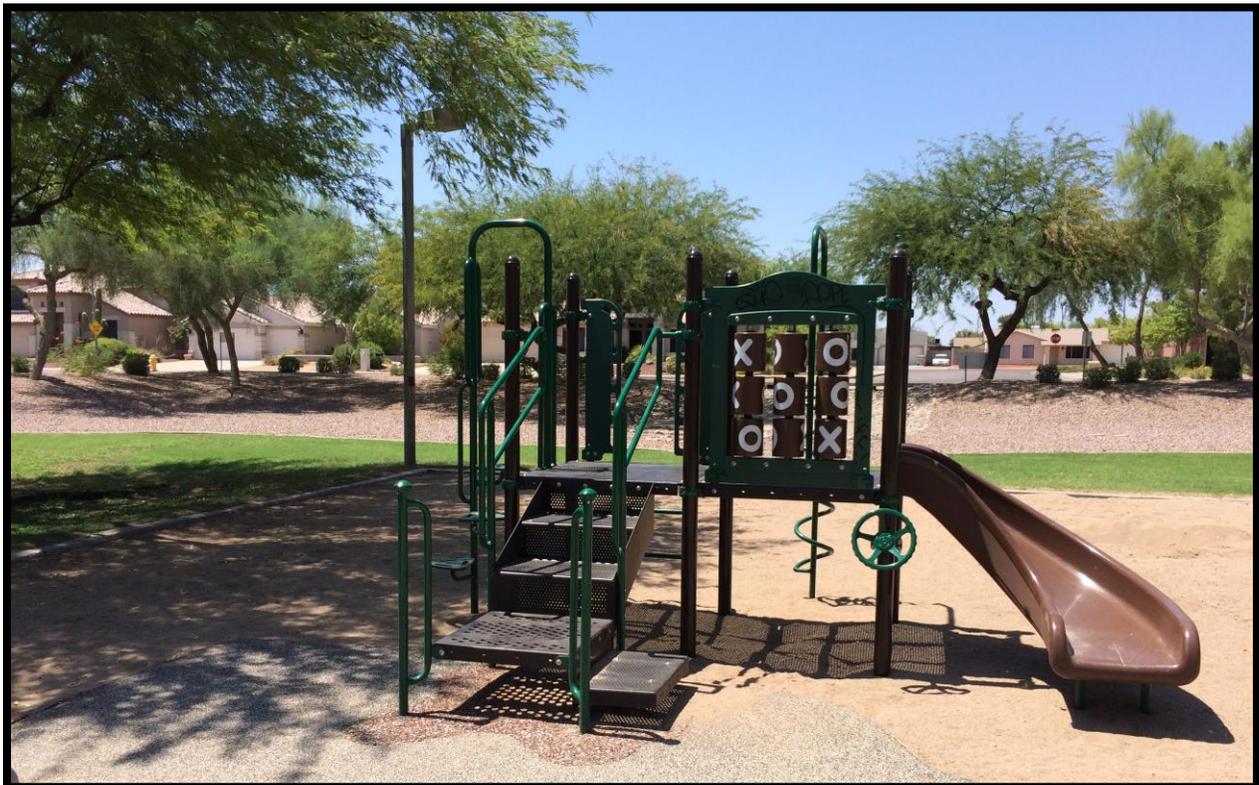
| Asset #103A | Tot Lot | Quantity | 1 |

These components are to be completely replaced at the end of their useful lives which has been estimated to be 25 years based on current visible condition. The cost is cheaper to remove and replace the entire structure in lieu of replacing individual components and leaving the concreted posts due to individual product mark up and excessive labor costs. The components life expectancy will depend on proper use, maintenance, exposure to the elements, and vandalism. We recommend that these components are inspected at a minimum annual occurrence and repairs made as needed. All plastic components are warranted for 10 years with most tot lot manufacturers. We recommend this/ these component(s) be inspected and repaired as needed but at a minimum annual occurrence. The pricing was based using Playworld Systems Components of similar event features as we could not get the actual part number information.

1 - 6 component Playworld Systems Playmaker series 5-12 year old Tot Lot @ \$30,500.00

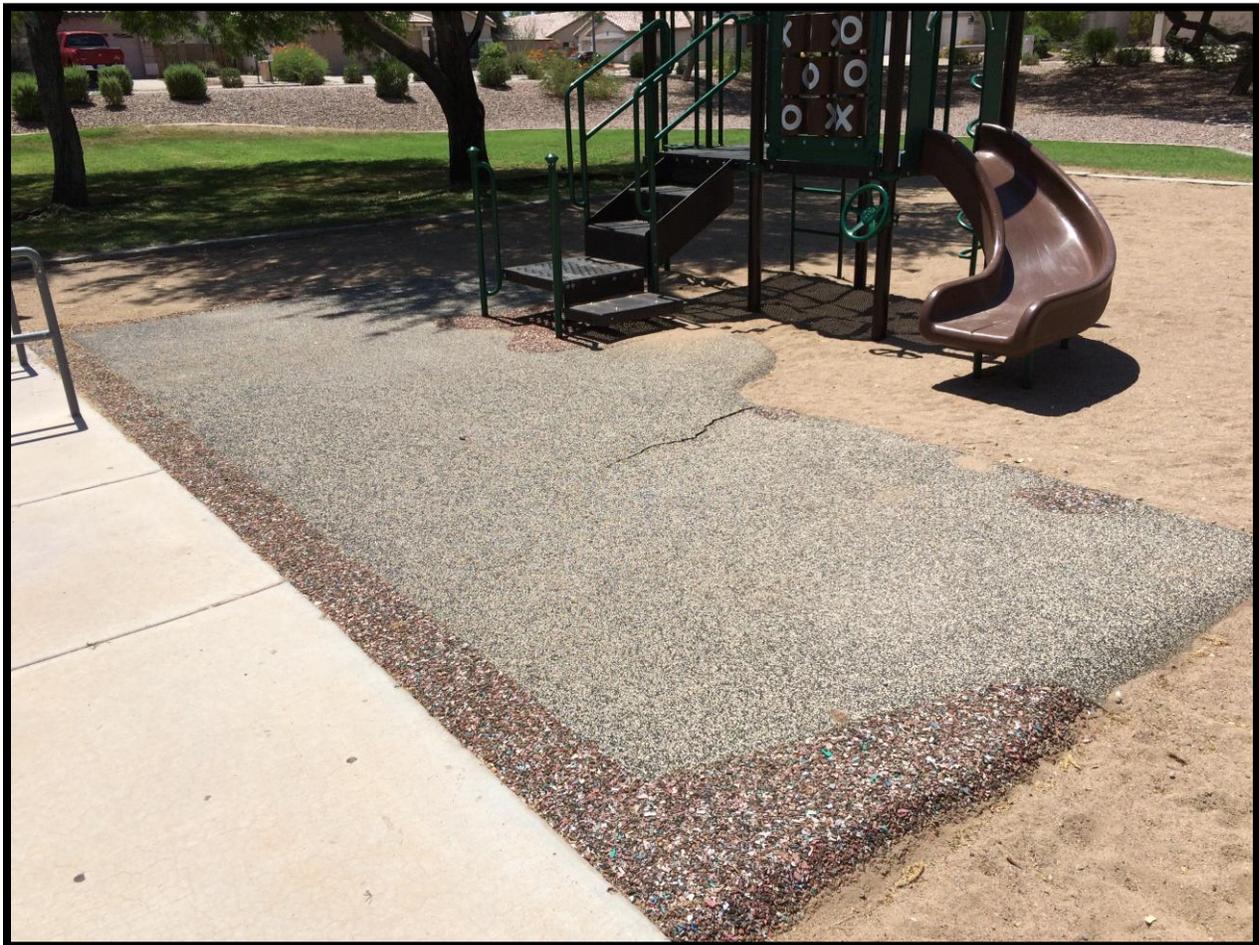
| Asset #111 | Tot Turf | Quantity | 220 SQ FT |

The Tot Turf appeared to be repaired but more cracks and separation are occurring. This asset has a 10 year useful life and needs to be replaced. The benches and picnic tables are losing their coating and will need replacement as well. The only asset we didn't fund for was the monument entry signs. They should last the life of the community and we did add some cleaning and sealing in the report to ensure the longevity of this asset.

We have given the tot turf surface a useful life of 10 years based on current use and exposure. This component will typically need to be removed and replaced between 5 and 10 years. The unit cost includes all removal and preparation fees along with new tot turf surfacing.

Approximately 220 square feet at \$25.00 each = **\$5,500.00**

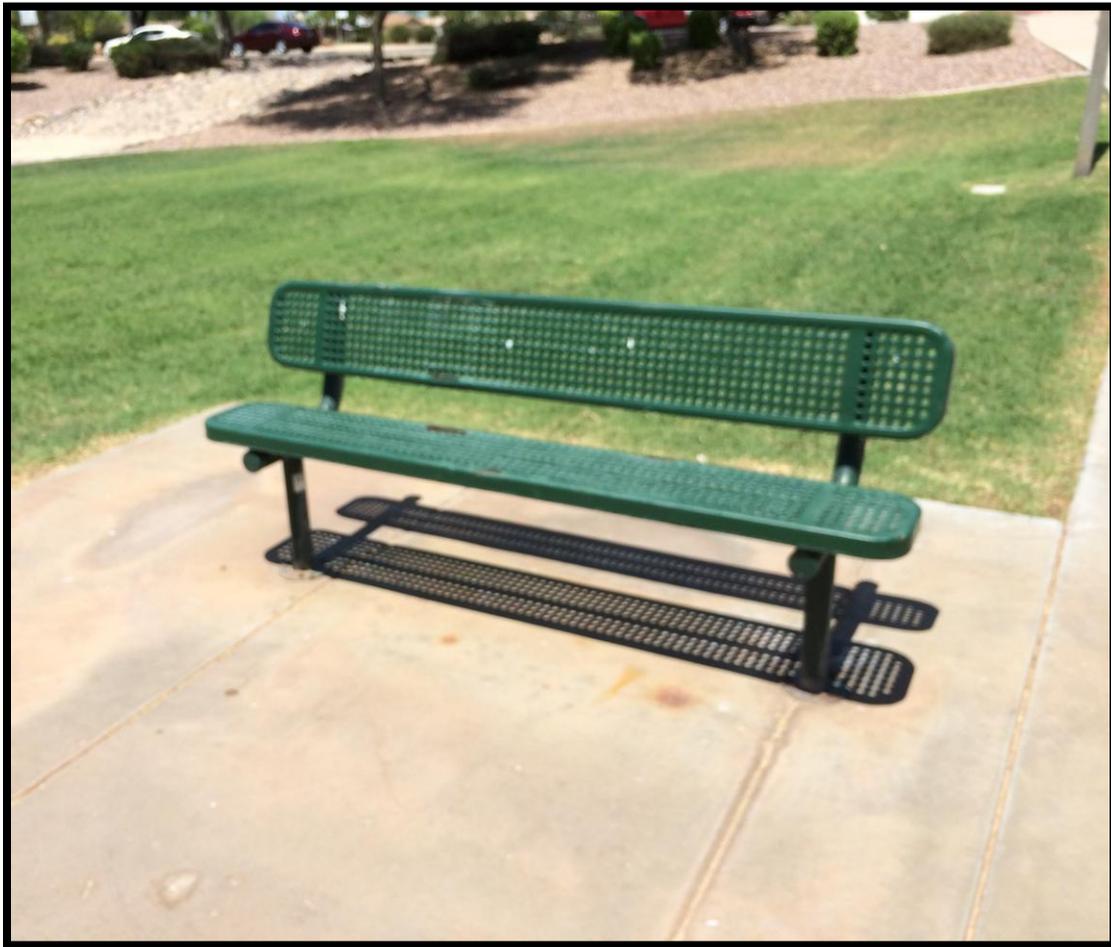
| Asset # 113A | Bench | Quantity | 2 |

We have provided funding for all park equipment based on Wabash Valley products as the exact product information was not visible on the benches. We have included shipping, removal and disposal of existing unit and replacement.

2 Wabash Valley Product 8' Diamond Benches @ \$900.00 each = **\$1,800.00**

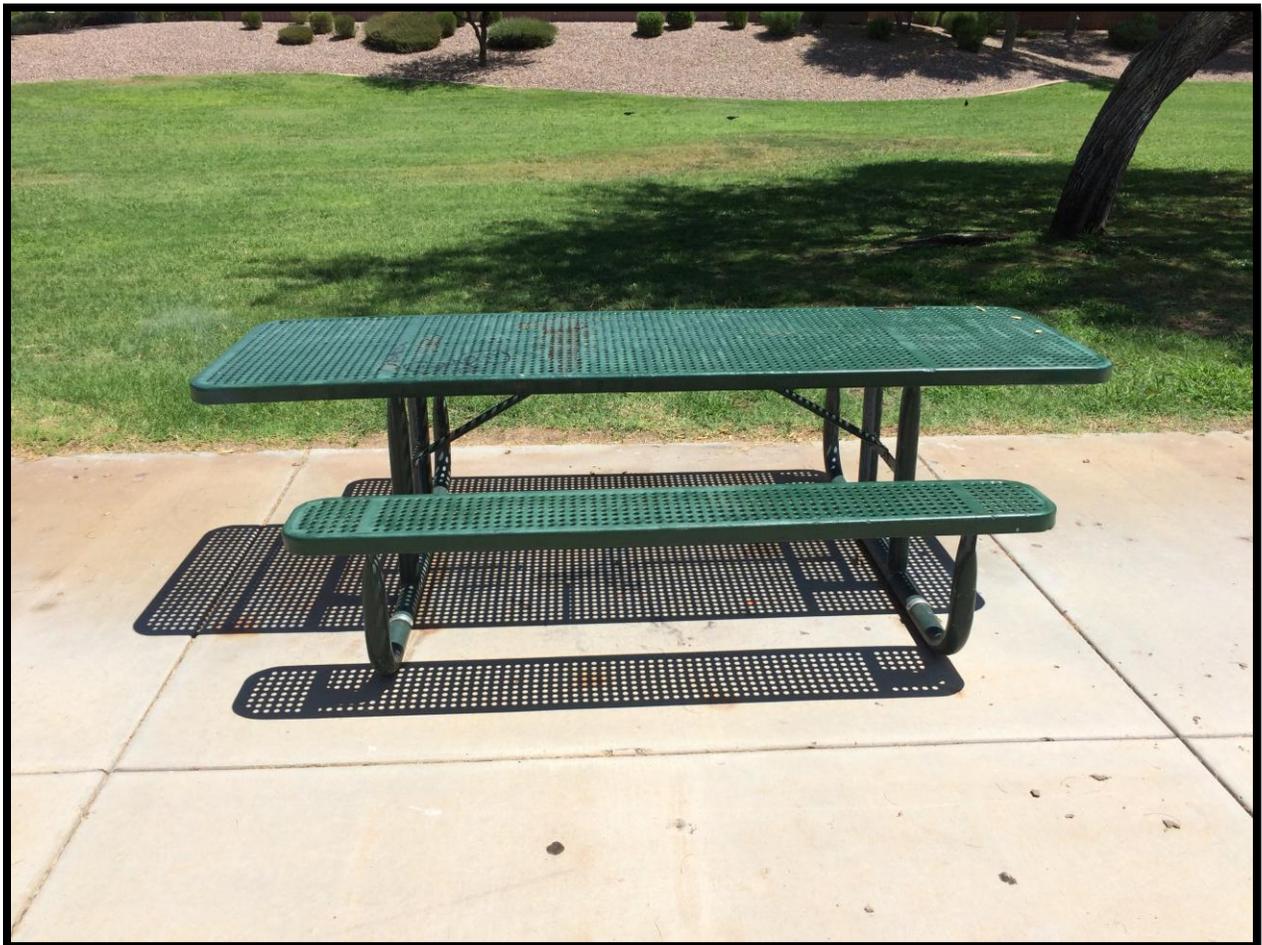
| Asset # 113C | Picnic Table | Quantity | 2 |

We have provided funding for all park equipment based on Wabash Valley products as the exact product information was not visible on the picnic tables. We have included shipping, removal and disposal of existing unit and replacement.

2 Wabash Valley Signature Series 8' Portable Picnic Tables with benches, ADA accessible @ \$1,400.00 each= **\$2,800.00**

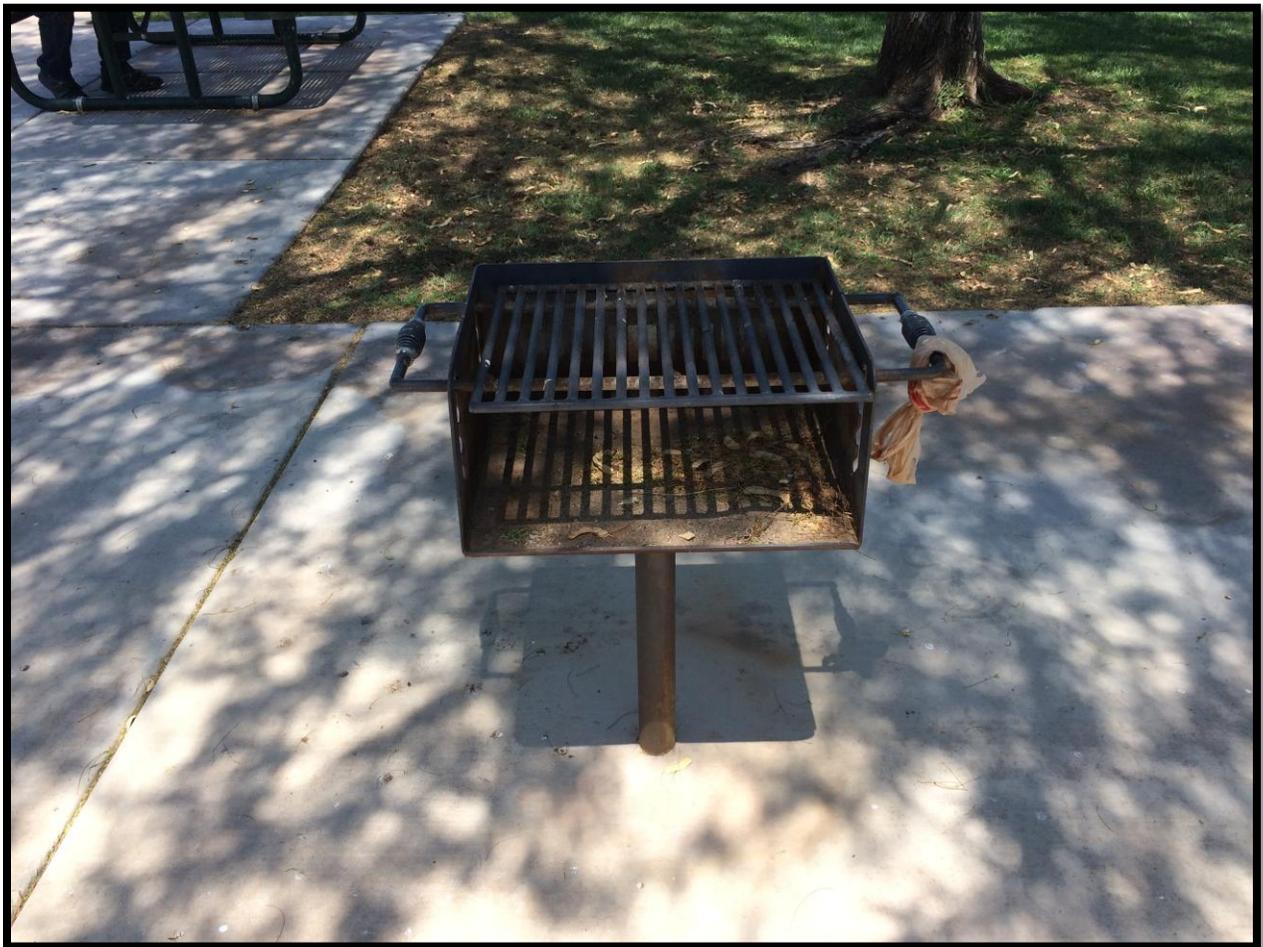
| Asset # 113D | BBQ Grill | Quantity | 1 |

1 DUMOR Inc. # 21 BBQ Grills. We have assessed the useful life of this component to be Total price for removal and replacement is **\$450.00**

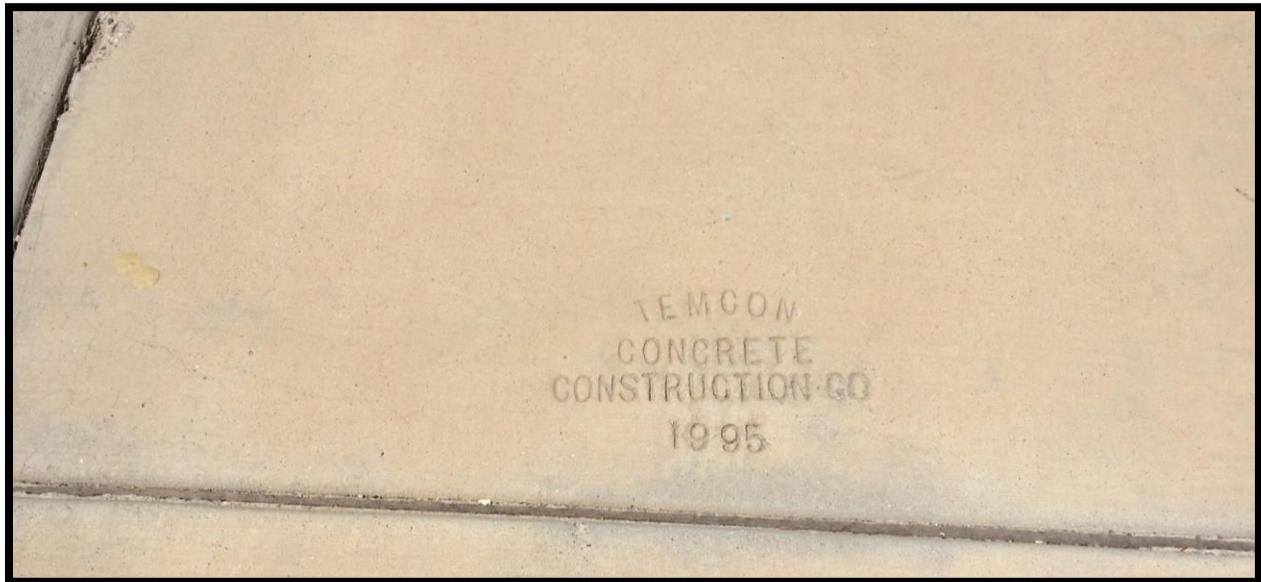
| Asset #118 | Concrete Components | Quantity | See Below |

The sidewalks and concrete slabs are in great condition. As this product has a useful life that should last the life of the community, the dollars reflected in the reserve study are typically for maintenance and upkeep every **15 years** (at **10%** of the full replacement cost) starting in year 30 or 25. It should be expected that any safety hazards be repaired immediately. We strongly recommend that an inspection of this asset be performed by a professional no less than one time per year. This is a service we offer and will provide for you with a detailed report, photos of the necessary repairs, and proposals for the replacement or repair. We recommend that a minimum of 410 square feet of concrete be removed and replaced at any one time as the concrete material providers charge a 5 cubic yard minimum delivery charge to the contractors. 410 square feet at 4" depth is 5 cubic yards, thus maximizing the use of your funds. This is for the assets owned by the HOA.

Approximately 1,760 square feet of concrete @ \$7.00 each = **\$12,320.00**

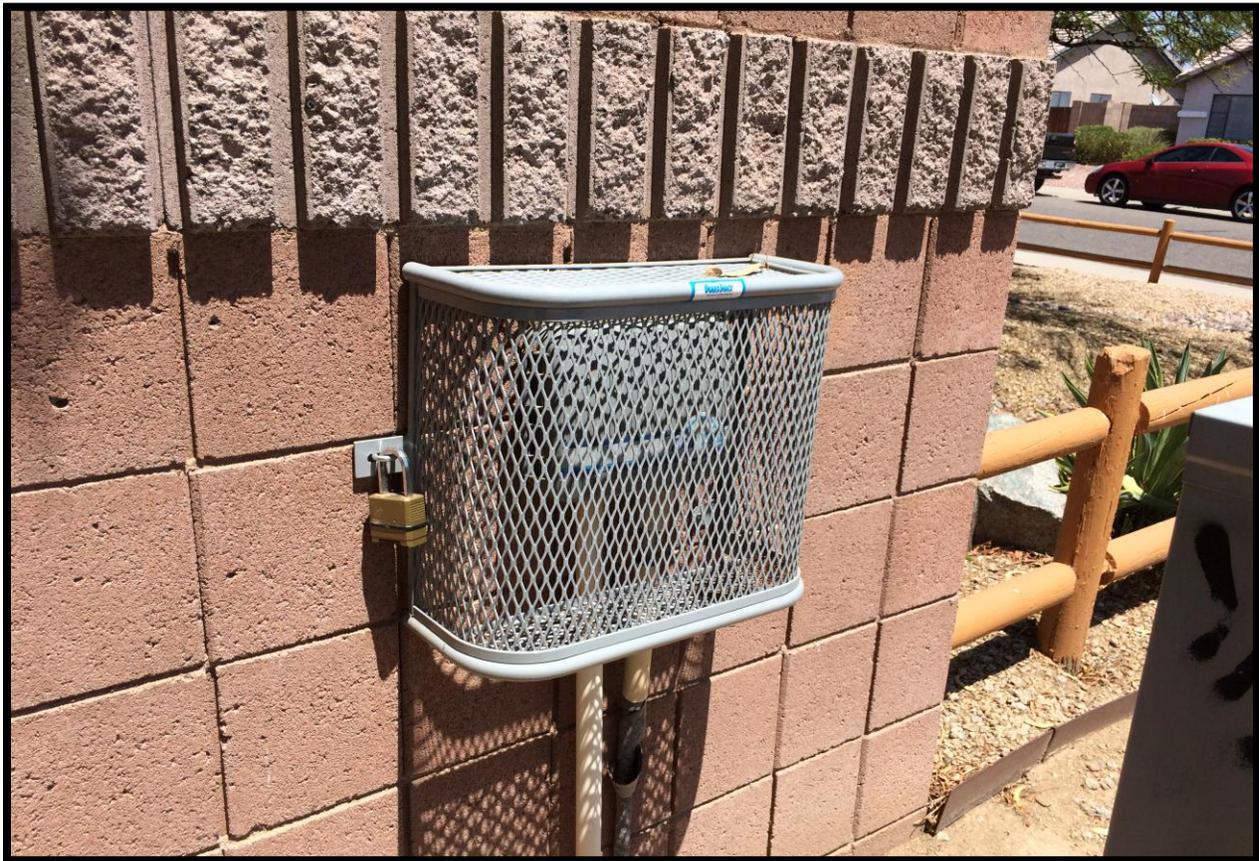
| Asset #119 | Irrigation Controllers | Quantity | 2 |

These components appear to be in good condition and have a useful life ranging from 8 to 15 years depending on use and exposure. We have estimated the useful life of these components to be 12 years.

There are three additional controller boxes that have been terminated and replaced with battery operated valves as there was only one valve per controller. By maintaining the current system the controllers do not have to be replaced and the power service does not need to be reconnected.

This component controls the electric landscape valves.

2 - 16 Station Irritrol Raindial Controllers@ \$700.00 each =**\$1,400.00**

This Price includes removal, replacement, valve ID and reprogramming.

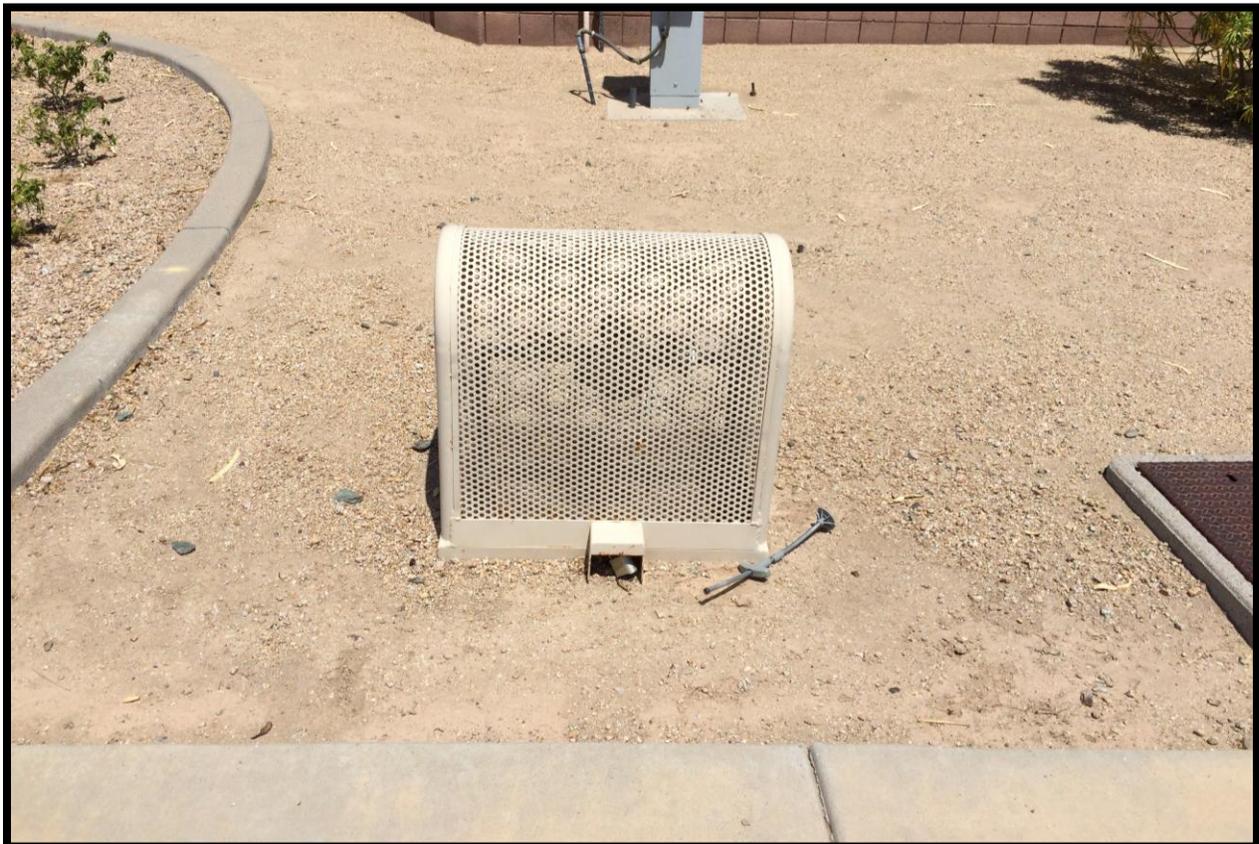
| Asset #120 | Backflow Preventers | Quantity | 5 |

This component separates the potable drinking water from the landscape water preventing backflow of stagnant water that carries harmful bacteria in to the city water. These components have a useful life of 20 years before needing replacement. We are not sure when this component was last replaced but we are assuming they have been replaced at least one time since the community has been in service.

3 – 1” Febco 825YA backflow device removed and replaced with Cage @ \$900.00 each = **\$2,700.00**

1 – 1 ½” Febco 825YA backflow device removed and replaced with Cage @ **\$1,500.00**

1 – 2” Febco 825YA backflow device removed and replaced with Cage @ **\$2,050.00**

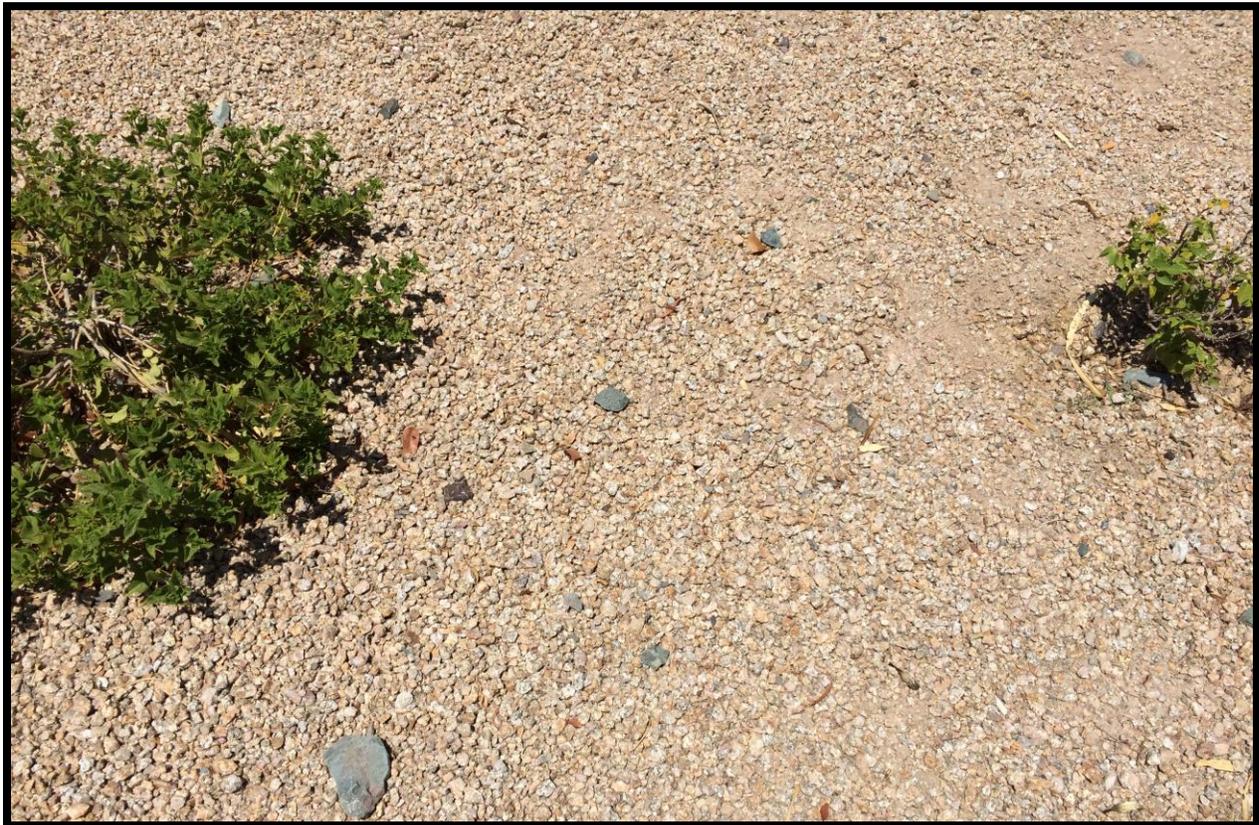
| Asset #123 | Granite Replenishment | Quantity | 100 Tons |

We recommend replenishing 30 tons landscape granite every 5 years based on the size of the community. The granite should be regularly maintained by the landscape maintenance contractor and any replenishment should be performed prior to the scheduled pre-emergent treatment to avoid duplicate efforts and cost. We have provided funding to start in 2014.

100 tons X \$60.00 = **\$6,000.00**

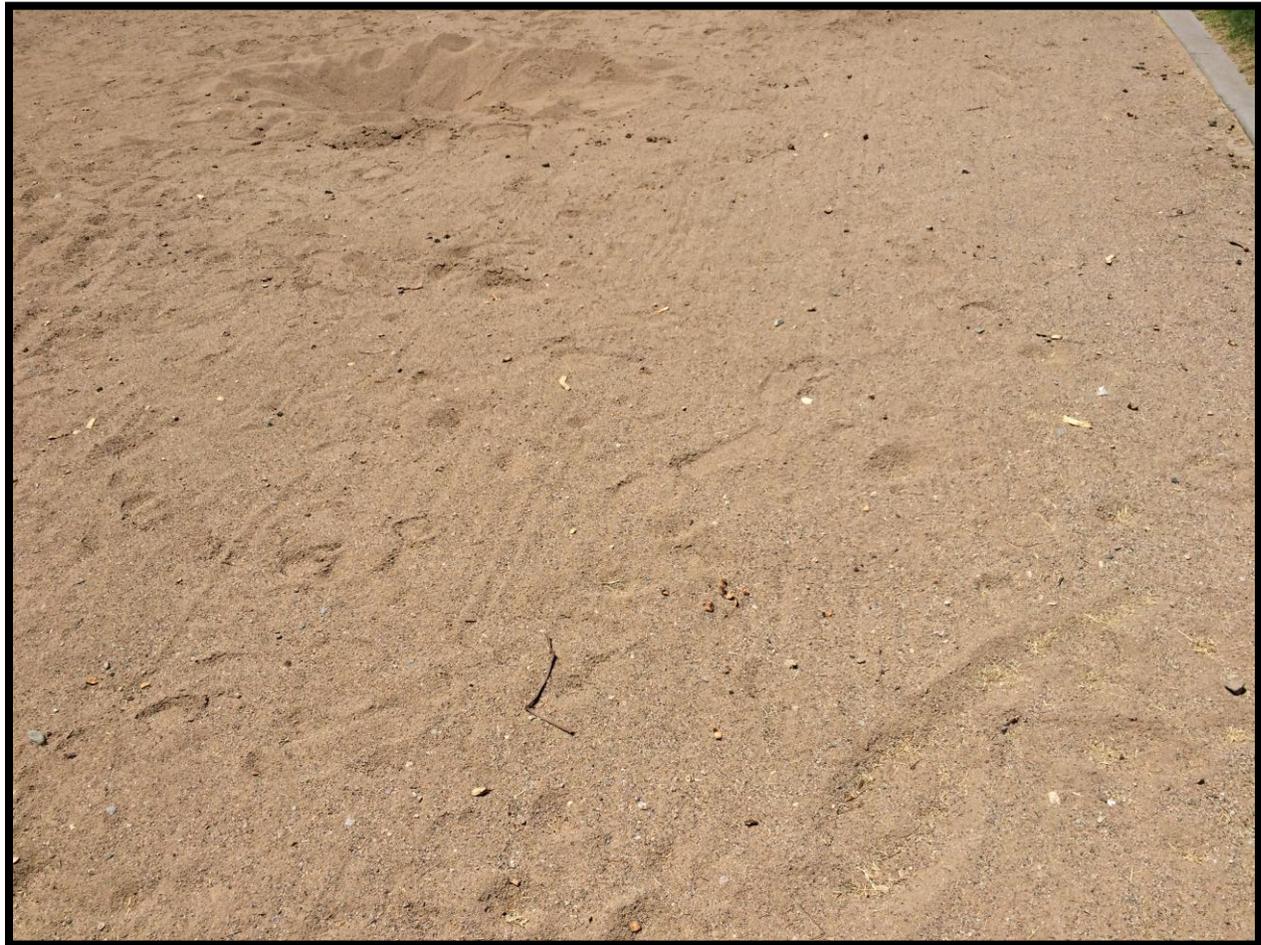
| Asset #123B | Sand Replenishment | Quantity | 20 Tons |

We recommend washed play sand, replenishing 20 tons every 6 years. This product is located at the play structure and swings should be maintained as part of the landscape maintenance. Removal of debris and raking is recommended at a minimum one time per month occurrence.

20 tons X \$45.00 = **\$900.00**

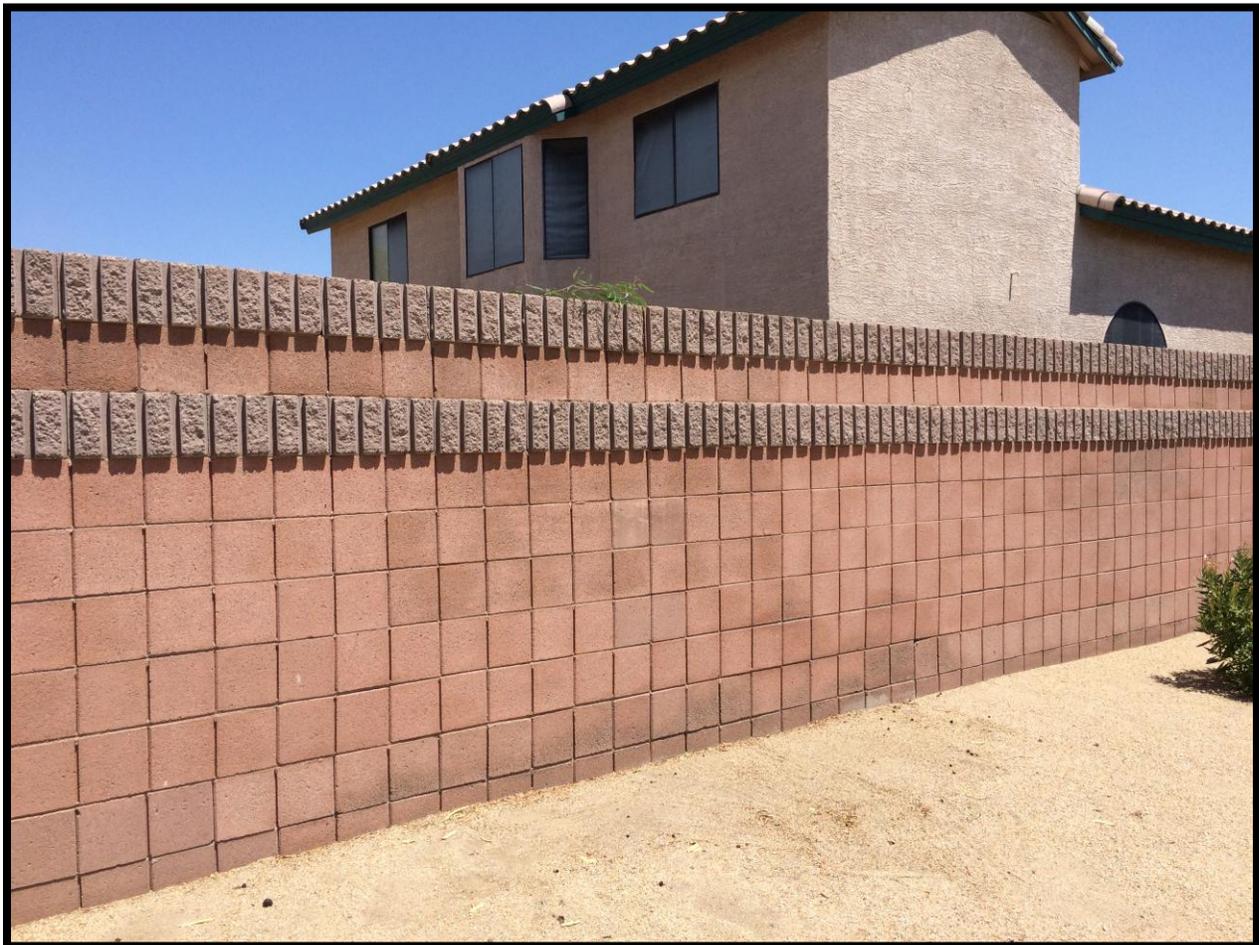
| Asset #125 | Masonry Wall | Quantity | See Below |

The masonry walls in this community are made of 8”X4”X16” and 8”X 6” X16” block which is not structurally designed to bare any load or retain moisture. These types of walls will start to fail early on of they are not maintained and painted as needed. Keeping landscape moisture away from these walls is critical to their longevity. We have provided a budget for repair based on 5% of total replacement cost every 10 years starting in year 30 or 2025.

Approximately 5,358 linear feet of 6’ wall removed, replaced at \$60.20 each = **\$322,551.60**

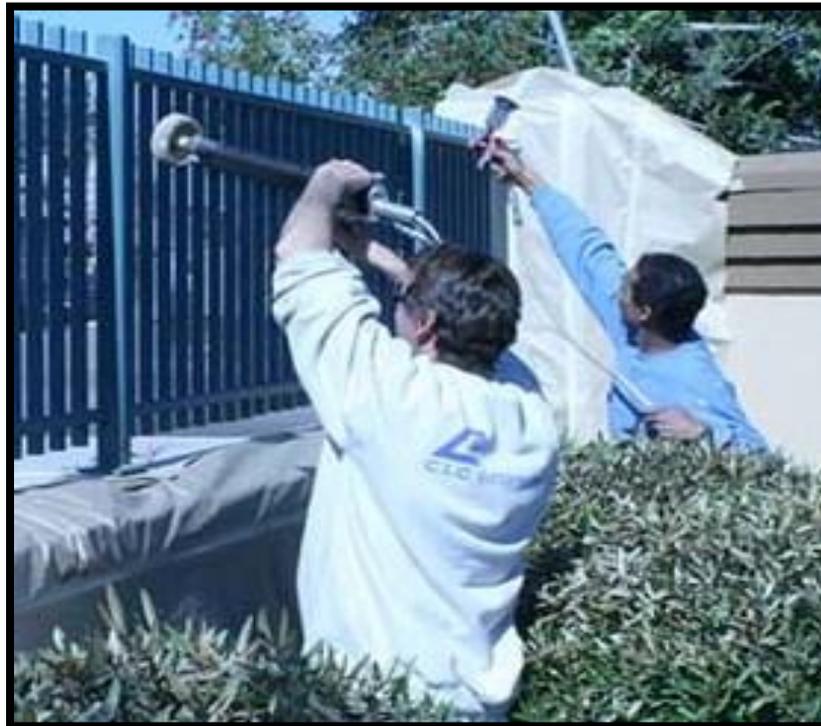
| Asset #128 | Paint Metal Components | Quantity | (See Below) |

The metal components in the community are in good but in need of painting. We have started funding for this in 2014 in an effort to try and offset expenses over the 30 year projection. The painting of these component are based on electrostatic painting (Recommended) and includes removal of rust and primer coat for the rusted areas. We are recommending that this component be painted every 5 years in an effort to extend the useful life of the components. We recommend all metal components be inspected annually and paint to be maintained as needed to ensure the longevity.

2 Monument signs cleaned and sealed @ \$400.00 each = **\$800.00**
