## “Full” Reserve Study

### Sanalina HOA Surprise, Arizona

**Report #: 25047-0**  
**For Period Beginning: January 1, 2015**  
**Expires: December 31, 2015**  
**Date Prepared: November 4, 2014**

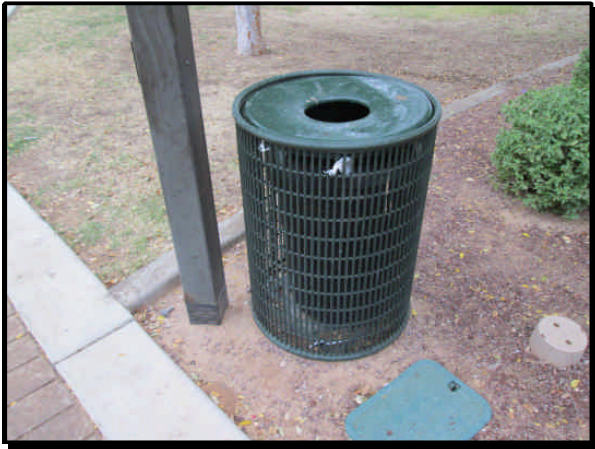
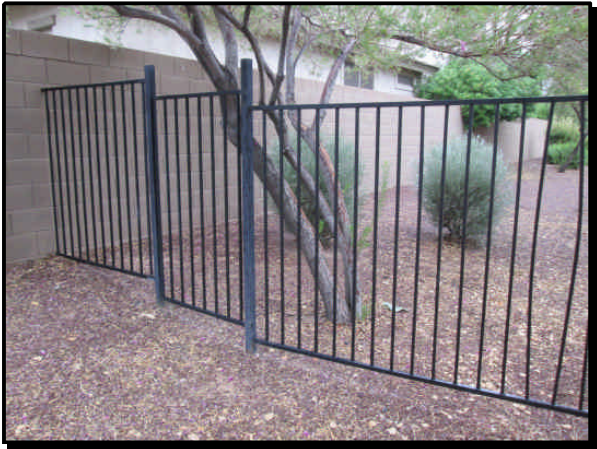
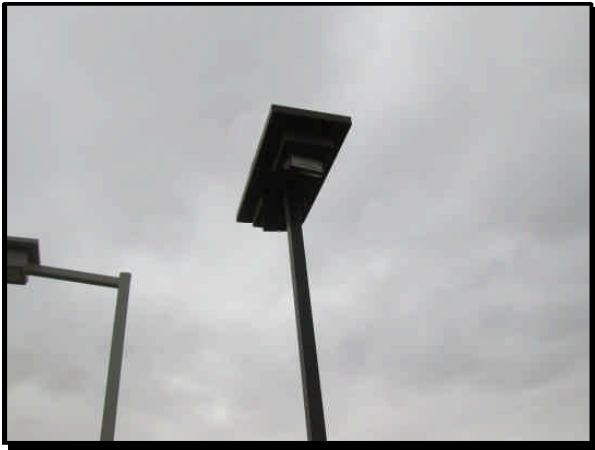
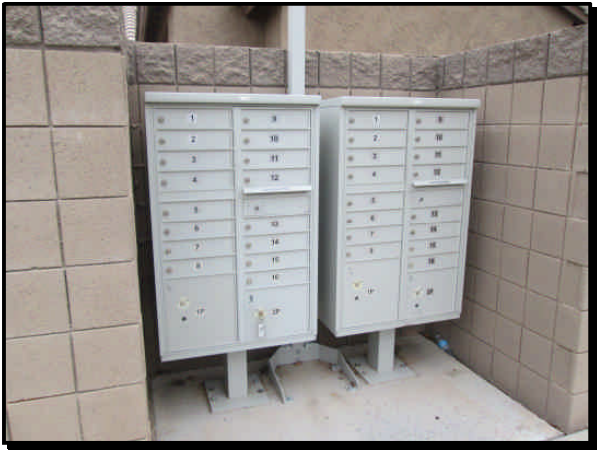
**Site Inspection Notes**

During our site visit on October 8, 2014, we started by meeting with Community Manager Mr. Roger Hartzog with FirstService Residential to discuss the property and any issues or concerns. We then started the site inspection with the playground and basketball court area. Next, we inspected the common walls and fencing. Finally, we inspected the monuments, landscaping, and remaining common areas.

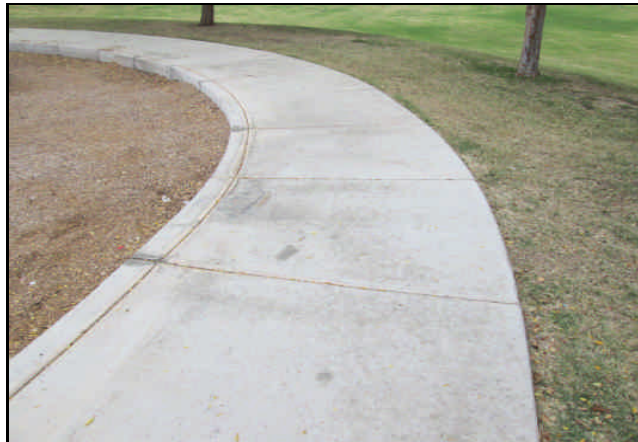
**Comp # : 103      Concrete - Repair**      Quantity: Numerous Sq Ft  
Location : Common area walkways; Landscape curbing; Basketball court  
Funded? : Yes

Evaluation : There is no expectancy to completely replace the concrete. This component provides an allowance for periodic repairs and/or partial replacements. Generally smooth and in good shape overall.

Allowance for repairs and/or partial replacement

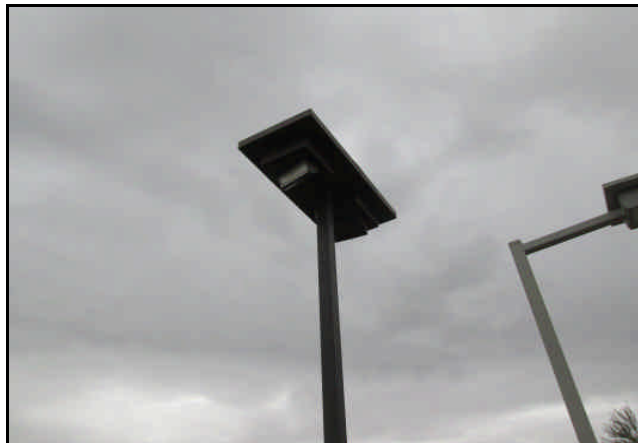
**Comp # : 320      Solar Lights - Replace**      Quantity: (12) Lights  
Location : Adjacent to mailboxes, east end of community, & ramada at the playground  
Funded? : Yes

Evaluation : Appear newer and in good shape. Manufactured by Solar King. This component provides funding for complete replacement of the pole, fixture, and solar panel assembly.

Estimate to replace

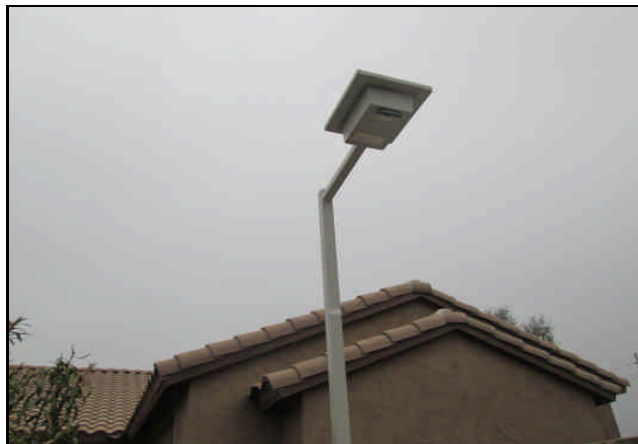
Useful Life:  
15 years

Remaining Life:  
14 years

Best Case: \$6,500  
Estimate to refurbish

Worst Case: \$7,900  
Higher estimate

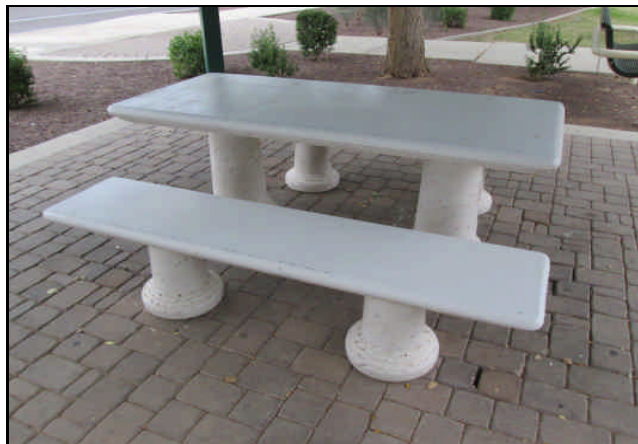
Useful Life:  
25 years

Remaining Life:  
14 years

Best Case: \$1,200  
Estimate to replace

Worst Case: \$1,500  
Higher estimate

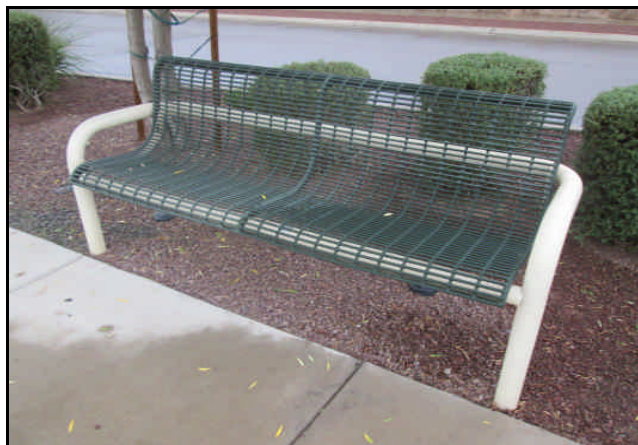
Useful Life:  
15 years

Remaining Life:  
4 years

Best Case: \$4,300  
Estimate to replace

Worst Case: \$5,200  
Higher estimate

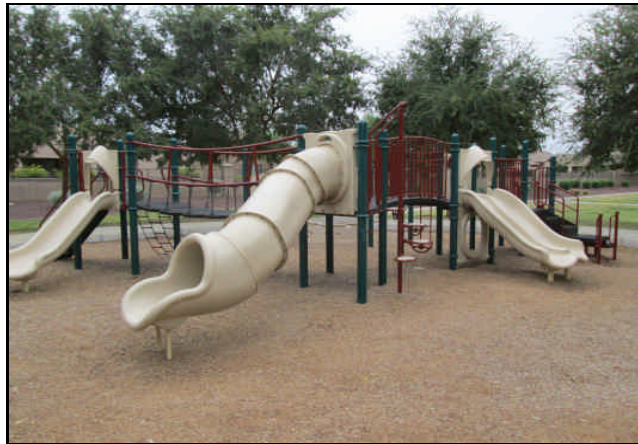
Useful Life:  
20 years

Remaining Life:  
9 years

Best Case: \$33,000  
Estimate to replace

Worst Case: \$47,000  
Higher estimate

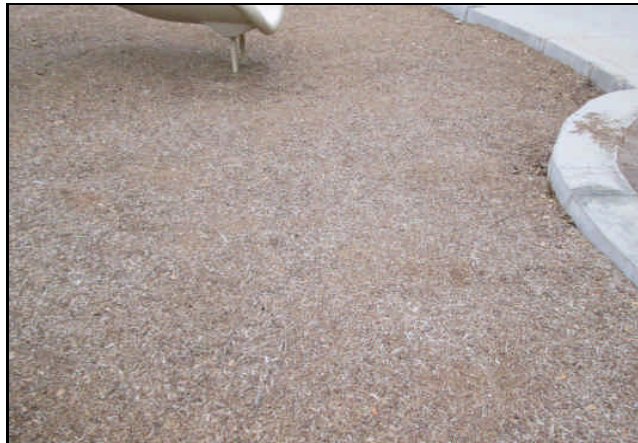
Useful Life:  
10 years

Remaining Life:  
0 years

Best Case: \$3,500  
Estimate to replenish

Worst Case: \$4,500  
Higher estimate

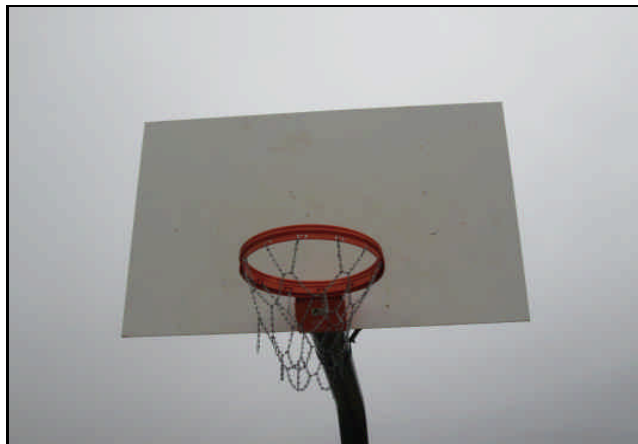
Remaining Life:

7 years

Best Case: \$1,400

Worst Case: \$1,800

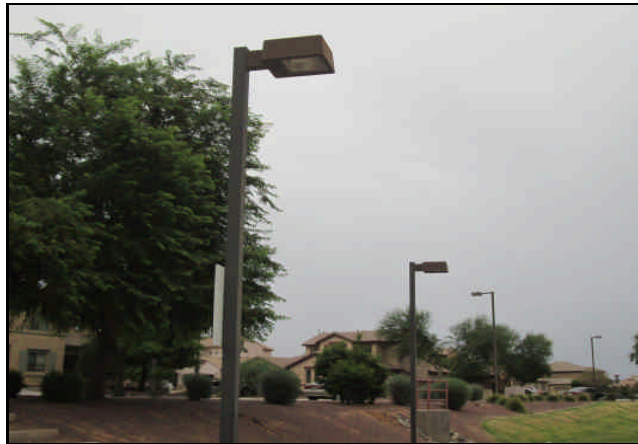
Useful Life:  
45 years

Remaining Life:  
34 years

Best Case: \$12,000  
Estimate to replace

Worst Case: \$15,000  
Higher estimate

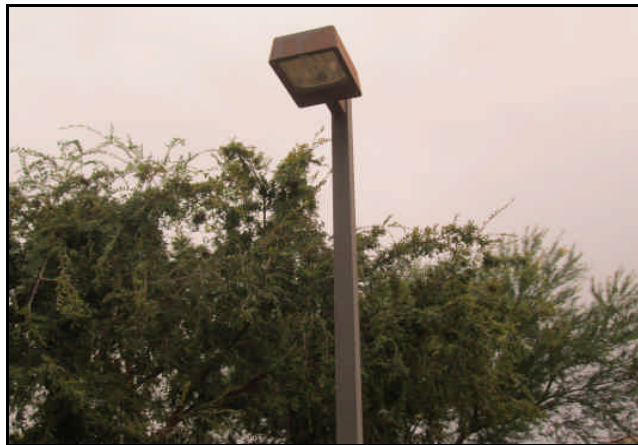
Useful Life:  
15 years

Remaining Life:  
4 years

Best Case: \$4,800  
Estimate to refurbish

Worst Case: \$6,000  
Higher estimate

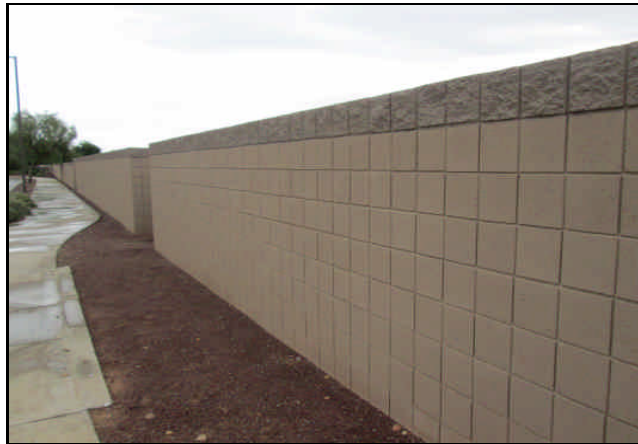
Useful Life:  
25 years

Remaining Life:  
14 years

Best Case: \$3,800

Worst Case: \$4,700

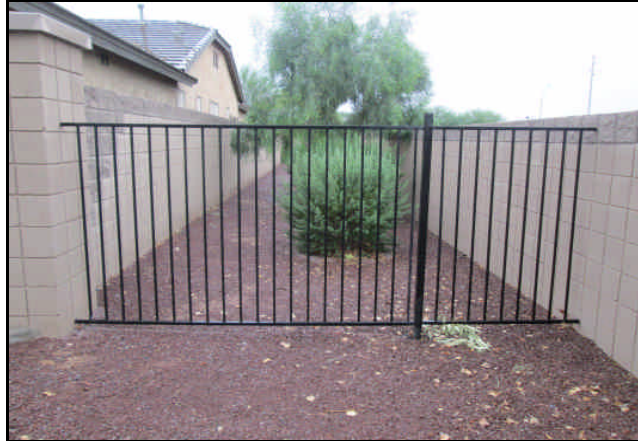
Useful Life:  
24 years

Remaining Life:  
13 years

Best Case: \$2,000  
Estimate to replace

Worst Case: \$2,500  
Higher estimate

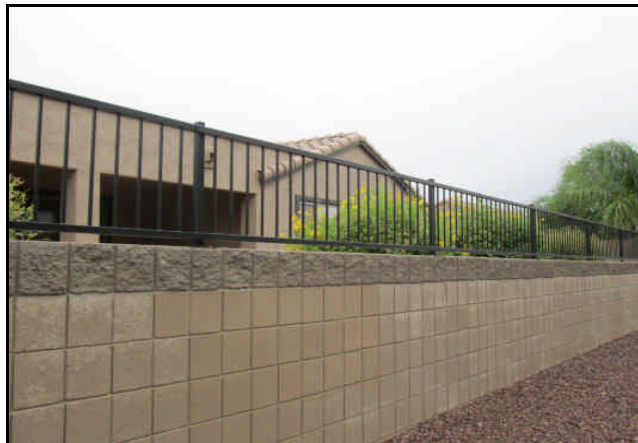
Useful Life:  
40 years

Remaining Life:  
29 years

Best Case: \$9,000  
Estimate to replace

Worst Case: \$11,000  
Higher estimate

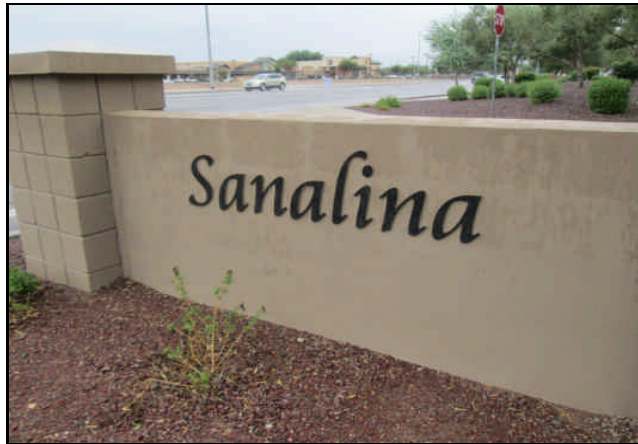
Useful Life:  
20 years

Remaining Life:  
9 years

Best Case: \$4,400  
Estimate to refurbish

Worst Case: \$5,600  
Higher estimate

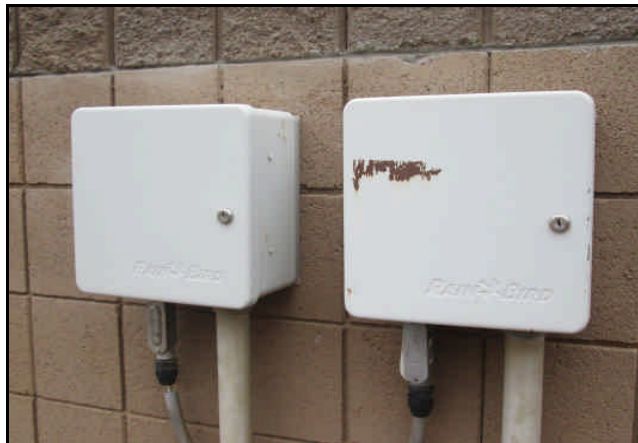
Useful Life:  
12 years

Remaining Life:  
1 years

Best Case: \$5,300  
Estimate to replace

Worst Case: \$6,700  
Higher estimate

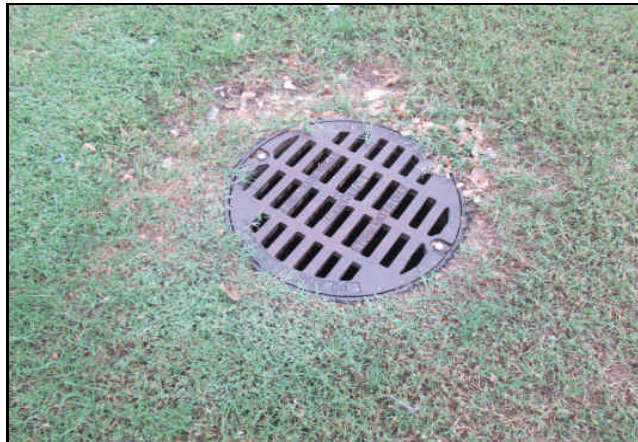
Remaining Life:

4 years

Best Case: \$2,300

Worst Case: \$2,900

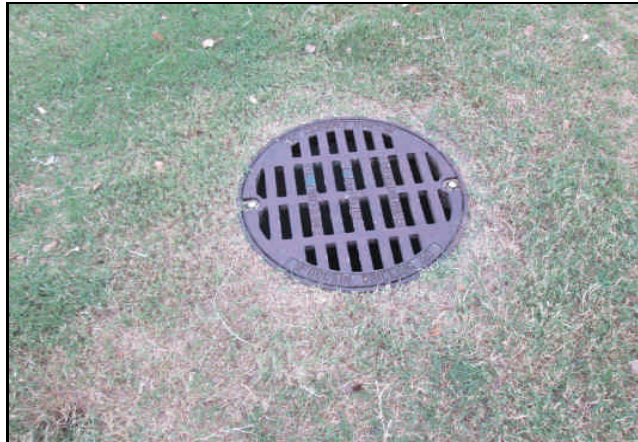
Useful Life:  
25 years

Remaining Life:  
14 years

Best Case: \$14,000

Worst Case: \$19,000

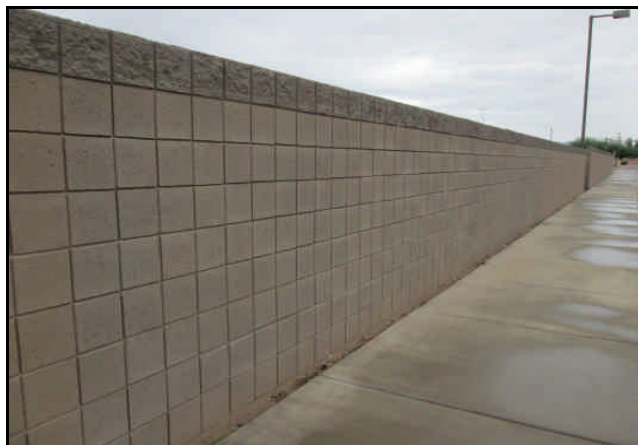
Useful Life:  
7 years

Remaining Life:  
2 years

Best Case: \$2,400

Worst Case: \$3,000

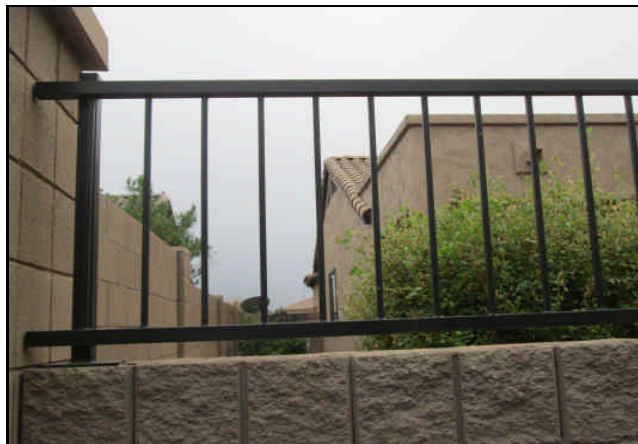
Remaining Life:

2 years

Best Case: \$3,500

Worst Case: \$4,500

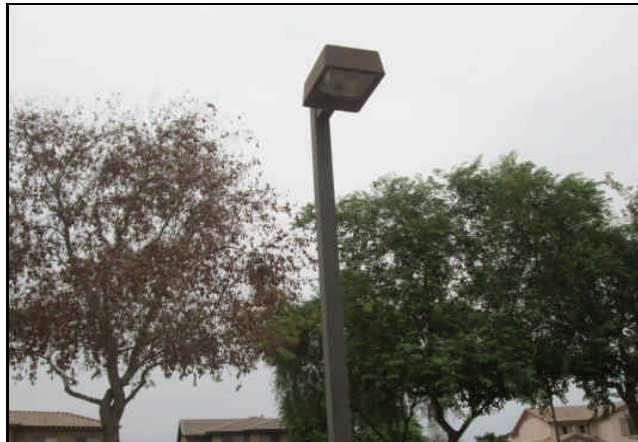
Useful Life:  
5 years

Remaining Life:  
0 years

Best Case: \$900  
Estimate to repaint

Worst Case: \$1,100  
Higher estimate

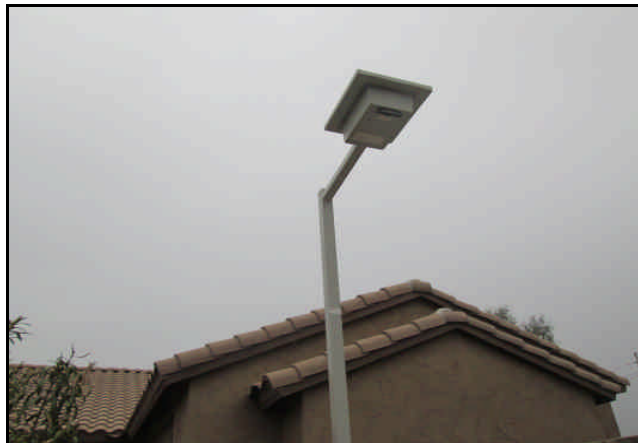
Useful Life:  
5 years

Remaining Life:  
9 years

Best Case: \$1,300  
Estimate to repaint

Worst Case: \$1,700  
Higher estimate

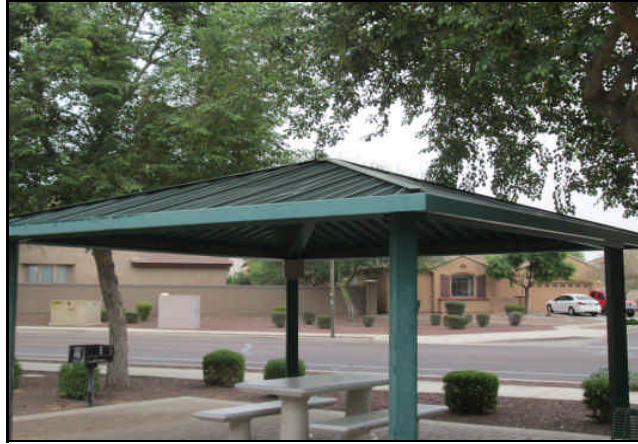
Useful Life:  
20 years

Remaining Life:  
5 years

Best Case: \$4,700  
Estimate to replace

Worst Case: \$5,800  
Higher estimate
