**RESERVE STUDY
FOR
TEMPE VILLAGES HOMEOWNERS
ASSOCIATION, INC**

Prepared By:
FDReserve Studies, LLC
Goodyear, AZ 85338
8/31/2016

TEMPE VILLAGES HOMEOWNERS ASSOCIATION, INC

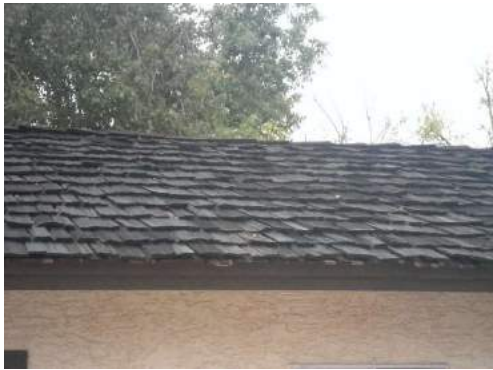
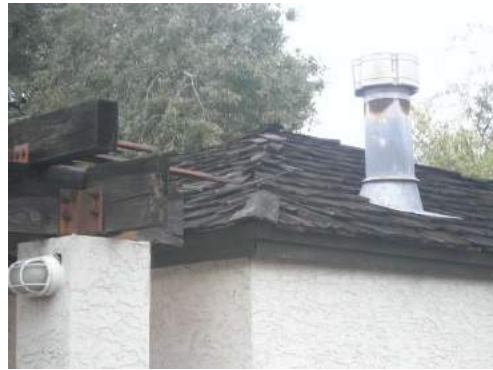
Poor condition. No signs of leaking but noticeable movement away from roof. Our cost is based on replacing with a composite 20 year shingle.

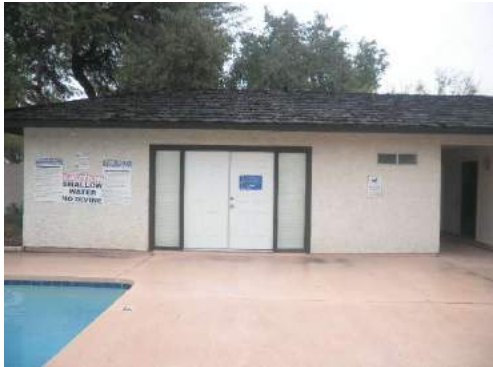
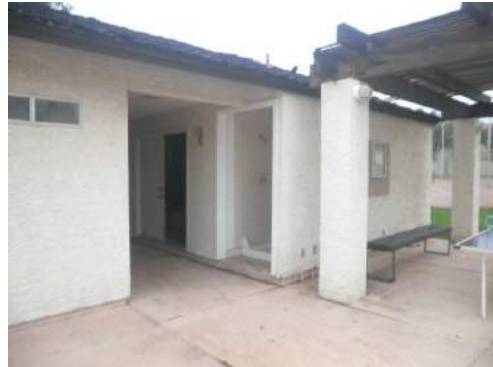
Clubhouse & Pool Equipment Buildings - Paint continued...

Fair to good condition. Cost to paint clubhouse and pool equipment building located in recreation/pool area. Estimate by Marcel Painting in Oct 2015. Last repaint date unknown.

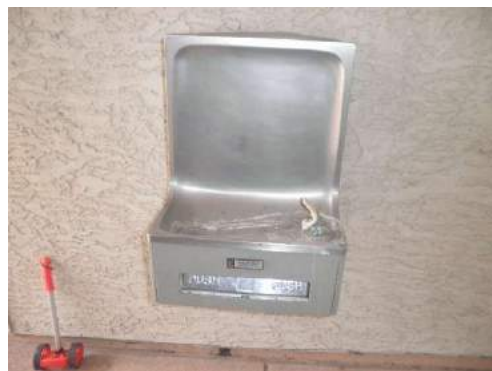
Non usable condition. Broken and disconnected. Elkay.

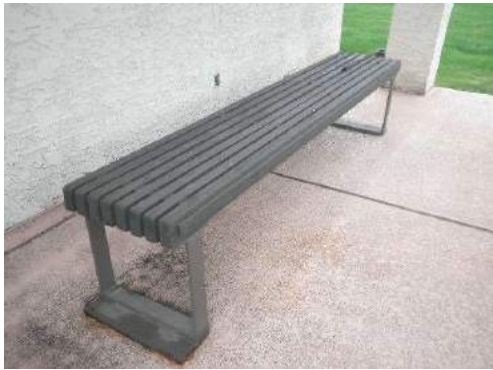
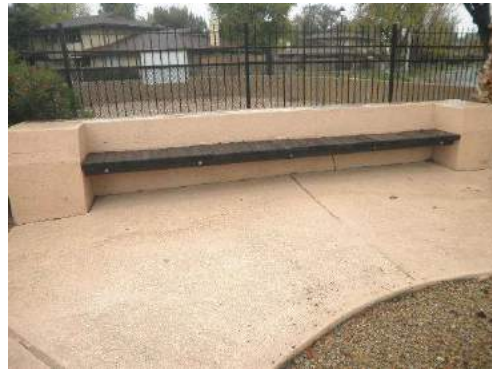
Good condition. Replacement based on purchasing new thermoplastic coated 6' park benches.

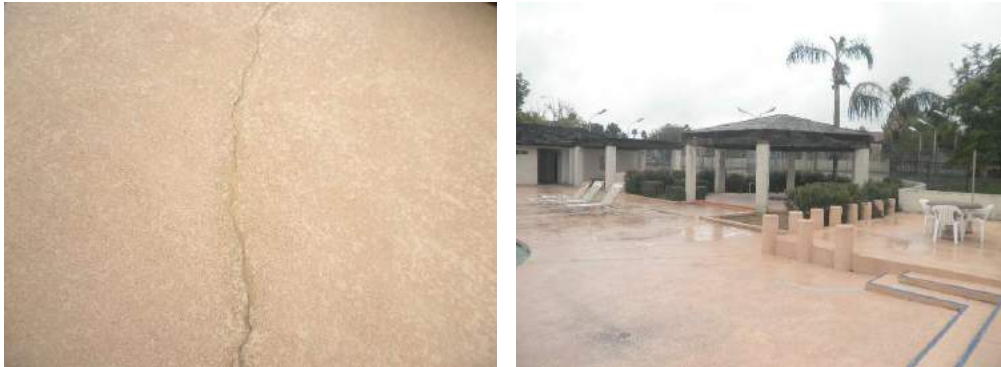
Pool Deck - Recoat continued...

Good to fair condition. Some limited cracking. Suggest cleaning. Date of last recoat unknown.

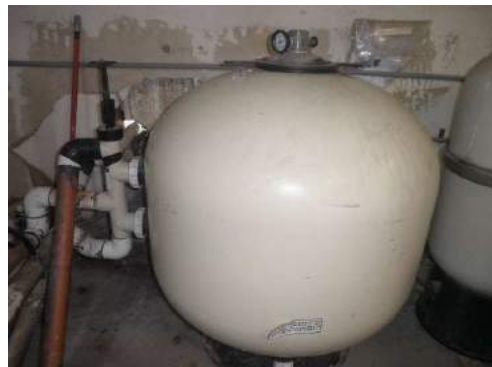
Good condition. Triton II TR-140C. Replaced 1/1/2015

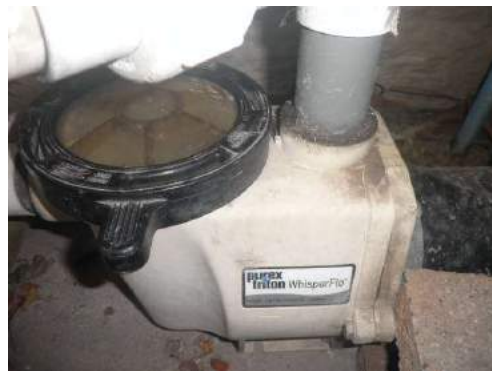
Poor condition. Purex Triton Whisperflow 3 hp. Noise emitting. Last replacement date unknown.

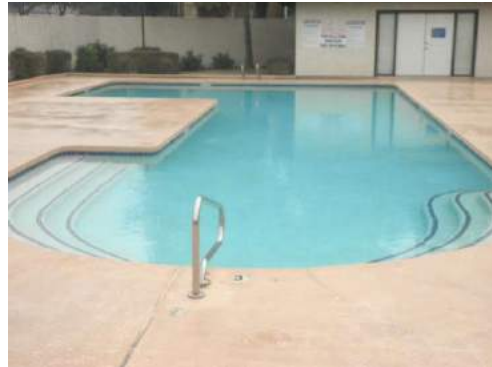
Pool Surface - Replace continued...

Good condition. Plaster pool with tile. Last resurface unknown.

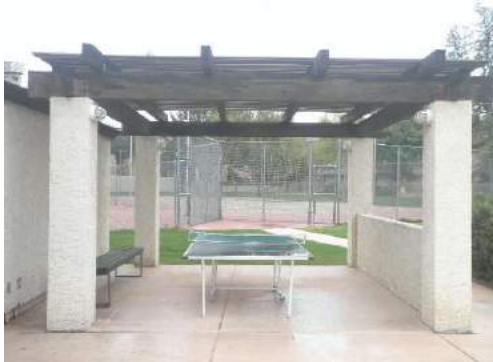
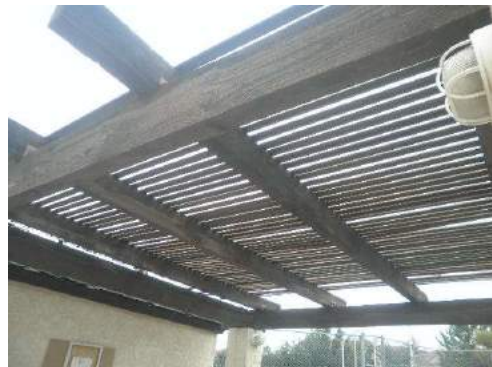
Good condition. Stucco posts with wood supports and metal slats. Ramada next to pool equipment building in pool recreation area. Estimate wood structure to last another 5 years so long as upkeep is maintained. Noted wood deteriorating from sun and weather exposure.

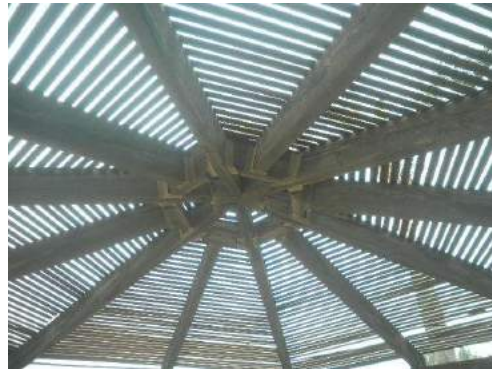
Good condition. Stucco posts with wood supports and metal slats. Ramada location is covering spa in pool recreation area. Estimate wood structure to last another 5 years so long as upkeep is maintained. Noted wood deteriorating from sun and weather exposure.

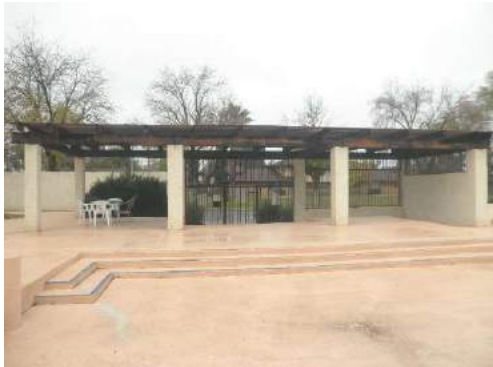
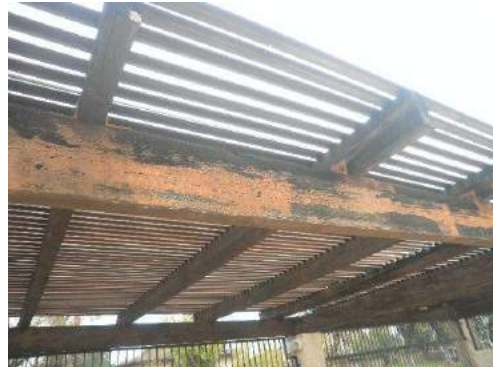
Ramada Roof Structure (3) - Replace continued...

Good condition. Stucco posts with wood supports and metal slats. Ramada is at entrance to pool recreation area. Estimate wood structure to last another 5 years so long as upkeep is maintained. Noted wood deteriorating from sun and weather exposure.

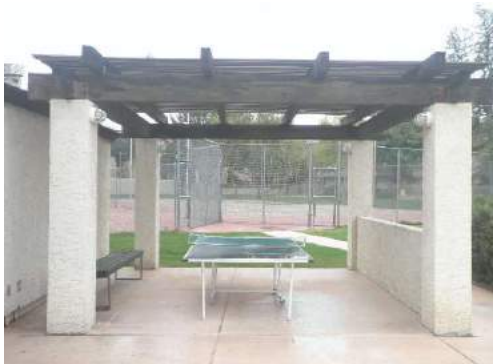
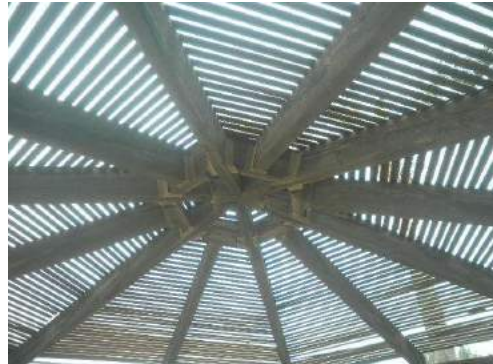
Fair condition. Lump sum cost to paint 3 ramadas located in recreation/pool area. Estimate by Marcel Painting in Oct 2015. Last repaint date unknown.

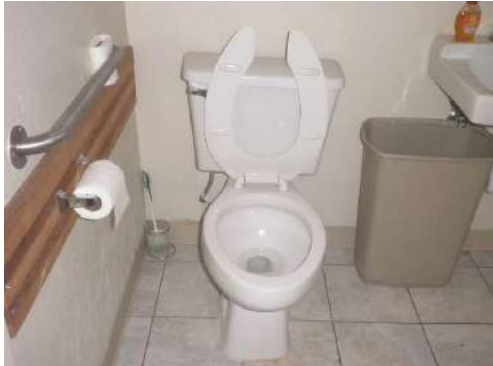
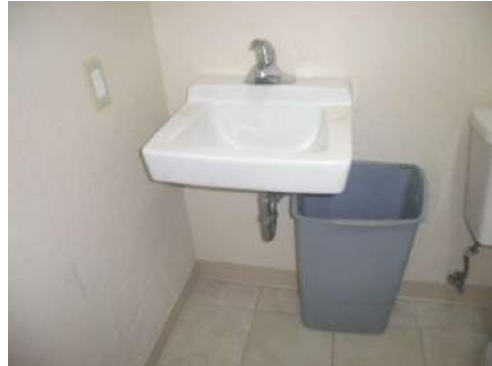
Good condition. Both the men's and womens restrooms contain (1) stool, (1) sink, tile floors, painted walls. Plumbing needs work as faucets are loose. This component covers entire replacement as needed for updating. Tile needs cleaning. Work that needs to be done is really maintenance work.

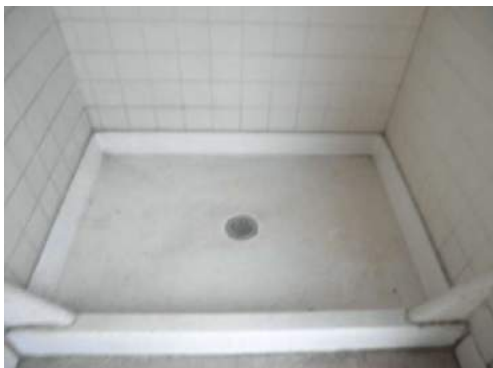
Good condition. Needs cleaning and paint. Ceramic tile floor to ceiling above pan.

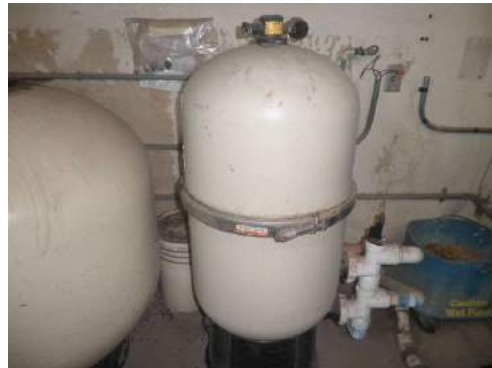
Good condition. Pentair FNS-48 DE. Diatomaceous earth filter. Last replacement unknown.

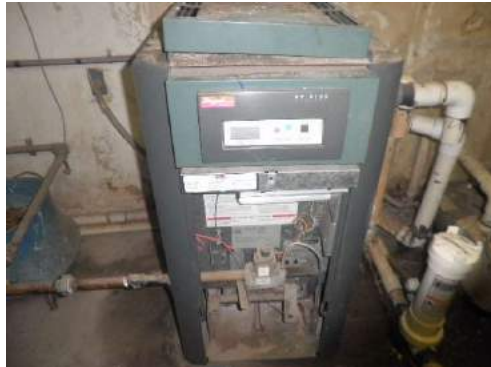
Spa Heater - Replace continued...

New condition. Replaced 1/22/2016 by Aqua Patrol with Raypak 399BTU ASME NG Heater 009271 C-R406A-EN. 1 year manufacture warranty. Price includes labor.

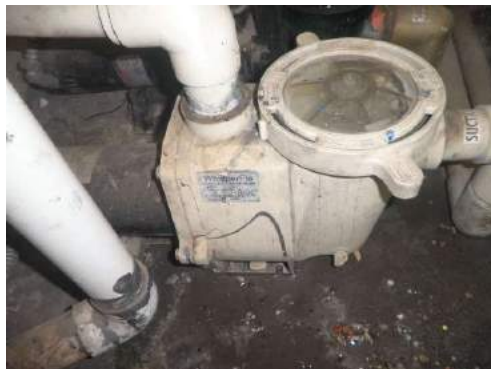
Poor condition. Whisperflow 3/4 hp. Leaking. Suggest replacing along with spa motor. Last replacement unknown.

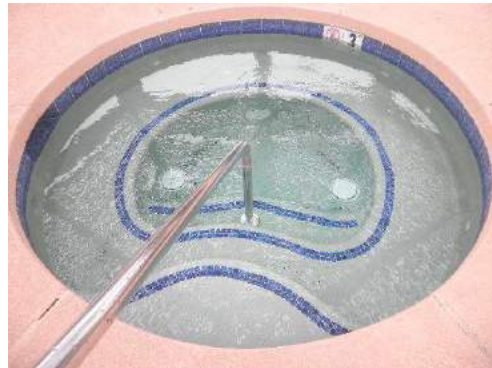
Good condtion. Plaster spa with tile. Last resurface unknwn.

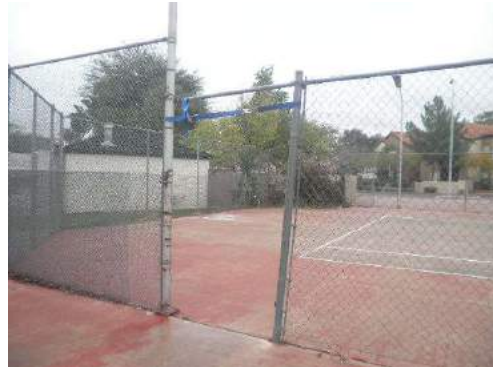
Tennis Court Chain Link Fencing - Repair continued...

Poor condition. Will need to replace most posts. Cost anticipates reusing some fencing.

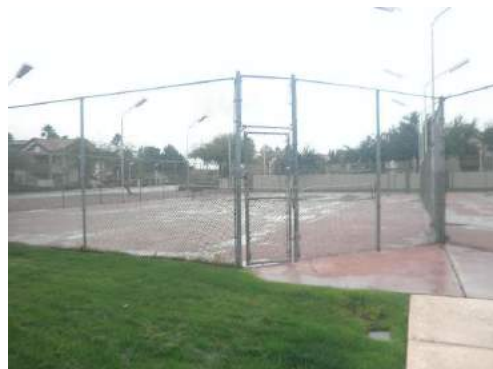
Poor condition. This is for a one time repair and resurface.

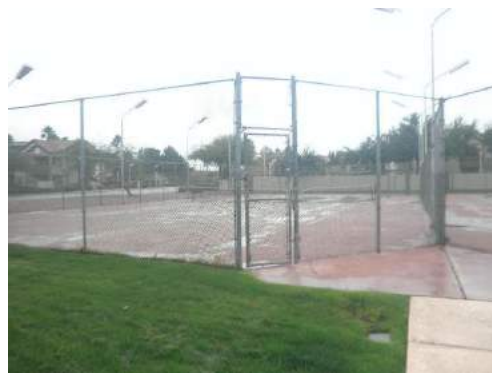
Tennis Courts - Resurface

2 EA	@ \$5,000.00
Asset ID	1029	Asset Cost	\$10,000.00
Pools & Recreation Area		Percent Replacement	100%
	Tennis	Future Cost	\$12,667.70
Placed in Service	January 2015	Assigned Reserves	<i>none</i>
Useful Life	8		
Adjustment	1	Annual Assessment	\$208.00
Replacement Year	2024	Interest Contribution	<u>\$1.46</u>
Remaining Life	8	Reserve Allocation	\$209.46

This is for resurfacing every 8 years once repairs and resurfacing are complete.

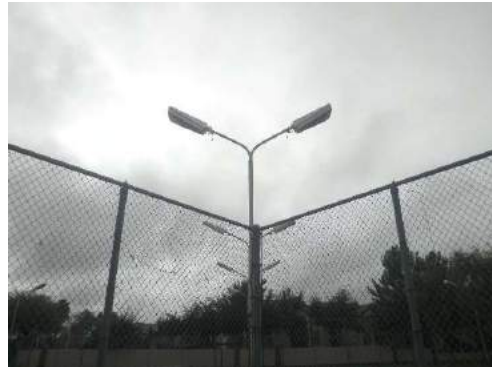
Tennis Courts Lighting - Replace continued...

4 doubles and 8 single lights. Could not evaluate if lights are working so budgeted for full replacement.

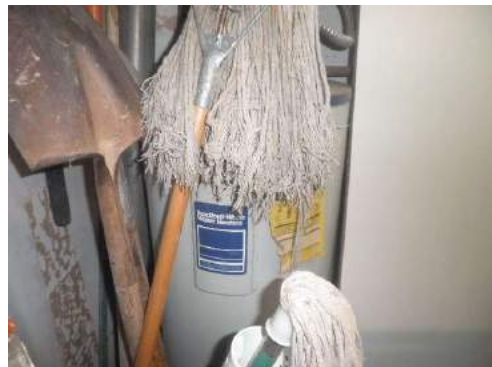
Stratford White 53 gallons. Could not access to confirm if in working condition. Last replacement unknown.

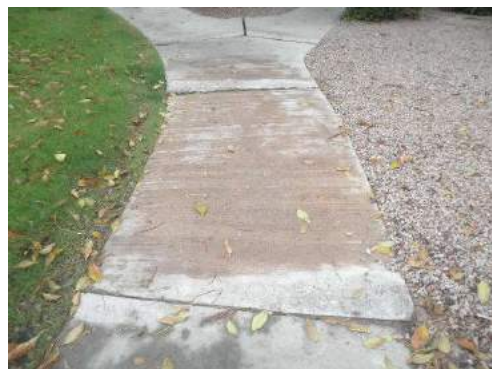
Concrete - Repair & Replace

Fair condition. Some tripping hazards. Budget for annual concrete repair work.

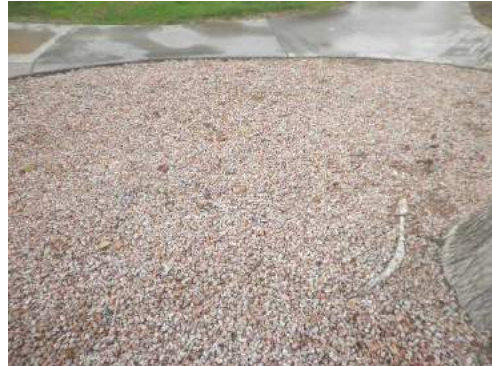
Information Sign - Replace

1002	1 LS	@ \$600.00
Asset ID	1002	Asset Cost	\$600.00
	Grounds	Percent Replacement	100%
	Signs	Future Cost	\$782.86
Placed in Service	January 2015	Assigned Reserves	<i>none</i>
Useful Life	10		
Replacement Year	2025	Annual Assessment	\$11.39
Remaining Life	9	Interest Contribution	<u>\$0.08</u>
		Reserve Allocation	<u>\$11.47</u>

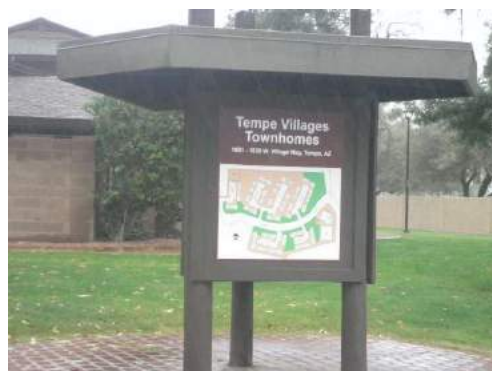
Good condition.

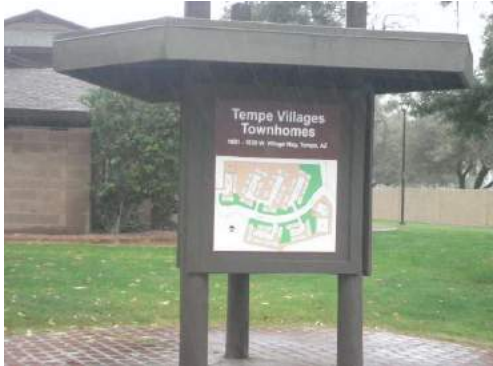
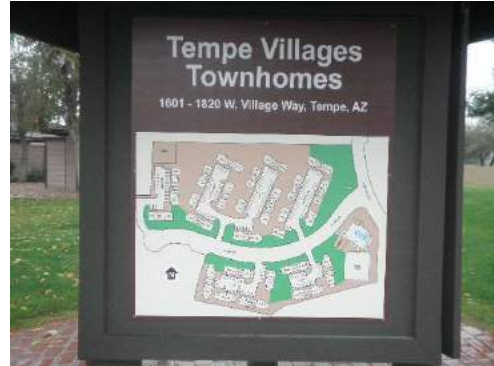
Information Signs - Paint

1 LS	
Asset ID	1003	Asset Cost	
	Grounds	Percent Replacement	100%
	Painting	Future Cost	
Placed in Service	January 2008	Assigned Reserves	<i>none</i>
No Useful Life			
<i>No Future Assessments</i>

Included in exterior wall painting.

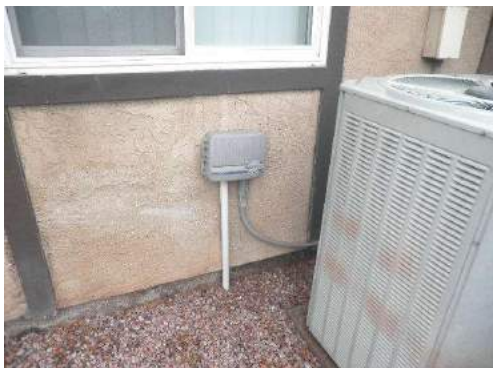
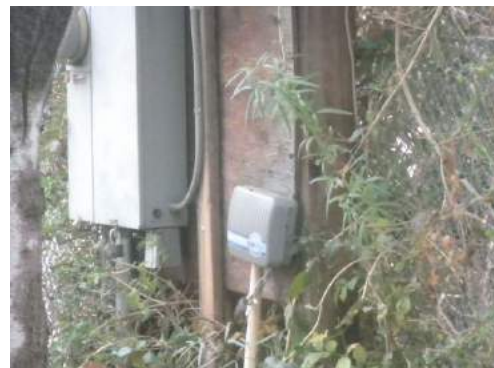
Irrigation Controllers - Replace

6 EA	@ \$700.00
Asset ID	1033	Asset Cost	\$4,200.00
	Grounds	Percent Replacement	100%
	Equipment	Future Cost	\$5,480.05
Placed in Service	January 2010	Assigned Reserves	<i>none</i>
Useful Life	15		
Replacement Year	2025	Annual Assessment	\$79.70
Remaining Life	9	Interest Contribution	<u>\$0.56</u>
		Reserve Allocation	<u>\$80.26</u>

There are a total of 6 timers on the property. 3 on the south side and 3 on the north side. Date

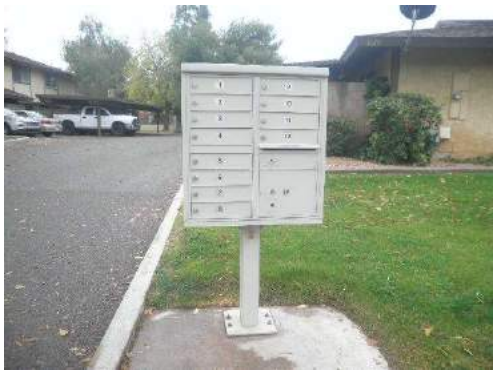
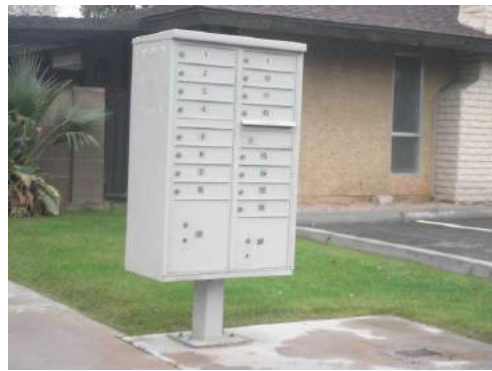
Good condition. Some have been replaced.

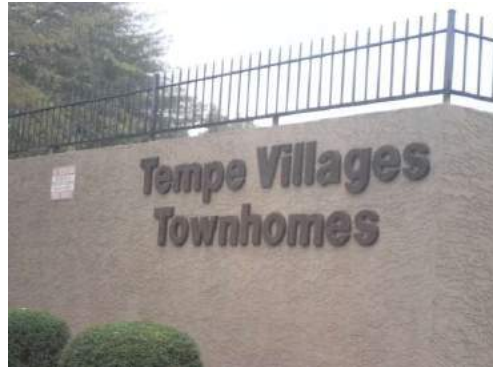
Monument - Replace continued...

Good condition. Metal letters painted. May need periodic painting to freshen appearance.

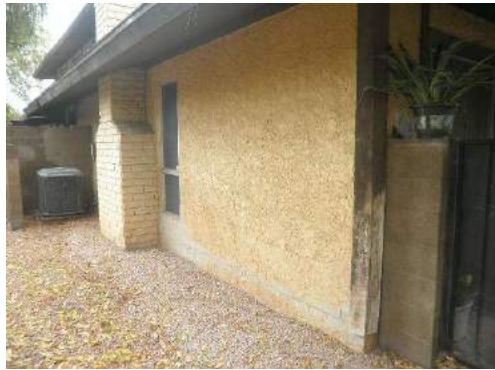
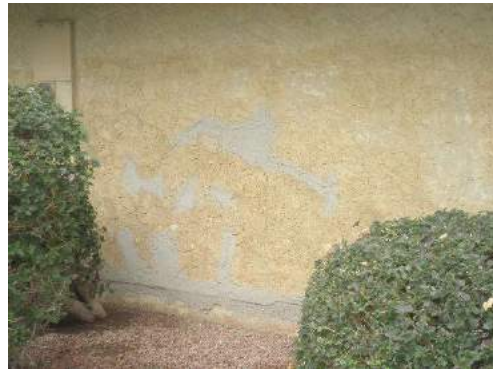
Fair to poor condition. Estimate by Marcel Painting in Oct 2015 includes stucco and fascia on all buildings. Last repaint date unknown.

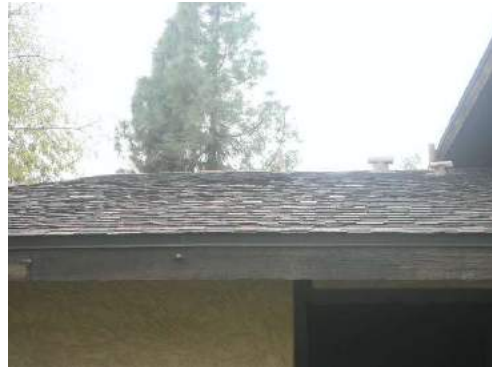
Buildings Roof Shingle - Replace - Phase 1 continued...

No roof leaks reported.

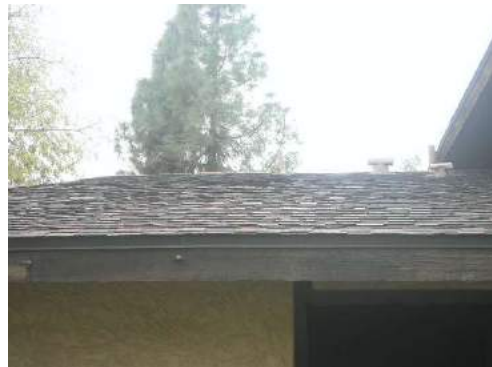
Buildings Roof Shingle - Replace - Phase 3

Asset ID	1039	66,000 SF	@ \$3.00
	Buildings	Asset Cost	\$65,993.40
	Roofing	Percent Replacement	33.33%
Placed in Service	August 1998	Future Cost	\$88,689.61
Useful Life	20	Assigned Reserves	<i>none</i>
Adjustment	8	Annual Assessment	\$1,156.82
Replacement Year	2026	Interest Contribution	<u>\$8.10</u>
Remaining Life	10	Reserve Allocation	\$1,164.92

No roof leaks reported.

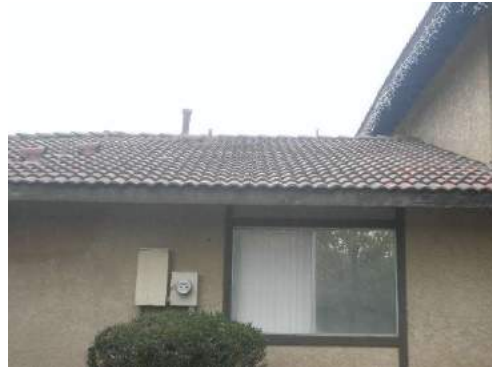
Buildings Roof Tile - Replace continued...

Appears to be in good condition. Tile material will last indefinitely and underlayment will last approximately 30 years.

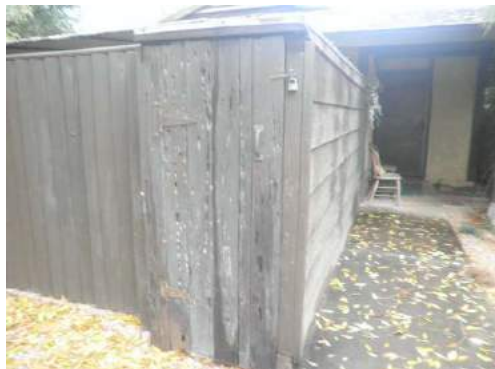
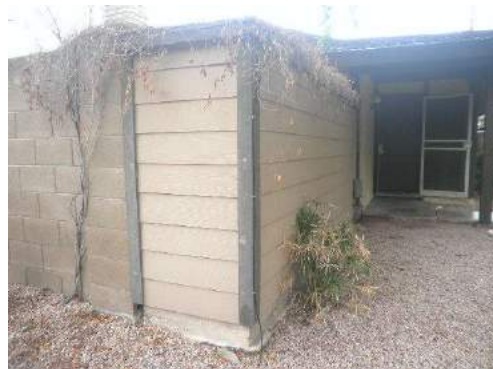
Storage Sheds - Replace

1 LS	@ \$5,000.00
Asset ID	1042	Asset Cost	\$5,000.00
	Buildings	Percent Replacement	100%
	Building Components	Future Cost	\$5,150.00
Placed in Service	July 1974	Assigned Reserves	<i>none</i>
Useful Life	5		
Replacement Year	Deferred 2017	Annual Assessment	\$693.30
Remaining Life	1	Interest Contribution	<u>\$4.85</u>
		Reserve Allocation	<u>\$698.15</u>

Replaced on as needed basis. This component reserves for \$5000 a year on a non recurring 5 year basis.

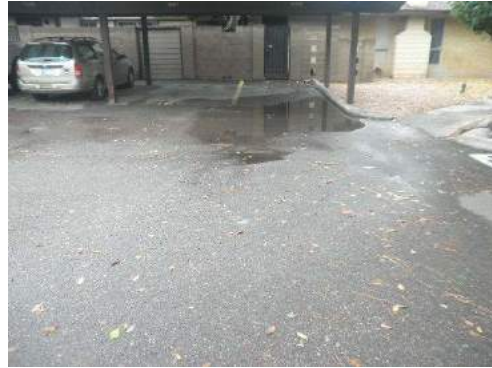
Poor to fair condition.

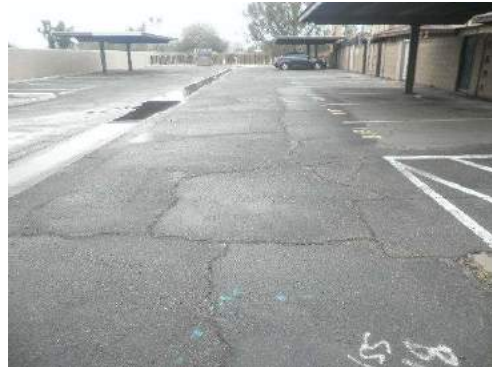
Asphalt - Seal Coat continued...

Poor to fair condition.

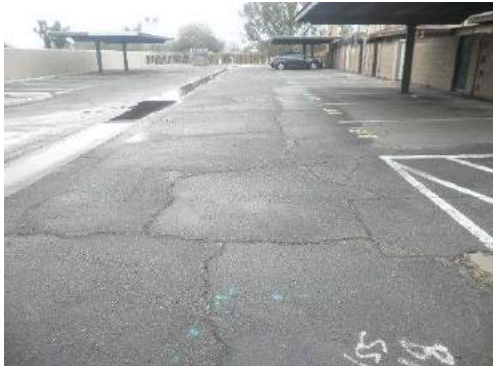
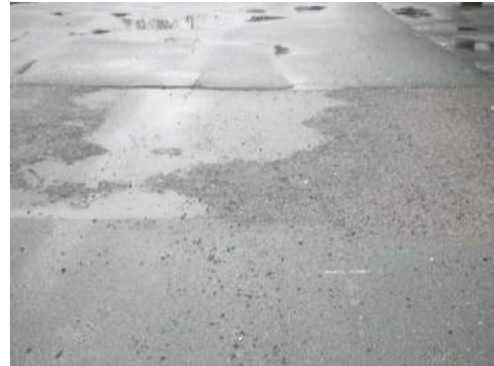
Poor to Fair condition. Recommend sully seal to extend the life of the pavement. Should include crack sealing prior to slurry seal. One time application.

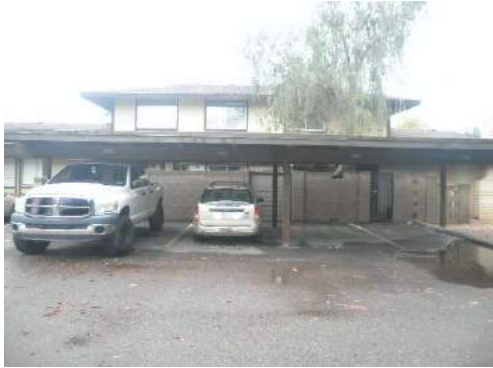
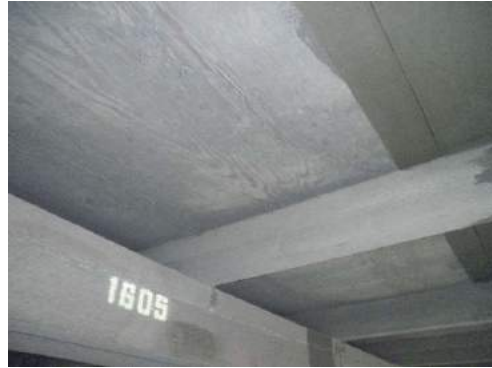
Carports - Repair

12,800 SF	@ \$2.00
Asset ID	1044	Asset Cost	\$25,600.00
	Parking Areas	Percent Replacement	100%
	Parking Structures	Future Cost	\$28,813.03
Placed in Service	July 1974	Assigned Reserves	<i>none</i>
Useful Life	25		
Adjustment	21	Annual Assessment	\$959.59
Replacement Year	2020	Interest Contribution	<u>\$6.72</u>
Remaining Life	4	Reserve Allocation	\$966.30

Roof material is an asphalt rolled material.

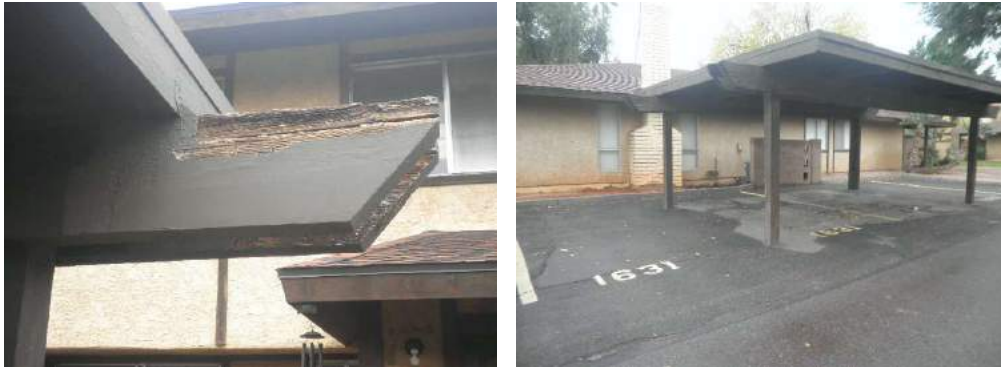
Good condition except where wood exposed (showing dry rot) on ends protruding from Asphalt roofs.

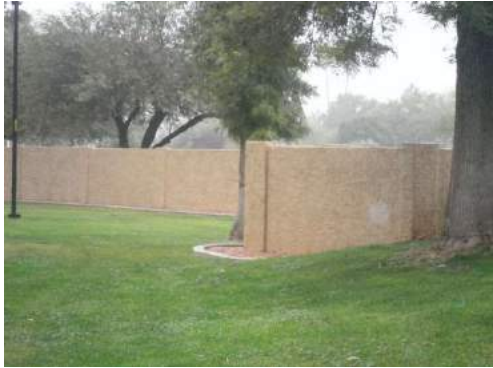
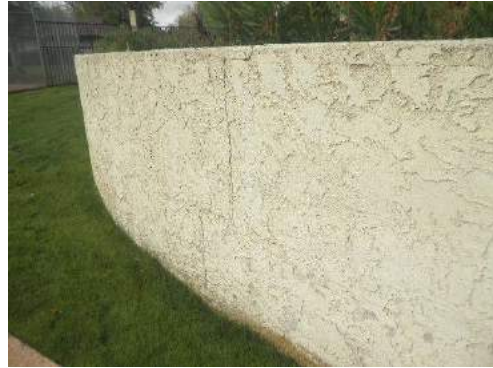
Good to fair condition. Some cracking and poor paint on interior walls at pool recreation area. Outside walls in surrounding community good condition. Last repaint date unknown.

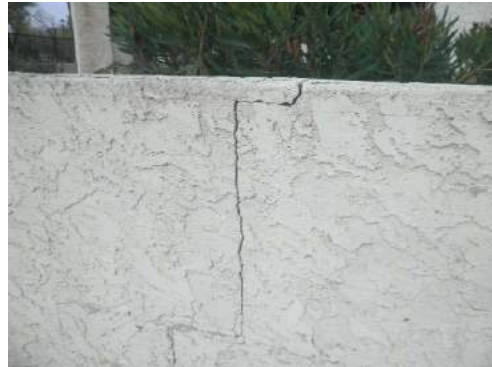
Good to fair condition. Some cracked and poor paint on interior walls at pool recreation area. Outside walls in surrounding community good condition. A budget for making wall repairs on a 5 year recurring schedule with approximate replacement of 1%. Total of approximately 20000 sf.

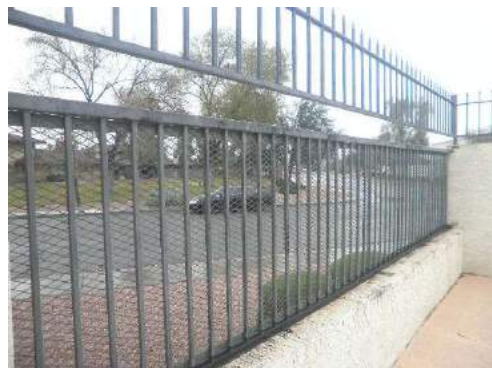
Poor condition. Surrounding pool recreation area. Rust and deterioration evident where spray irrigation hits. Last repaint date unknown.

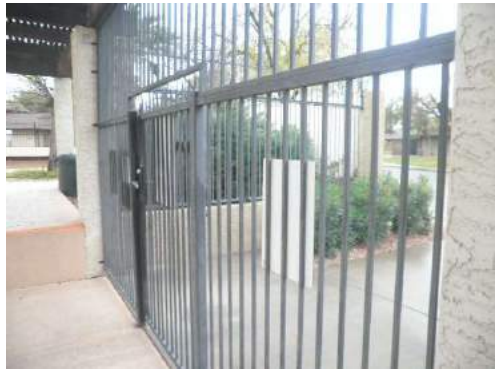
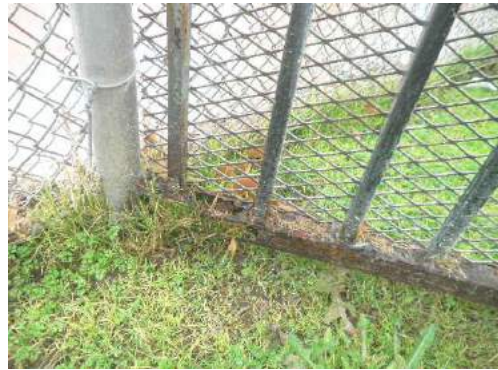
Good to fair condition. Some rusting visible at pool recreation area with some rusted out areas where irrigation hits. A budget for making wall repairs on a 5 year recurring schedule with approximate replacement of 5%. Total of approximately at approximately 1150 sf.
