Update "No-Site-Visit" Reserve Study

Premiere at Desert Breeze HOA Chandler, AZ

Report #: 27989-1
For Period Beginning: January 1, 2020
Expires: December 31, 2020

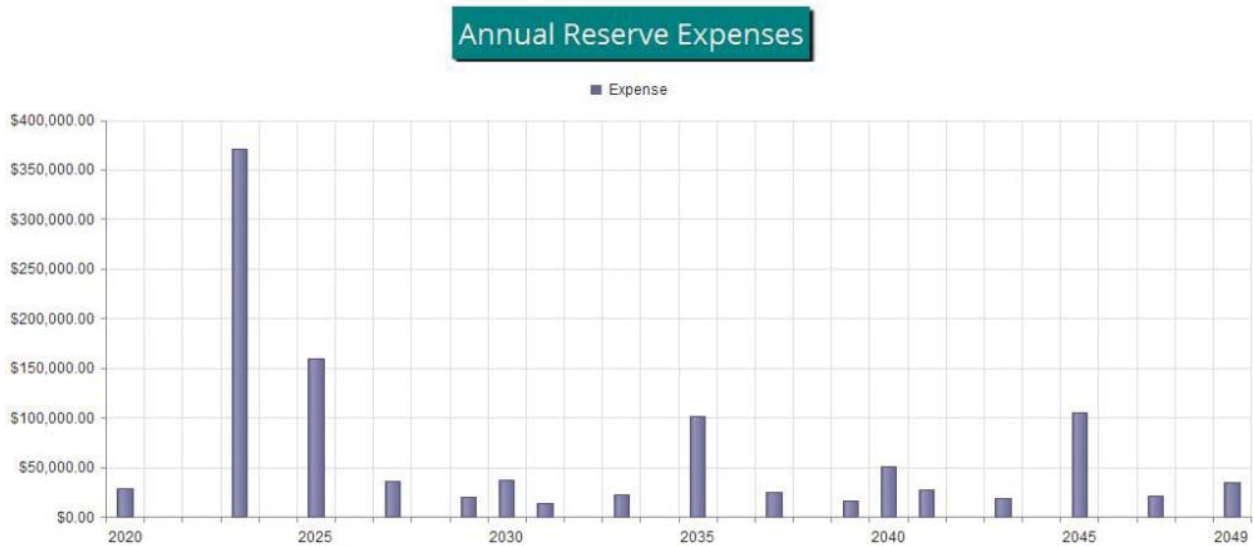
Figure 1

The chart below summarizes the projected future expenses at your association as defined by the Reserve Component List. A summary of these components is shown in the Component Details Table, while a summary of the expenses themselves is shown in the 30-yr Expense Summary Table.

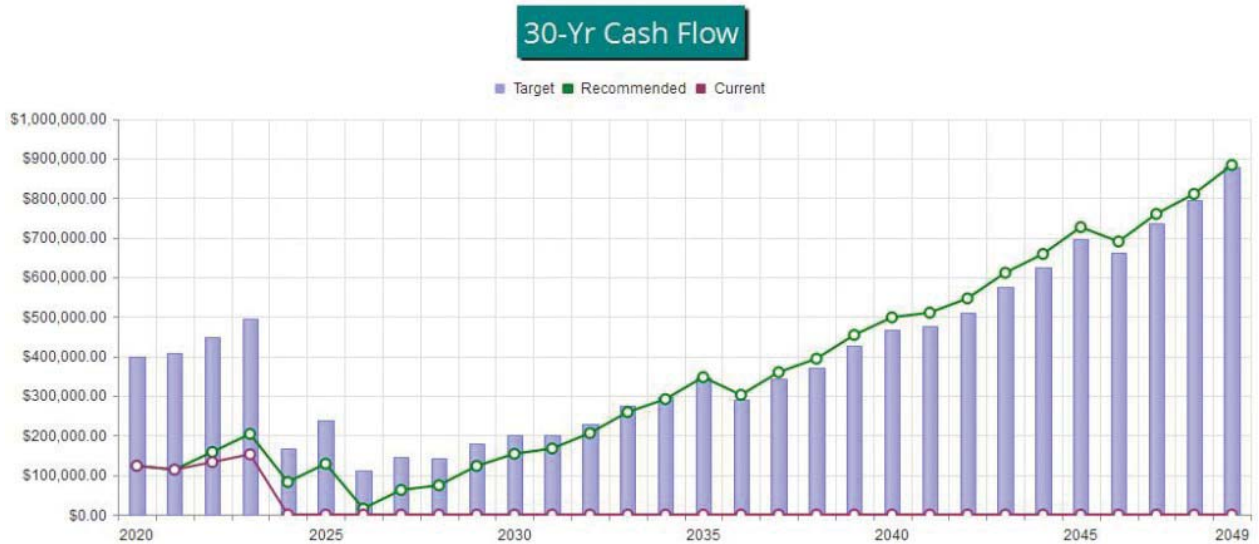
Figure 3

The following chart shows your Reserve balance under our recommended Funding Plan and your currently budgeted contribution rate, compared to the always-changing Fully Funded Balance target.
