Villas at Palm Valley

Supplementary Schedules Reserve Management Plan

Reserve Study with On-Site Analysis

For 30-Year Projection Period Beginning January 1, 2020

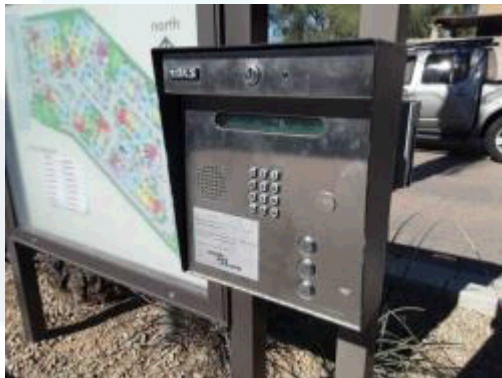
Access Phone - Replace

Location	Desc.	Condition	Service Date	Replace Date	Rem Life	Adj Life	Quantity	Current Cost	Future Cost
Entry		Good	01/01/2017	01/01/2027	7:00	10:00	1	4,150.00	5,103.98
								\$ 4,150.00	\$ 5,103.98

Elite DIALCODELC entry phone to be replaced as needed.

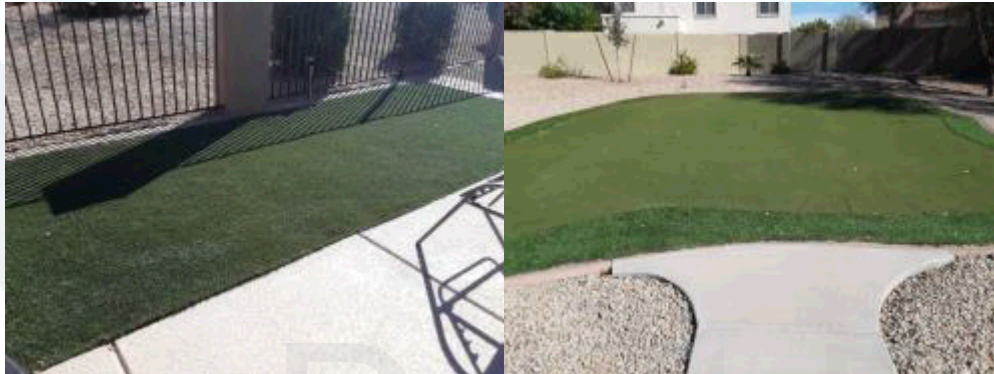
Location	Desc.	Condition	Service Date	Replace Date	Rem Life	Adj Life	Quantity	Current Cost	Future Cost
Putting Green Area		Poor	01/01/2001	01/01/2021	1:00	20:00	3	6,000.00	6,180.00
Pool		Good	01/01/2001	01/01/2021	1:00	20:00	1	2,000.00	2,060.00
								<u>\$ 8,000.00</u>	<u>\$ 8,240.00</u>

Funding to refurbish putting green and pool areas or create new common area element as determined.

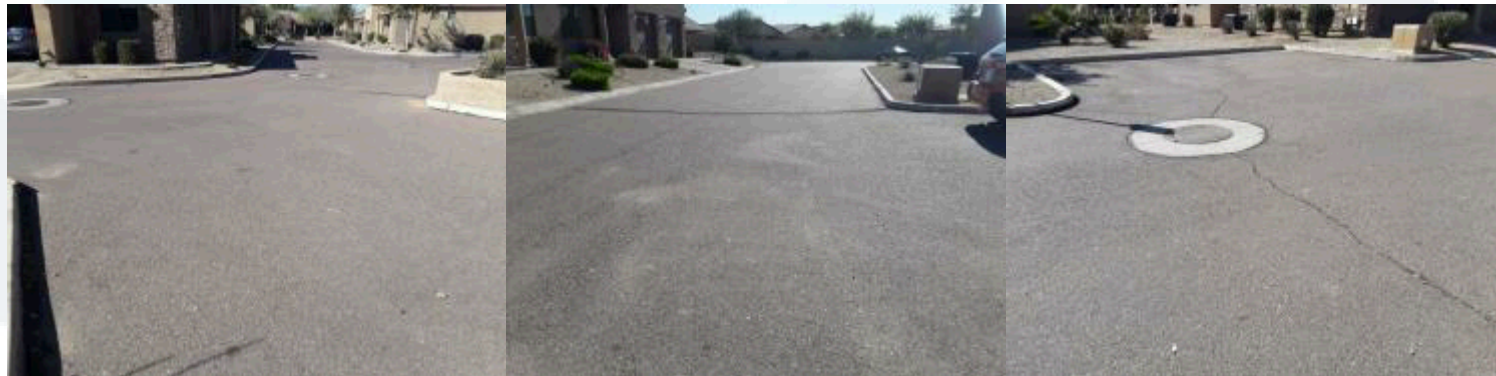
Location	Desc.	Condition	Service Date	Replace Date	Rem Life	Adj Life	Quantity	Current Cost	Future Cost
Community		Fair	01/01/2006	01/01/2036	16:00	30:00	71,714	106,853.86	171,469.08
								\$ 106,853.86	\$ 171,469.08

Installed: 10/2007

Funding to eventually Mill & Overlay all community asphalt in 2037. Full cost to Mill and Overlay funded by Asphalt - Repair and Reseal AND Asphalt - Mill & Overlay components for a full \$2.00 / per sq ft at current costs.

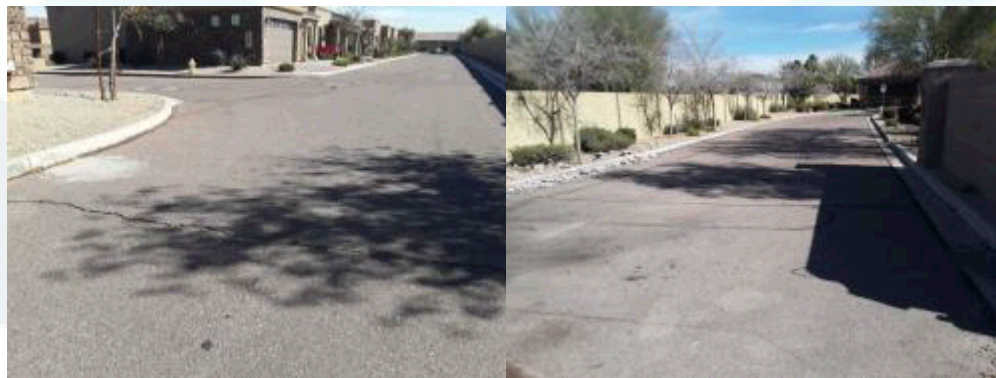
Asphalt - Repair & Reseal

Location	Desc.	Condition	Service Date	Replace Date	Rem Life	Adj Life	Quantity	Current Cost	Future Cost
Community		Poor	01/01/2012	01/01/2020	0:00	8:00	71,714	36,574.14	36,574.14
								\$ 36,574.14	\$ 36,574.14

Funding to repair and fill asphalt cracks to cycle with resealing projects. See bid from Sunland Asphalt - 12/16/2019 - \$35,982.

Repair cracked/broken concrete collars around 2 water valves and 1 manhole.

Remove Approx. 3,646 Square Feet Of Wide Cracks In Asphalt To A Depth Of 3".

Power Clean With High Volume Air As Needed And Seal All Cracks 1/4" And Larger With Crafcro PolyFlex III Crack Sealant.

Power Clean With High Volume Air As Needed And Seal Curb Line 1/4" And Larger With Crafcro PolyFlex III Crack Sealant.

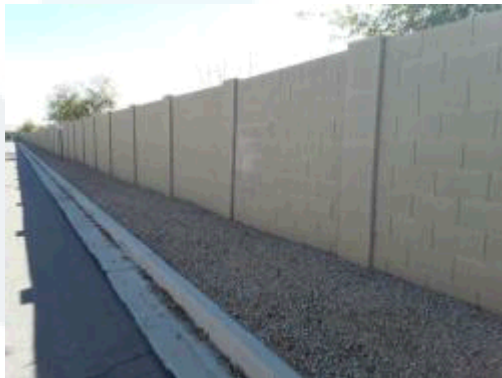
Block Walls - Inspect and Repair

Location	Desc.	Condition	Service Date	Replace Date	Rem Life	Adj Life	Quantity	Current Cost	Future Cost
Community		Fair	01/01/2017	01/01/2027	7:00	10:00	1	6,750.00	8,301.65
								\$ 6,750.00	\$ 8,301.65

The masonry wall in this community should last the life of the community providing it is maintained as needed. There will be a need to repair this component at some time and we are providing funding for this purpose. The need for repair may be less, or exceed the provisions we have made and can be adjusted over time. Currently there are a few areas that need to be addressed regarding stair step cracking as shown in the picture below. This type of cracking is typically a result of soil shifting which has a variety of causes. Initially these types of repairs can be minor in expenses using elastomeric caulk to patch and then a paint touch up. If the cracking persists, we recommend hiring a licensed and bonded masonry contractor to investigate the problem and propose a permanent solution for repair.

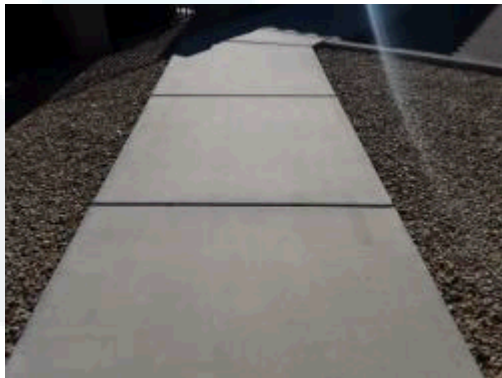
Concrete - Repair & Replace

Location	Desc.	Condition	Service Date	Replace Date	Rem Life	Adj Life	Quantity	Current Cost	Future Cost
Community		Good	01/01/2011	01/01/2026	6:00	15:00	1	6,500.00	7,761.34
								\$ 6,500.00	\$ 7,761.34

Approximately 1,540 square feet of concrete and 5,110 lineal feet of concrete curbing to be repaired or replaced as needed.

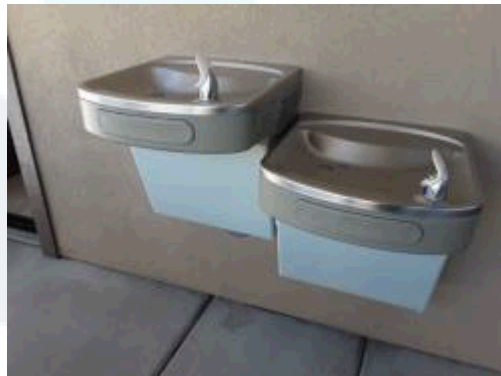
Drinking Fountain - Replace

Location	Desc.	Condition	Service Date	Replace Date	Rem Life	Adj Life	Quantity	Current Cost	Future Cost
Pool		Fair	01/01/2008	01/01/2023	3:00	15:00	2	2,300.00	2,513.27
								\$ 2,300.00	\$ 2,513.27

Elkal drinking fountains to be replaced as needed.

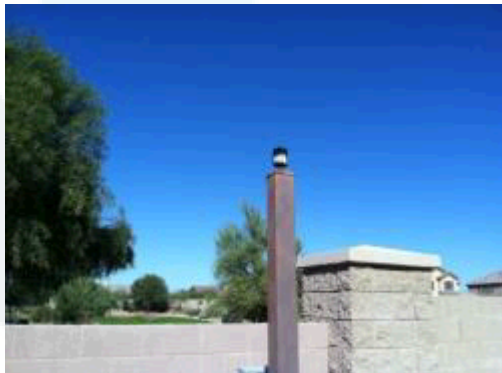
Entry System - Replace

Location	Desc.	Condition	Service Date	Replace Date	Rem Life	Adj Life	Quantity	Current Cost	Future Cost
Entry		Good	01/01/2016	01/01/2020	0:00	4:00	2	3,000.00	3,000.00
								\$ 3,000.00	\$ 3,000.00

This component is for the access of emergency services and must be operational at all times. It has a useful life of 4 years. We recommend that this be inspected at a minimum occurrence of a quarterly inspection by a licensed professional. This component opens the gates for emergency services equipped with strobe lights.

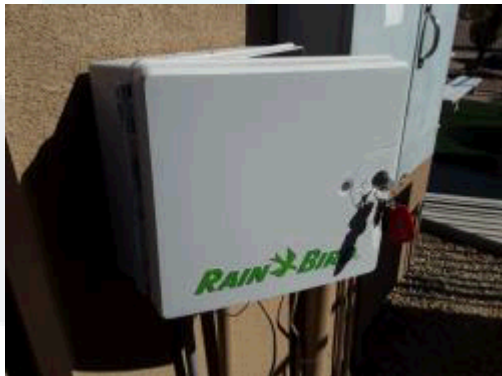
Irrigation Controller - Replace

Location	Desc.	Condition	Service Date	Replace Date	Rem Life	Adj Life	Quantity	Current Cost	Future Cost
Community		Good	01/01/2018	01/01/2030	10:00	12:00	3	3,600.00	4,838.10
								\$ 3,600.00	\$ 4,838.10

Rainbird controllers to be replaced as needed.

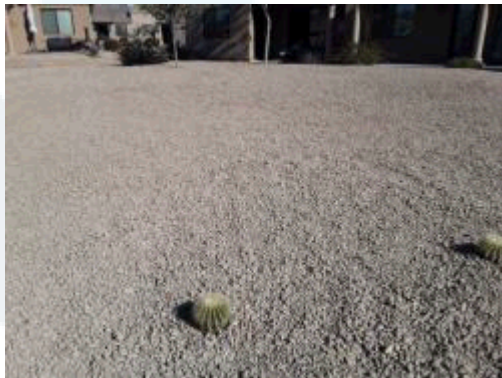
Location	Desc.	Condition	Service Date	Replace Date	Rem Life	Adj Life	Quantity	Current Cost	Future Cost
Community		Fair	01/01/2019	01/01/2024	4:00	5:00	30	2,100.00	2,363.57
								\$ 2,100.00	\$ 2,363.57

The granite should be regularly maintained by the landscape maintenance contractor and any replenishment should be preformed prior to the scheduled pre-emergent treatment to avoid duplicate efforts and cost.

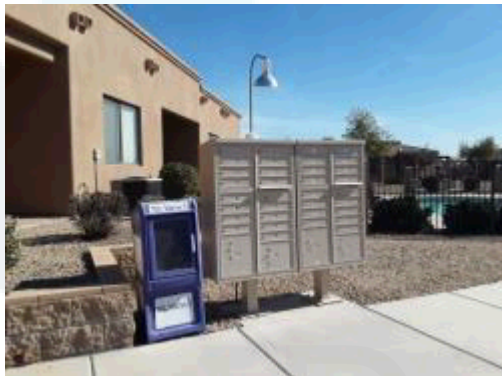
Mailbox Cluster - Replace

Location	Desc.	Condition	Service Date	Replace Date	Rem Life	Adj Life	Quantity	Current Cost	Future Cost
Community		Good	01/01/2008	01/01/2033	13:00	25:00	2	4,000.00	5,874.13
Community		Good	01/01/2017	01/01/2042	22:00	25:00	2	4,000.00	7,664.41
								<u>\$ 8,000.00</u>	<u>\$ 13,538.54</u>

16 unit 2 Parcel lockers AF Florence Vigilant 1565 to be replaced as needed.

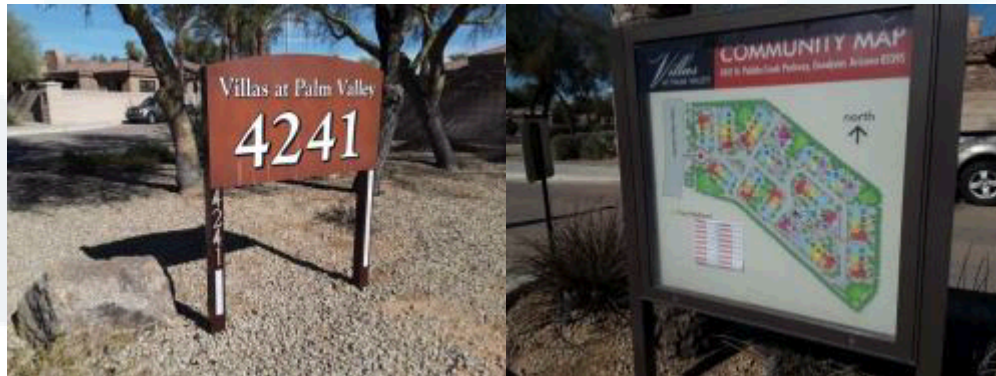
Location	Desc.	Condition	Service Date	Replace Date	Rem Life	Adj Life	Quantity	Current Cost	Future Cost
North Entry		Fair	01/01/2008	01/01/2028	8:00	20:00	1	3,000.00	3,800.31
								\$ 3,000.00	\$ 3,800.31

Funding to refurbish address monument, community map, and signage throughout community as needed.

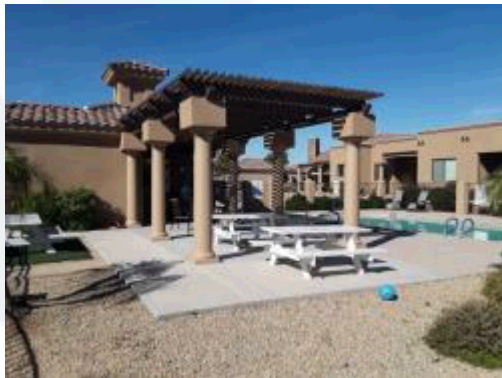
Pergola - Replace

Location	Desc.	Condition	Service Date	Replace Date	Rem Life	Adj Life	Quantity	Current Cost	Future Cost
			01/01/2008	01/01/2033	13:00	25:00	1	4,000.00	5,874.13
								\$ 4,000.00	\$ 5,874.13

Pergola to be replaced as needed.

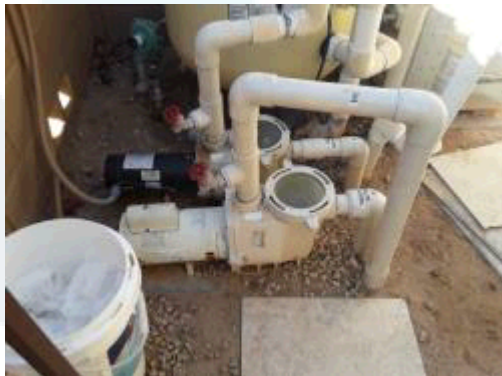
Pool Pumps - Replace

Location	Desc.	Condition	Service Date	Replace Date	Rem Life	Adj Life	Quantity	Current Cost	Future Cost
Pool		Good	01/01/2017	01/01/2022	2:00	5:00	1	1,500.00	1,591.35
								\$ 1,500.00	\$ 1,591.35

This component will accumulate funds for the major repair/replacement of the pool and spa pumps and motors.

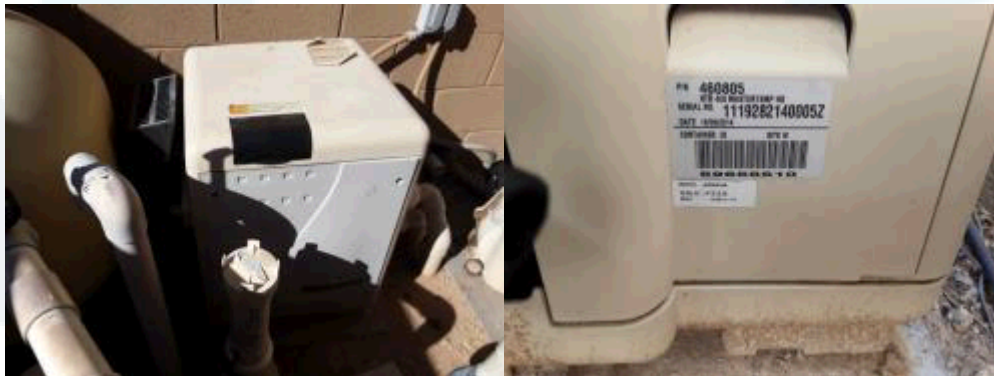
Pool Spa Heater - Replace

Location	Desc.	Condition	Service Date	Replace Date	Rem Life	Adj Life	Quantity	Current Cost	Future Cost
Pool		Fair	01/01/2015	01/01/2027	7:00	12:00	1	3,500.00	4,304.56
								\$ 3,500.00	\$ 4,304.56

Pentair Master Temp HTR 400 - 250,000 BTU heater to be replaced as needed. Model# 460805. Serial# 1119282140005Z. Installed 2015

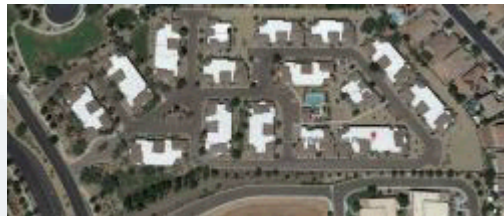
Roof Flat - Repairs

Location	Desc.	Condition	Service Date	Replace Date	Rem Life	Adj Life	Quantity	Current Cost	Future Cost
Community		Good	01/01/2016	01/01/2022	2:00	6:00	1	3,200.00	3,394.88
								\$ 3,200.00	\$ 3,394.88

Funding for periodic repairs to flat and tile roof areas.

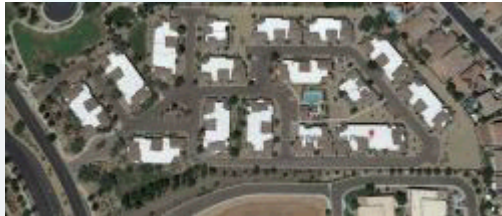
Funding to reseal the flat roofs as needed.

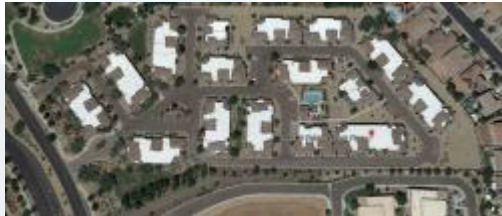
Funding to resurface the flat roofs as needed.

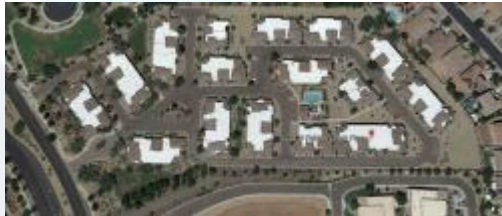
Funding to replace underlayment on all tile roof areas. Tile roof systems are designed to last for the life of the project. However, the integrity of the tile roof is dependent on the condition of the roof underlayment. The tile can last indefinitely but will not keep the building watertight unless the underlayment is intact.
