## **RESERVE STUDY UPDATE**

## SILVERHAWKE HOMEOWNERS ASSOCIATION

September 23, 2024

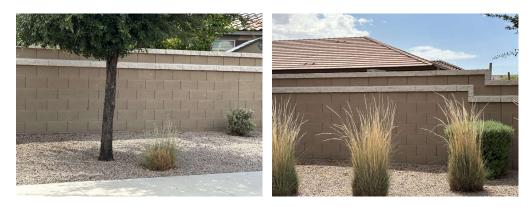
Masonry Walls - Repair		1 LS	@ \$7,000.00
Asset ID	1027	Asset Actual Cost	\$7,000.00
	Grounds	Percent Replacement	100%
Category	Fencing/Security	Future Cost	\$7,426.30
Placed in Service	June 2023		
Useful Life	3		
Replacement Year	2026		
Remaining Life	2

Budget for demo, removal and re-install of theme walls, painted to match every 3 years, where needed.

2023 - Valleywide Masonry repaired walls total \$6,700.

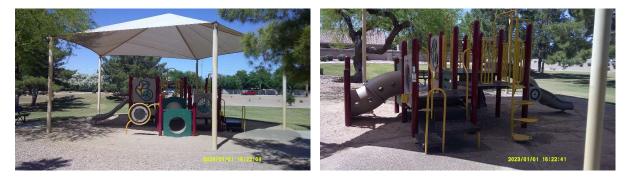
Playstructure (Dodge Park	) - Replace	1 EA	@ \$30,000.00
Asset ID	1014	Asset Actual Cost	\$30,000.00
	Recreation	Percent Replacement	100%
Category	Furnishings	Future Cost	\$38,003.10
Placed in Service	January 2012		
Useful Life	20		
Replacement Year	2032		
Remaining Life	8

Good condition including paint, sand, turf. Located at Dodge Park on east side of N Dodge St between W Scott Ave and W Harvard. Playworld Systems playstructure. This asset includes provisions for sand replenishment on an "as needed" basis. Date placed in service unknown, replacement based on current condition.

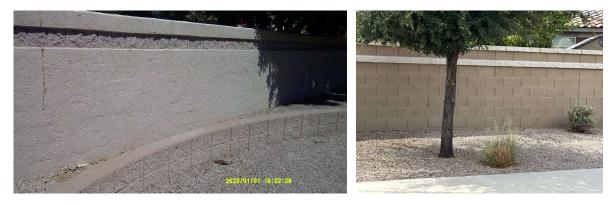
Masonry Walls - Paint		1 LS	@ \$124,000.00
Asset ID	1001	Asset Actual Cost	\$124,000.00
	Grounds	Percent Replacement	100%
Category	Painting	Future Cost	\$131,551.60
Placed in Service	April 2018		
Useful Life	8		
Replacement Year	2026		
Remaining Life	2

Good condition. This asset includes repair and painting of stucco masonry walls. Approximately 109,000 SF of community walls. Walls painted in 2018 for a total of \$106,849.98.
