**The Landings C.A.
*Litchfield Park, AZ***

Report #: 43744-0

RESERVE STUDY
"Full"

May 16, 2022

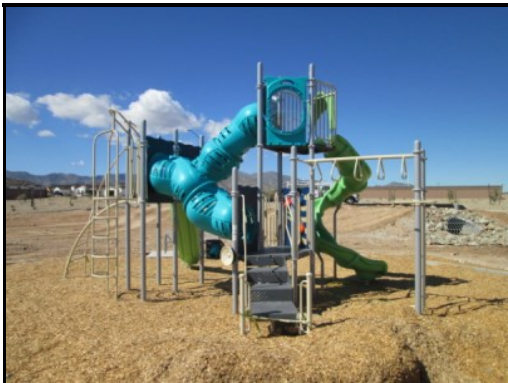
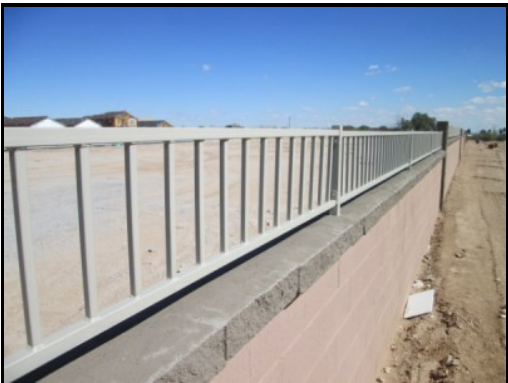
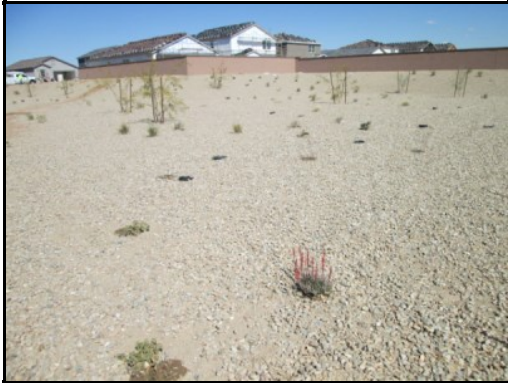
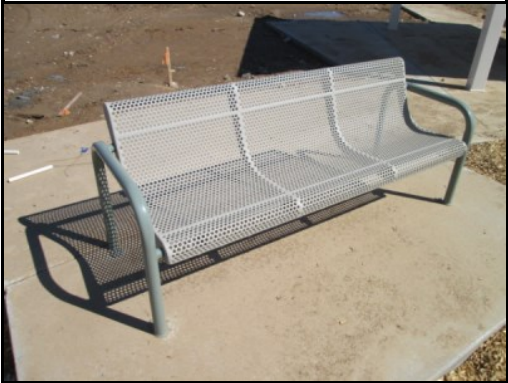
During the site visit on 2/24/2022, we started by visually inspecting the playground, followed by the remaining common areas.

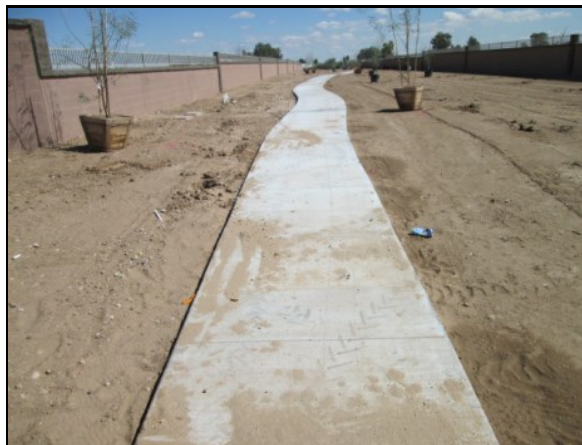
Comp #: 220 Concrete - Repair

Comments: There is no expectancy to completely replace the concrete. This component funds an allowance for periodic repairs and partial replacements as needed.

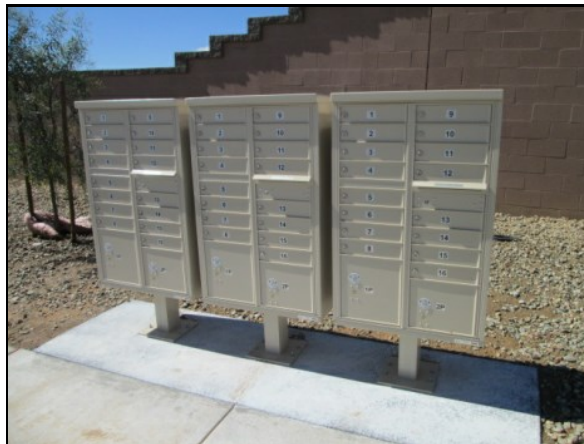
Comp #: 380 Mailboxes - Replace

Comments: Quantity includes (1) 8-box and (26) 16-box clusters. No significant wear or weathering evident.

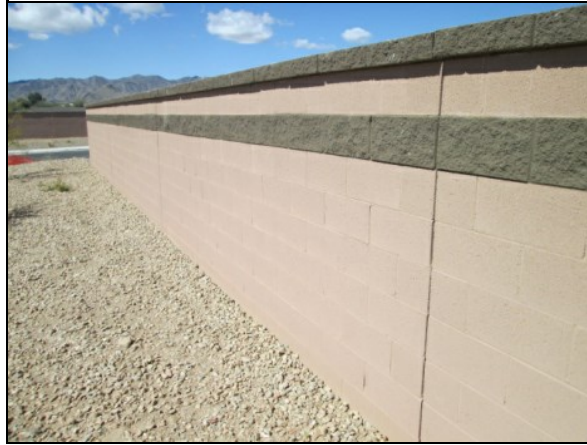
Comp #: 500 Block Walls - Repair

Comments: These are unpainted block walls. Walls are expected to last the life of the community under normal circumstances. This component funds an allowance for repairs and partial replacement due to excessive settling or other sources of damage.

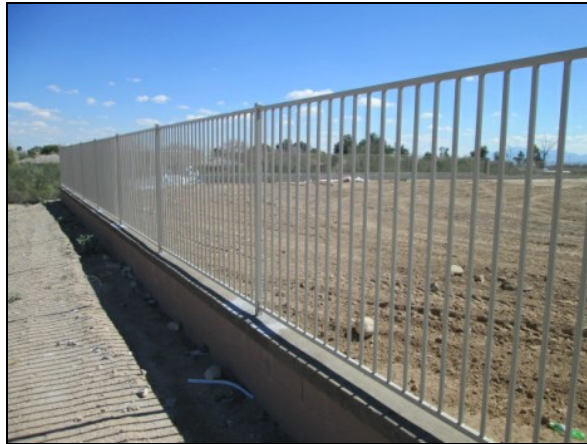
Comp #: 510 View Fence - Replace

Comments: Quantity includes approximately 1,150 LF of 1.5' tall view fence and 1,380 LF of 4.5' tall view fence. Observed to be intact and secure with no significant weathering or rust evident.

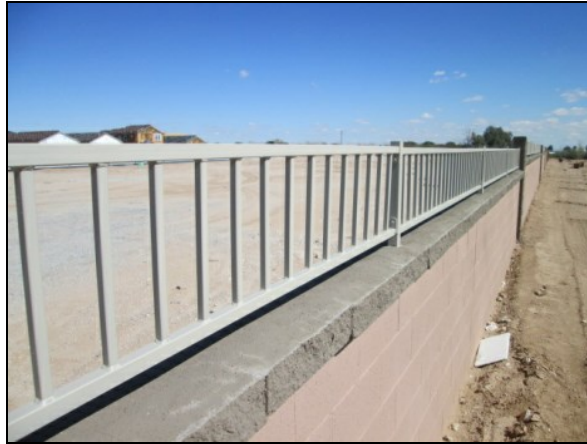
Comments: Quantity includes approximately 1,150 LF of 1.5' tall view fence and 1,380 LF of 4.5' tall view fence. Per the CC&R's (article 7, section 6), the view fence repaint cost is shared evenly between the HOA and each owner that has a lot with view fence. Surfaces appear to be uniform with no significant weathering or rust evident. Cost reflects 50% shared responsibility.

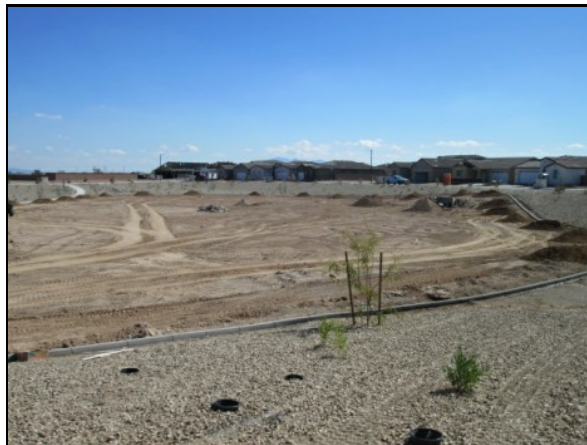
Comp #: 600 Irrigation System - Replace

Funded?: No. It is beyond the scope of this Reserve Study to quantify and assess conditions of the irrigation system. Funding can be added for future replacement at the client's request, but we need to be provided with cost and life expectancy estimates.

Repairs and partial replacements should be included in the annual landscape maintenance budget.

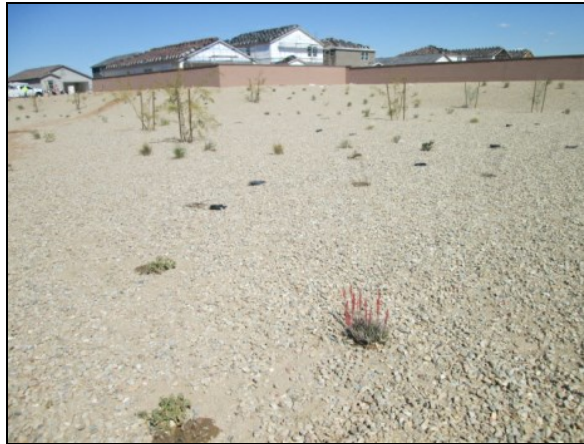
Comments: Complete replacement of the landscape granite is not anticipated. Coverage will deplete over time, so this component funds an allowance to top dress the existing granite with a new 1" layer.

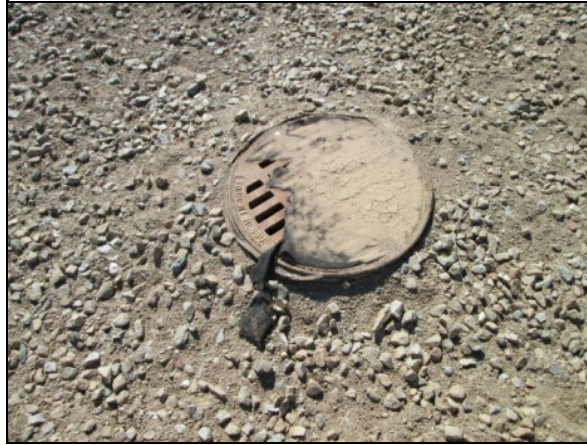
Comments: Drywells need to be inspected and cleaned out periodically to ensure proper operation and to prevent failure. Not all of the drywells will require clean-out at the same time, so this component funds for a portion of them at the scheduled interval.

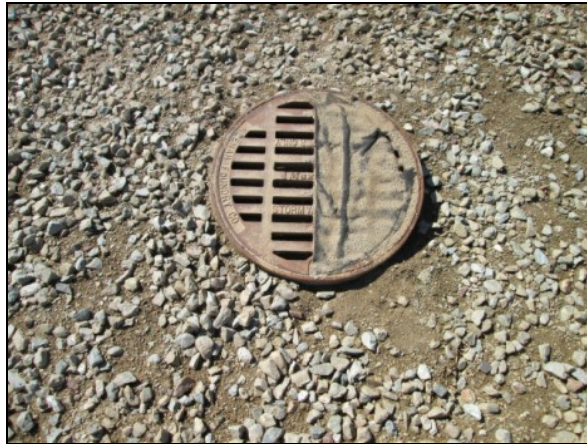
Comp #: 662 Drywells - Partial Replace

Comments: There is no expectancy to replace all drywells under normal circumstances. Replacement is usually the result of improper installation or neglect. This component funds a long-term allowance for partial replacement in the event some do fail.

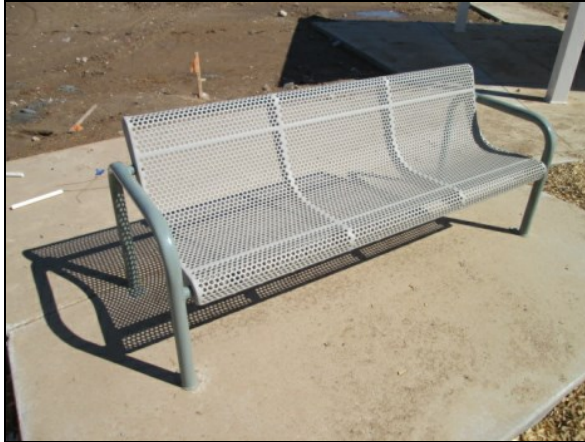
Comp #: 805 Park Furniture - Replace**Quantity: (6) Pieces**

Comments: Quantity includes (3) 6' benches, (1) picnic table, (1) trash can and (1) BBQ grill (PW Athletic). Primarily manufactured by Anova Furnishings. No significant wear or weathering evident.

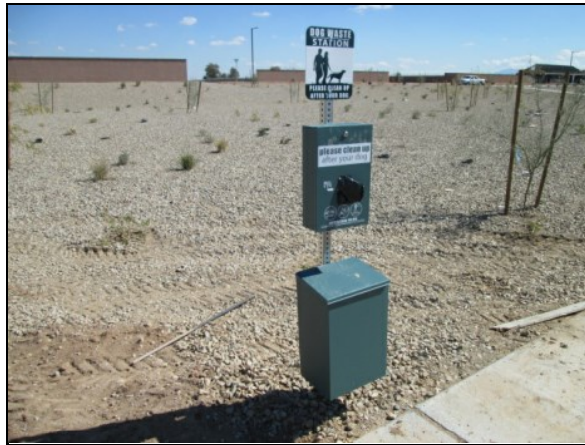
Comp #: 807 Pet Station - Replace**Quantity: (1) Station**

Funded?: No. Cost is below the Reserve expense threshold. Recommend replacing as needed with Operating funds.

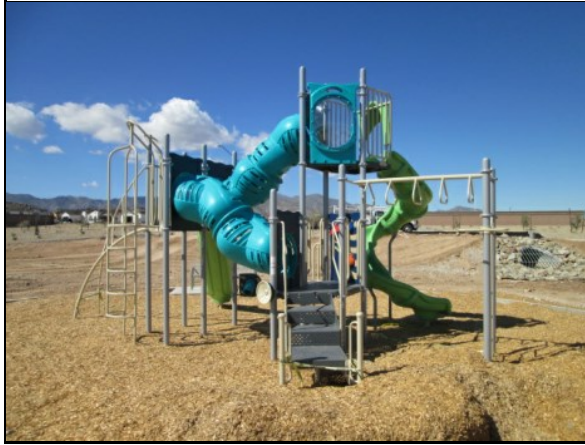
Comp #: 810 Playground Equip - Replace

Comments: This is a play structure manufactured by Playworld. No significant wear or weathering evident. Long life expectancy under normal circumstances. Replacement should be expected to update and modernize the equipment.

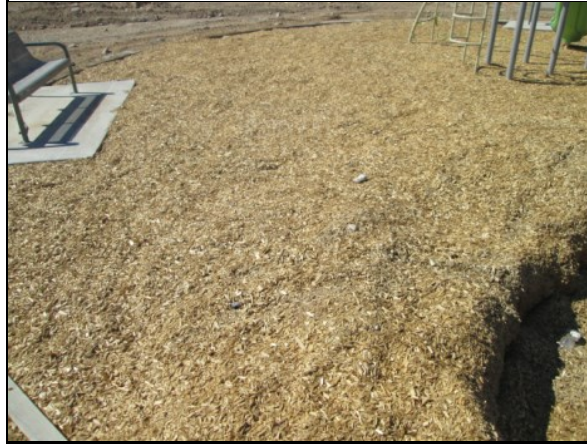
Comments: There is no expectancy to completely replace the wood mulch surface. HOA should expect to top dress/replenish it periodically to maintain proper surfacing depths.

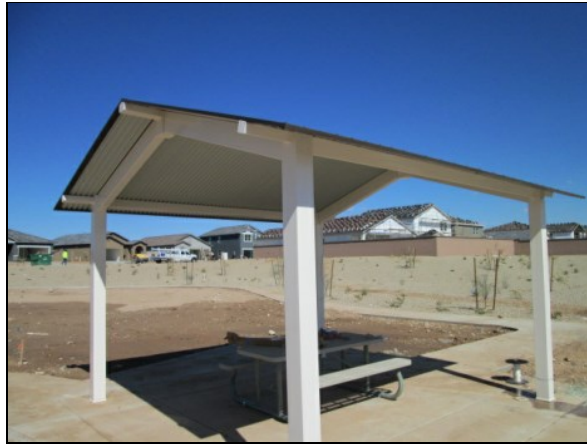
Comp #: 820 Ramada Roof - Replace

Comments: The ramada has a corrugated steel roof system. Long life expectancy under normal circumstances. Future replacement should still be planned, even if just for an aesthetic restoration.
