San Tan Ranch

San Tan Ranch HOA
Gilbert, AZ

Report #: 12402-3
Beginning: January 1, 2026
Expires: December 31, 2026

RESERVE STUDY
Update "With-Site-Visit"

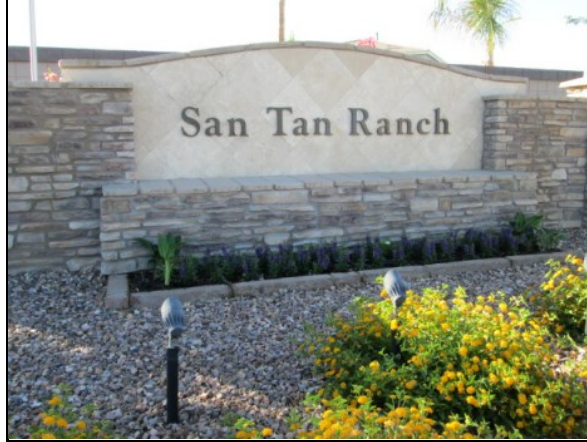
Comp #: 115 Monuments - Remodel**Approx Quantity: 3 Monuments****Location:** Napa Ln & Pecos Rd, Portola Valley Dr & Higley Rd, Menlo Park Dr & Germann Rd**Funded?:** Yes.**History:** Monuments were remodeled during 2012 for ~\$42,000.**Comments:** 2012 remodel included new letters, tile backdrop, stone wall, and lighting. Still decorative and in decent shape overall. Expect to remodel the monuments again at some point in the future to update and modernize the appearance.**Useful Life:**
25 years**Remaining Life:**
11 years

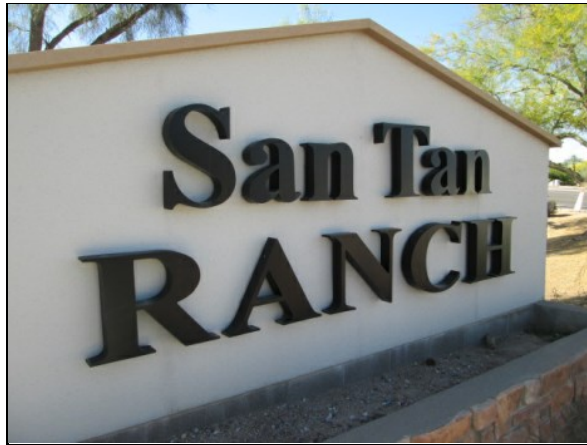
Comp #: 115 Monuments - Remodel**Approx Quantity: 1 Monument****Location:** Southeast corner of Higley Rd & Pecos Rd**Funded?:** No. The commercial property is responsible to maintain this monument, not the HOA.**History:****Comments:****Useful Life:****Remaining Life:**

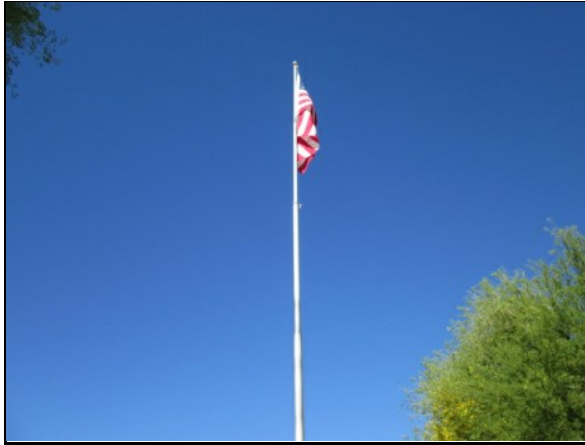
Comp #: 125 Flag Poles - Replace

Comments: Observed to be in good shape. Future replacement should be anticipated.

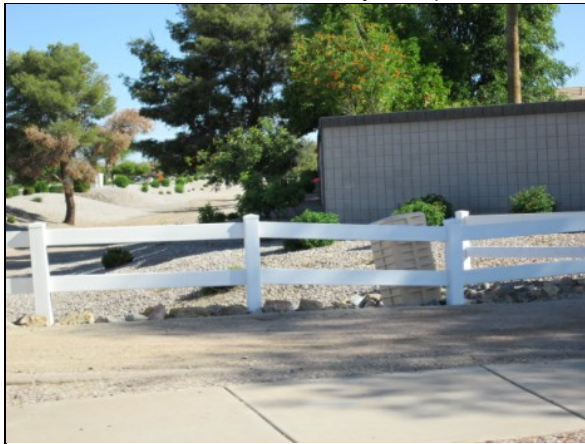
Comp #: 555 Vinyl Fence - Replace**Approx Quantity: 1 Lump Sum****Location:** Bordering Higley Rd**Funded?:** No. HOA plans to repair and replaced as-needed as an Operating expense.**History:** Installed during 1999-2001.**Comments:** 2025 note: Original quantity installed was ~700 LF and included multiple areas around the perimeter of the community. Most of the vinyl fence has since been removed, with only a couple small sections remaining bordering Higley Rd.**Useful Life:****Remaining Life:**

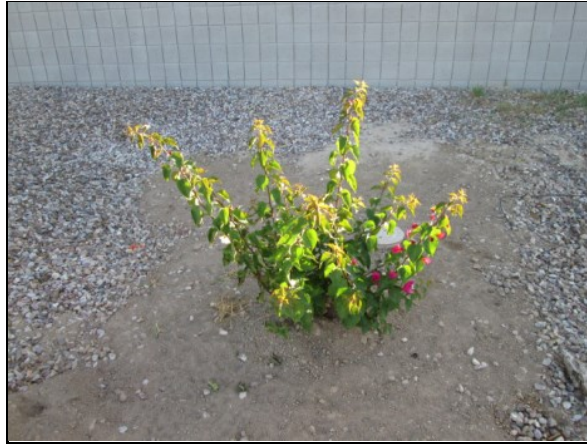
Comp #: 801 Irrigation - Replace (Drip)**Approx Quantity: 1 Lump Sum****Location:** Common areas throughout community**Funded?:** No. There is no expectancy for complete replacement of the PVC pipes in the foreseeable future.**History:** ~\$562,000 spent in 2018 to replace the polydrip lines with PVC pipe.**Comments:** According to ProQual Landscaping, who completed the replacement project in 2018, the PVC pipes will have a life span of 100+ years.**Useful Life:****Remaining Life:**

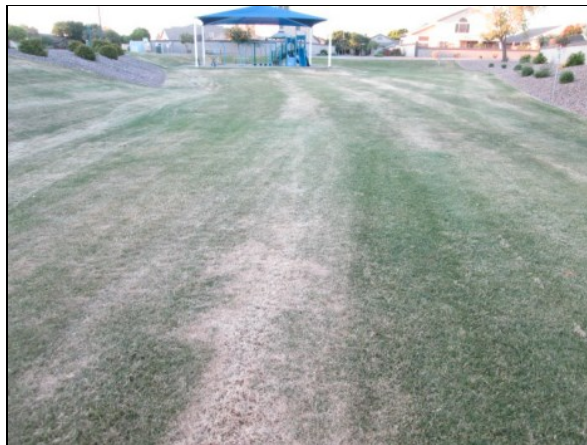
Comp #: 801 Irrigation - Replace (Sprinklers)**Approx Quantity: 1 Lump Sum****Location:** Grassy areas throughout community**Funded?:** No. We assume sprinkler heads will be replaced individually as an ongoing maintenance project.**History:****Comments:** Reserve funding can be added for future replacement of all sprinkler heads at one time if the HOA desires. We would need to be provided with cost and timing estimates, since irrigation system components are beyond the scope of this Reserve Study to quantify and assess.**Useful Life:****Remaining Life:**

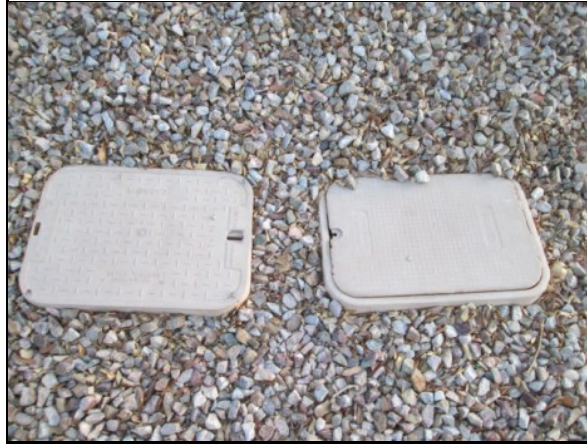
Comp #: 803 Irrigation - Repair**Approx Quantity: 1 Allowance****Location:** Common areas throughout community**Funded?:** Yes.**History:** Significant renovations completed in 2018.**Comments:** This component funds an allowance for larger repairs eventually. This may include replacing valves and PVC pipe repairs. Additionally, funds can be utilized for larger sprinkler head replacement projects if needed.**Useful Life:**

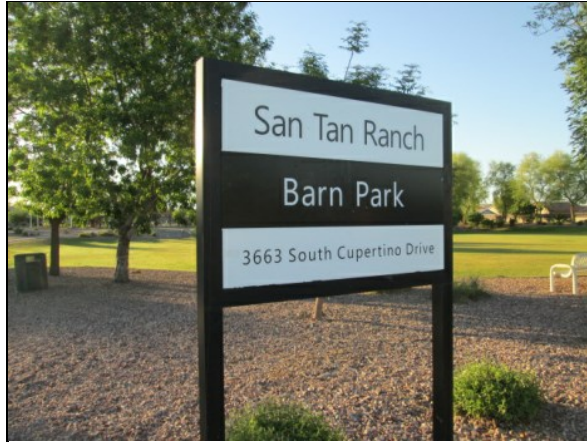
Comp #: 395 Park Signs - Replace**Approx Quantity: 5 Signs****Location:** Park areas: Train Park, Toddler Park, Menlo Park, Barn Park, Basketball Park**Funded?:** Yes.**History:****Comments:** These metal signs indicate the names of the parks. This component funds for complete replacement eventually to maintain an updated and uniform appearance. Budgeted cost includes replacing the metal frame and sign.**Useful Life:**
20 years**Remaining Life:**
4 years

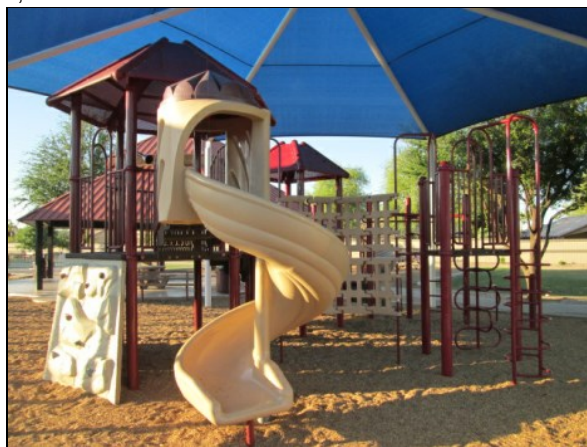
Comp #: 412 Playground Equipment - Repair**Approx Quantity: 1 Allowance****Location:** Park areas throughout community**Funded?:** Yes.**History:** ~\$2,300 spent in 2024. ~\$2,500 spent in 2023. ~\$2,600 spent in 2021. ~\$5,800 spent in 2020. ~\$7,200 spent in 2019.**Comments:** This component funds for repairs to the playground equipment as-needed. This may include replacing playstructure decks, swings, small spring riders, etc.**Useful Life:**
2 years**Remaining Life:**
0 years

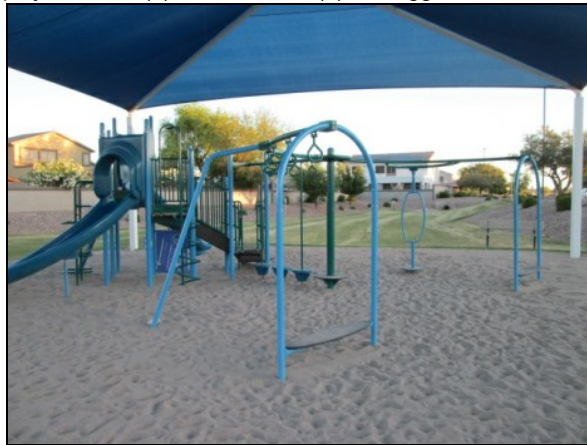
Comp #: 411 Playground Equipment - Replace**Approx Quantity: 3 Assorted Pieces****Location:** Park off Atherton Blvd and Los Altos Rd**Funded?:** Yes.**History:** Replaced in 2015. Previously original from 1999.**Comments:** Pieces include (1) playstructure, (1) see-saw, and (1) EZ-Digger. Normal use and wear evident.**Useful Life:**

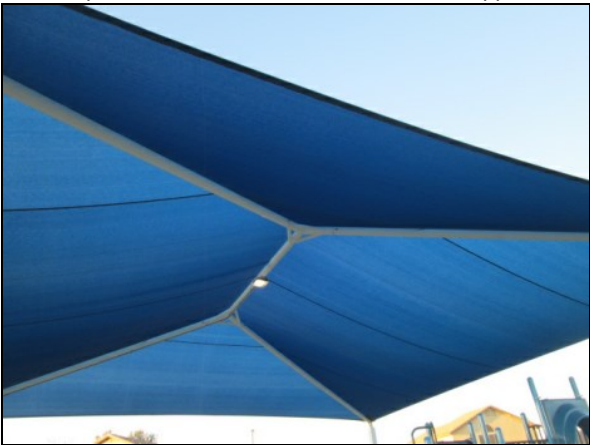
Comp #: 418 Shade Screen - Replace

Comments: This component funds to replace the shade screen fabric. Screen appears intact and in decent shape.

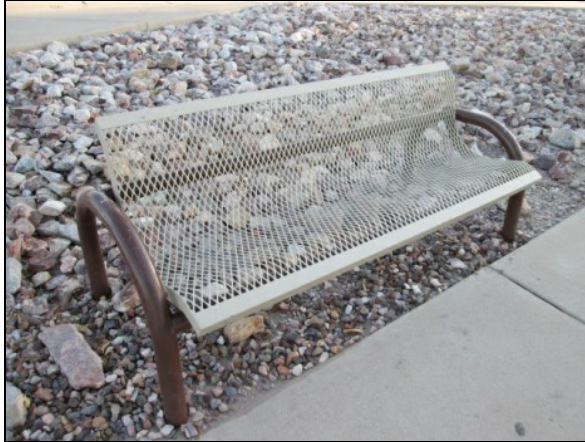
Comp #: 405 Park Furniture - Partial Replace**Approx Quantity: 3 Assorted Pieces****Location:** Park off Menlo Dr and Atherton Blvd**Funded?:** Yes.**History:** Original from 1999. Benches appear to have been repainted at some point.**Comments:** Pieces include (2) metal benches and (1) metal trash receptacle. Pieces vary in style and condition. There is no expectancy for complete replacement at the same time. This component funds to periodically replace 50% of the furniture pieces.**Useful Life:**
10 years**Remaining Life:**
4 years

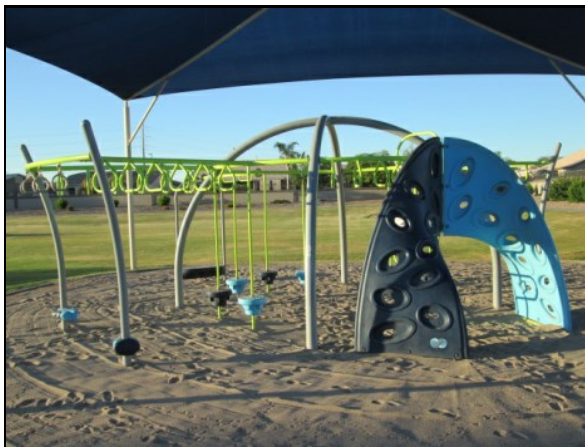
Comp #: 411 Playground Equipment - Replace**Approx Quantity: 1 Playstructure****Location:** Park off Menlo Dr and Atherton Blvd**Funded?:** Yes.**History:** Replaced in 2020 for ~\$27,000. Previously original from 1999.**Comments:** Manufactured by Little Tikes. This is a smaller playstructure which appears to be in good shape. Future replacement should be anticipated.**Useful Life:**
20 years**Remaining Life:**
14 years

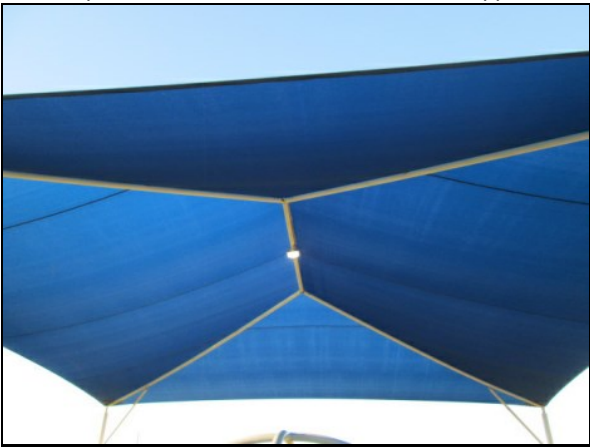
Comp #: 418 Shade Screen - Replace

History: Original screen from 2006 has been replaced at some point, although no information was provided on when.

Comments: This component funds to replace the shade screen fabric. Screen appears intact and in decent shape.

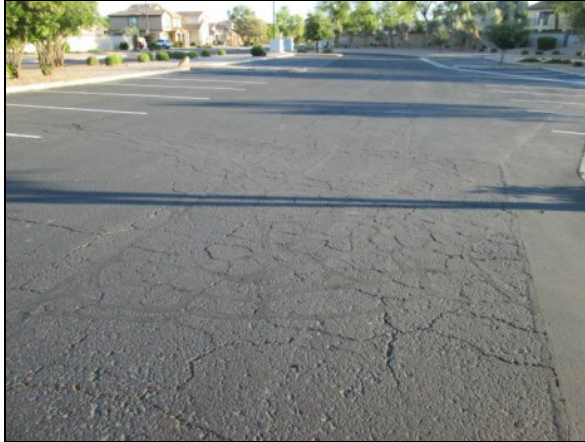
Comp #: 210 Parking Lot - Repave**Approx Quantity: 24,000 Sq Ft****Location:** Parking lot off Cupertino Dr**Funded?:** Yes.**History:** Installed in 2001. ~\$24,200 spent in 2021 to repave ~1/4 of the parking lot (5,700 sq ft).**Comments:** Parking lot still appears older and worn overall. Alligating and heavy cracks noted. HOA should still be prepared for a complete repave of the parking lot eventually. Life span is based on periodically seal coating and maintaining the surface.**Useful Life:**

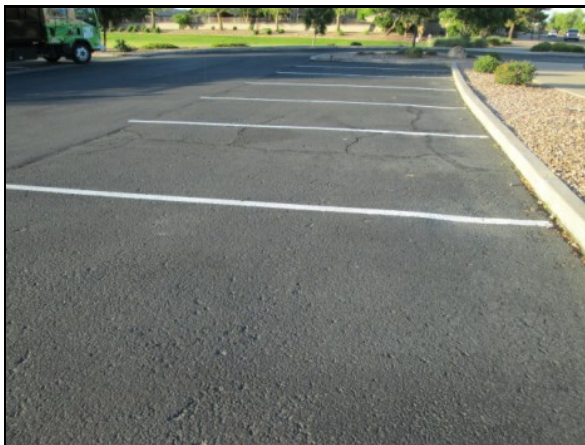
Comp #: 215 Parking Lot - Seal/Repair**Approx Quantity: 24,000 Sq Ft****Location:** Parking lot off Cupertino Dr**Funded?:** Yes.**History:** Sealed with HA5 in 2022 for ~\$6,300. Previously sealed around 2014 for ~\$4,000.**Comments:** Useful life and cost reflect upgraded seal applications. Seal coat asphalt surfaces periodically to prevent premature cracking and deterioration.**Useful Life:**

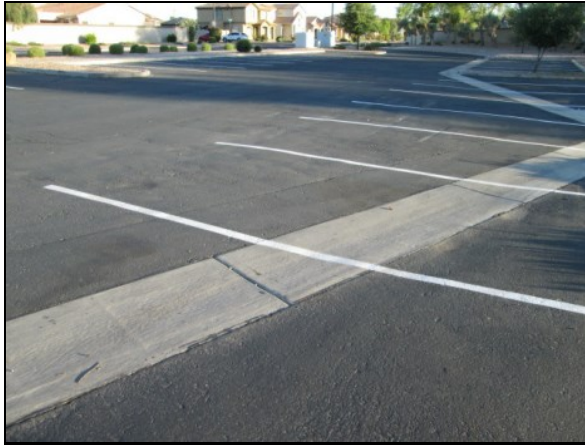
Comp #: 220 Valley Gutter - Replace**Approx Quantity: 1,000 Sq Ft****Location:** Parking lot off Cupertino Dr**Funded?:** Yes.**History:** Installed in 2021 for ~\$26,400.**Comments:** Long life expectancy under normal circumstances. Complete replacement should be expected eventually.**Useful Life:**

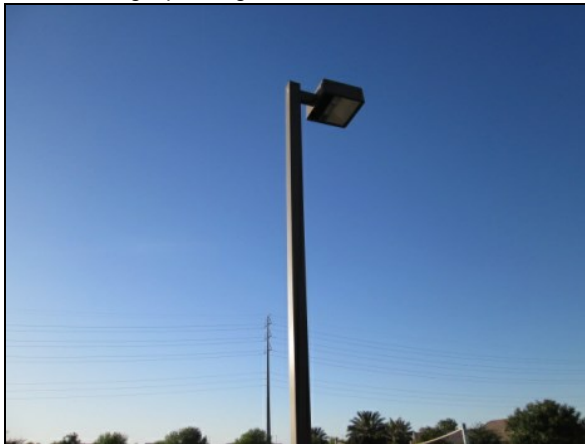
Comp #: 320 Pole Lights - Replace**Approx Quantity: 4 Pole Lights****Location:** Park off Cupertino Dr: (2) at pickleball & (2) at walking track**Funded?:** Yes.**History:** Installed during 2006-2012.**Comments:** This component funds for complete replacement of the poles and fixtures eventually. Replace the fixtures in-between complete replacement cycles as-needed using Operating funds.**Useful Life:**

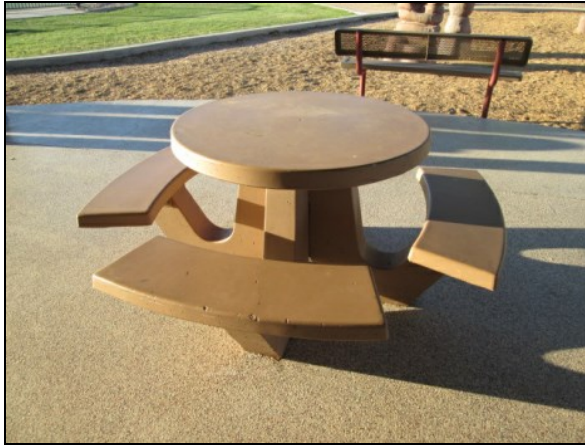
Comp #: 405 Park Furniture - Partial Replace**Approx Quantity: 24 Assorted Pieces****Location:** Park off Cupertino Dr**Funded?:** Yes.**History:** (6) concrete picnic tables installed in 2013 for ~\$7,700. Other pieces are primarily original from 2006.**Comments:** Pieces include (6) concrete picnic tables, (2) metal picnic tables, (8) metal benches, (6) metal trash receptacles, (1) BBQ grill, and (1) bike rack. Pieces vary in style and condition. There is no expectancy for complete replacement at the same time. This component funds to periodically replace 50% of the furniture pieces.**Useful Life:**

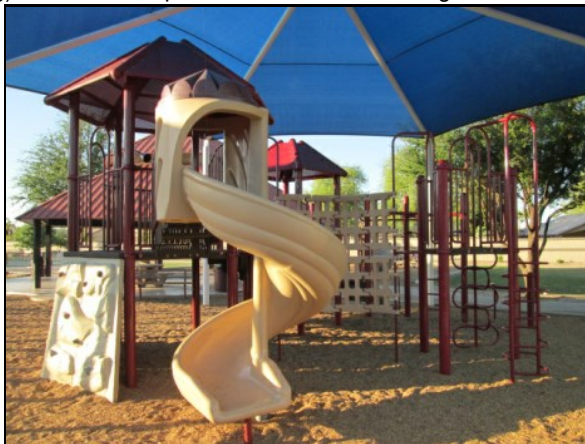
Comp #: 411 Playground Equipment - Replace**Approx Quantity: 9 Assorted Pieces****Location:** Park off Cupertino Dr**Funded?:** Yes.**History:** Installed in 2006.**Comments:** Pieces include (2) playstructures (1 medium-size, 1 small), (4) climbing boulders, (1) metal geodesic climber, and (2) swingsets (6-seater and T-swing). Still in fair shape overall with normal fading and wear evident.**Useful Life:**

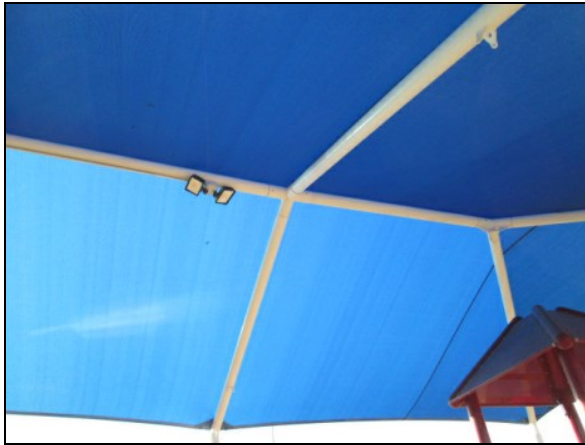
Comp #: 418 Shade Screens - Replace

Comments: This component funds to replace the shade screen fabric. Screens appear intact and in decent shape overall.

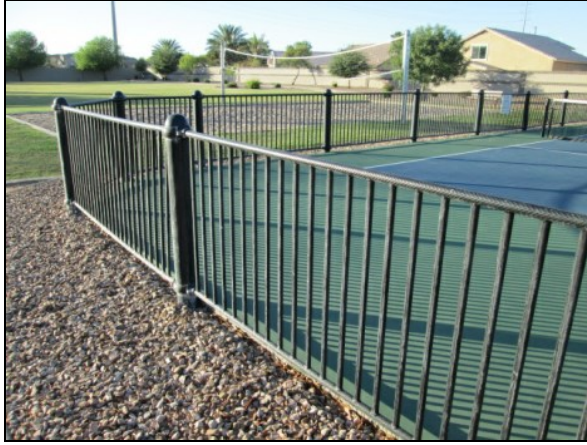
Comp #: 422 Pickleball Fence - Replace

Comments: Staining and wear evident. This component funds for complete replacement eventually. Recommend planning to repaint every 2-3 years as an Operating expense.

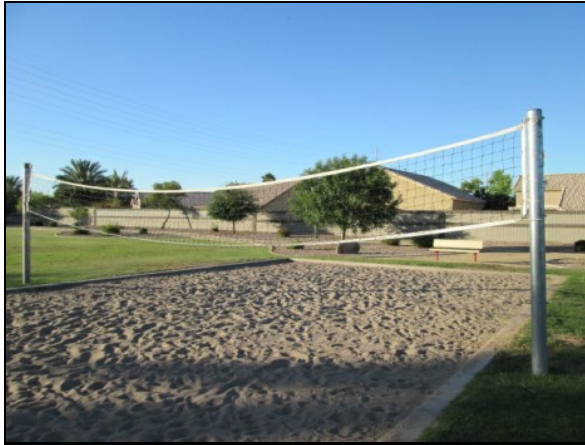
Comp #: 438 Volleyball Posts - Replace

Comments: This component funds to replace the metal posts for the volleyball net.

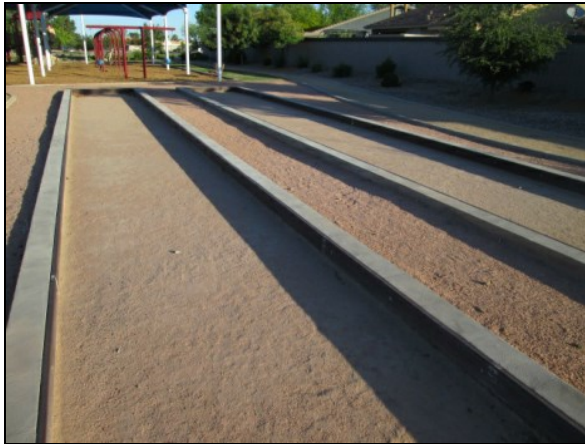
Comments: Bocce courts are constructed with concrete borders, composite bumpers, and granite playing surface. There is no expectancy to replace these courts in the foreseeable future. This component funds an allowance for future repairs and refurbishing of the bocce courts, which may include replacing composite bumpers or replenishing the playing surface.

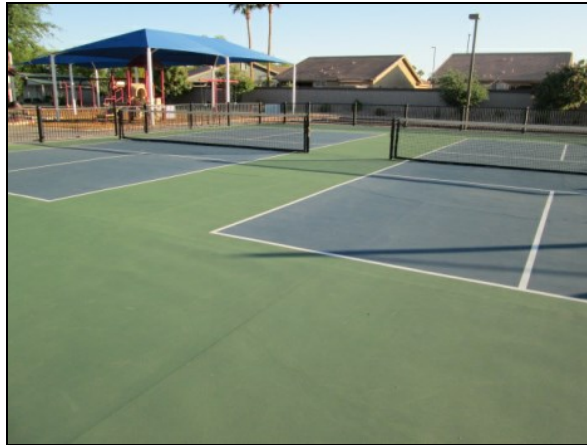
Comments: Some larger surface cracks in the courts noted. This component funds for periodic resurfacing.
