RESERVE ANALYSIS REPORT

Venu at Grayhawk Condominium Association

Version 004 (revised)

May 17, 2024

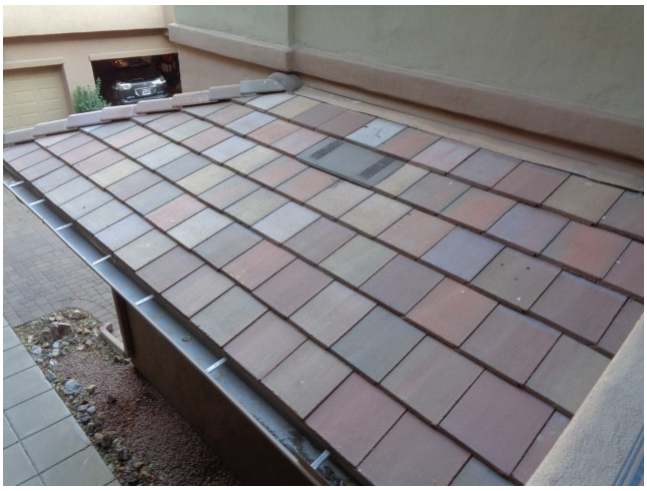
Roofs: Tile Maintenance

In 2023, the client will complete a community-wide tile roof underlayment replacement project. Going forward, this component includes a provision every five years for tile roof maintenance (replace broken tiles or missing tiles, resecure loose tiles, etc.).

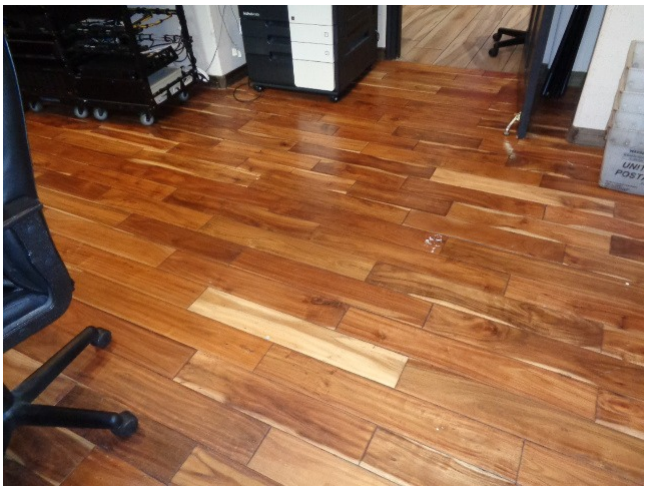
Category	075 Great Room
Placed In Service	01/2022
Useful Life	10
Remaining Life	8
Replacement Year	2032

A remodel project took place in the Great Room in late 2016 that included interior painting, game room carpet, main room tile flooring, installation of decorative ceiling wood, new furniture, some new countertops, a new oven/range, etc.

The pool table was recovered in June 2021 at a cost of $779.14, and a new window was purchased/installed in August 2020 at a cost of $2,751.95.

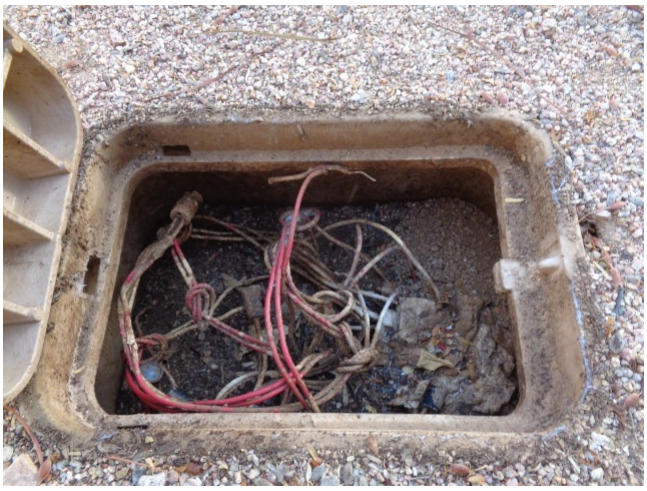
Grounds: Irrigation System Replacement

$124,089.79 was spent in early 2018 to replace the irrigation system (see the Desert Classic Landscaping bid dated November 1, 2017). This component budgets for similar work every 20 years.
