## Belmont at Triple Crown Scottsdale, AZ

Report #: 47163-0  
Beginning: January 1, 2024  
Expires: December 31, 2024

# RESERVE STUDY "Full"

October 19, 2023

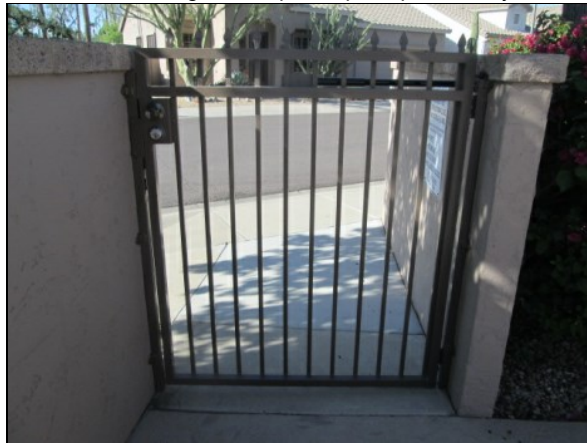
Comments: Observed to be appear uniform and in good shape. Repaint periodically to maintain the appearance and to inhibit rust.

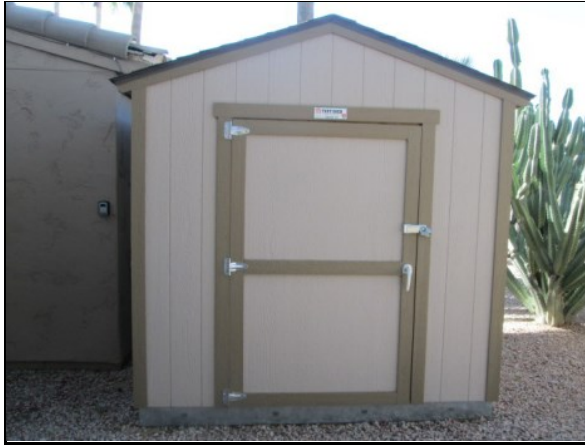
**Comp #: 1110 Storage Shed - Replace**

Comments: Observed to be in nice shape. This component funds for future replacement.

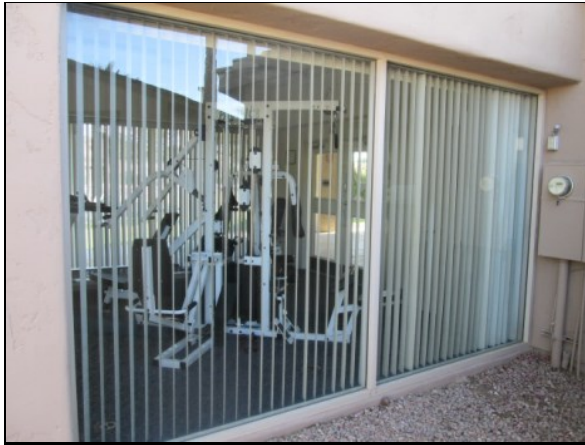
**Comp #: 1145 Doors + Windows - Replace**

Comments: Long life span anticipated under normal circumstances. Replacement should still be anticipated eventually.

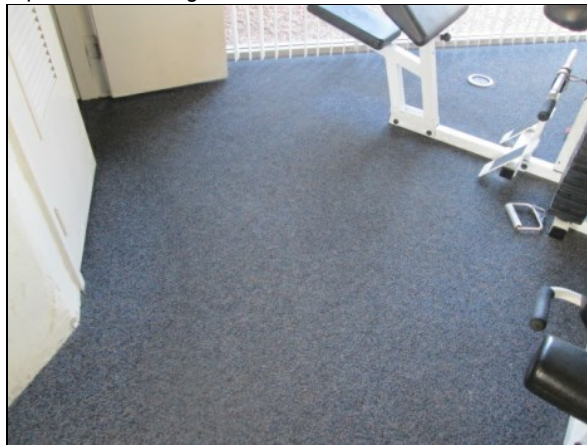
Comments: This component funds for a periodic minor remodel of the pool building. This would include replacing the fitness room carpet and repainting the interior surfaces of the fitness room and restrooms. Some fitness equipment, light fixtures/ceiling fans, drinking fountain, etc. may need replacement during this time as well.

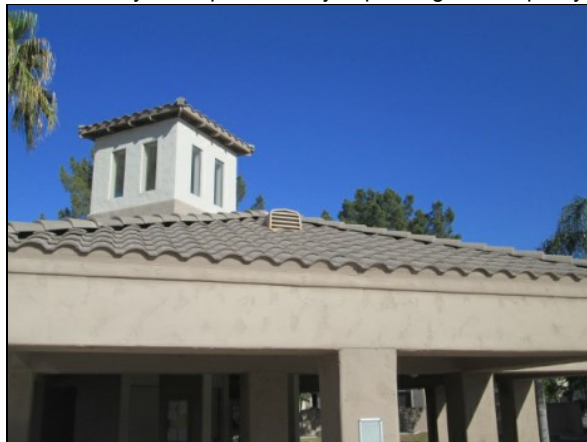
Comments: There is no expectancy to replace all of the tiles under normal circumstances. Replacement of the felt paper underlayment should be anticipated eventually. Life span will vary depending on the quality of underlayment installed.

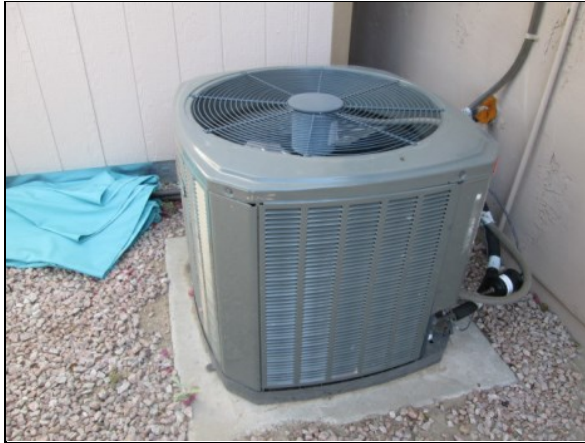
**Comp #: 1190 HVAC Unit - Replace**

History: Replaced in 2019. Previously original from 1996.

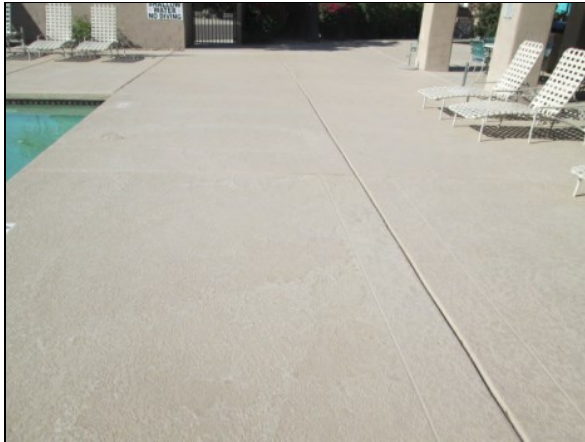
Comments: This is an acrylic coating applied to an underlying concrete deck. This component funds to periodically grind off the existing deck coating and re-apply a new surface. Combined cost with the seal/repair component accounts for the total estimated resurface budget.

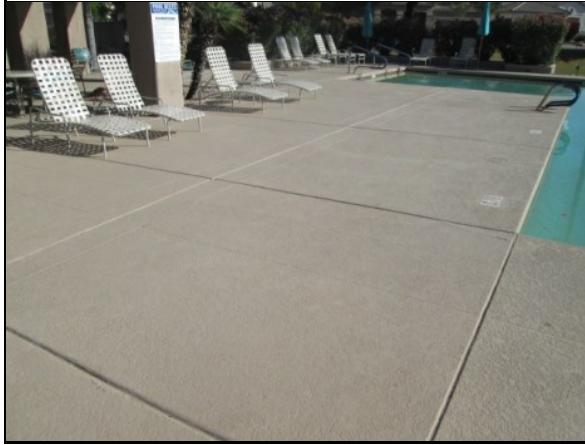
**Comp #: 1202 Pool Deck - Seal/Repair**

Comments: This component funds to periodically patch cracks and seal/repair the deck to cover stains and restore the appearance. Some staining and oxidation noted, but still appears to be in fair shape overall.

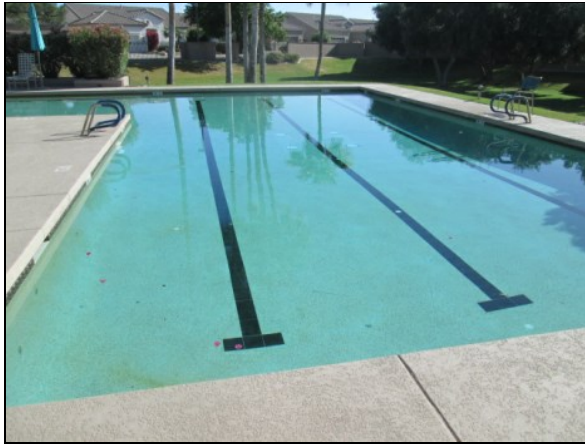
Comments: Surfaces are pebble with waterline tiles. Observed to be older with staining and discoloration evident. Based on age and appearance, it would be prudent to plan for resurfacing soon.

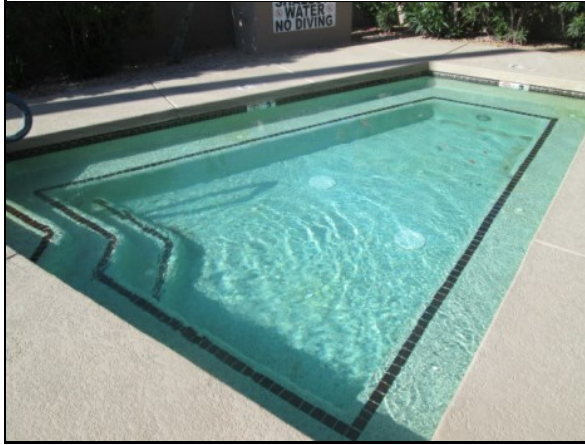
Comments: Surfaces are pebble with waterline tiles. Observed to be older with staining and discoloration evident. Crack issue also noted. Based on age and appearance, it would be prudent to plan for resurfacing soon.

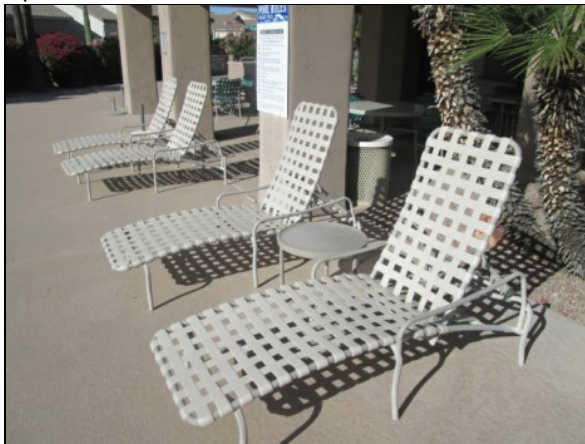
**Comp #: 1220 Pool Furniture - Replace**

History: Per satellite imagery, the pool furniture was replaced, or at least re-strapped, around 2014.

Comments: Pieces include (17) lounges, (32) chairs, (4) stools, (6) dining tables, (5) tea tables, (2) trash receptacles, (5) umbrella stands, and (3) umbrellas. Observed to be in fair shape overall. Longer life span has been assigned, assuming refurbish will be completed in-between complete replacement intervals.

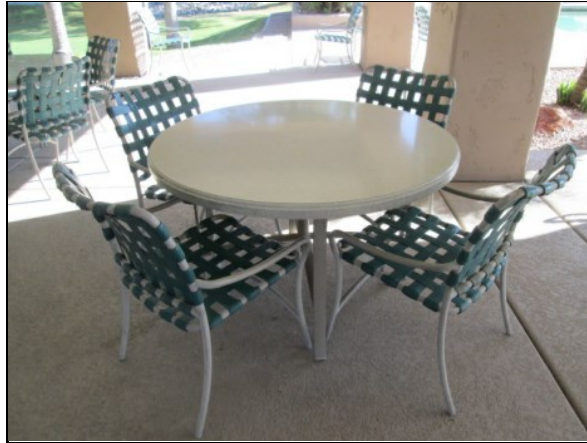
Comments: This component funds an allowance to refurbish the pool furniture in-between complete replacement intervals. Refurbish would primarily include re-strapping the lounges, stools, and chairs. Replacement of the umbrellas will likely be needed at this time as well.

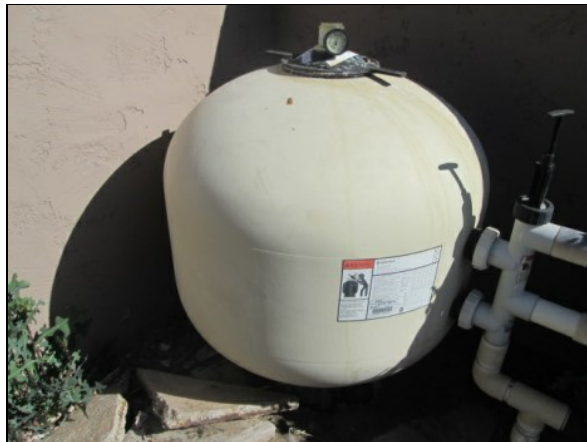
**Comp #: 1250 Pool Filters - Replace**

History: Replaced in 2015.

Comments: Fading and weathering evident. Assumed to be in fair shape. Future replacement should be anticipated. Mfg. Dates: 2015, Serial: 0101261150077V & 0101015150070D.

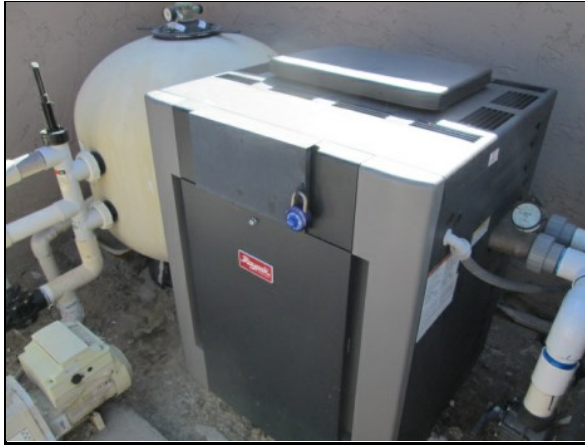
**Comp #: 1260 Pool Heater - Replace (A)**

History: Replaced in 2022.

Comments: Appears newer and in good shape. Future replacement should be anticipated. Model: BR406A, Serial: 2202537290.

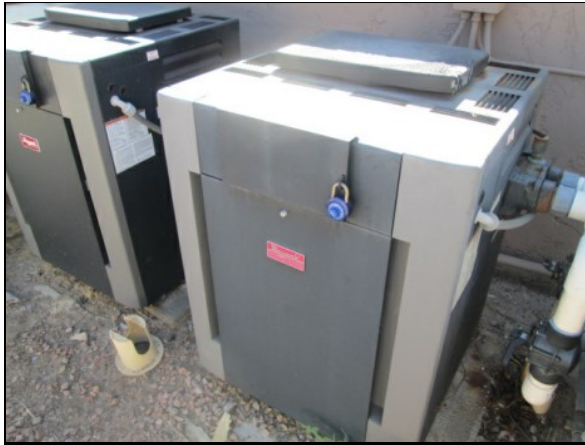
**Comp #: 1260 Pool Heater - Replace (B)**

History: Replaced in 2017.

Comments: Appears functional and in fair shape. Future replacement should be anticipated. Mode: CR406A, Serial: 1708449494.

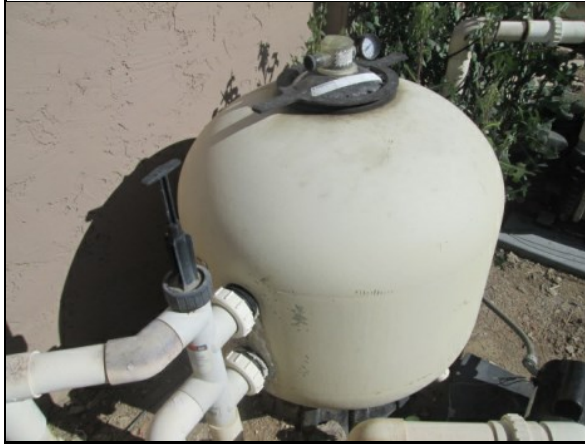
**Comp #: 1270 Spa Filter - Replace**

History: Replaced in 2008.

Comments: Appears older and worn. Based on age and appearance, it would be prudent to plan for replacement soon. Mfg. Date: 09/2008, Serial: 0101270080041K.

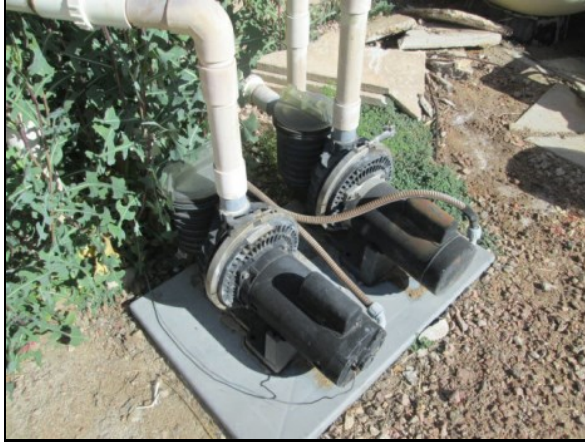
**Comp #: 1275 Spa Pumps - Replace**

Comments: It is unknown if these pumps are used for the spa, or what they service. Appear older and worn, and possibly not functional. This component funds for replacement.
