**Palm Valley Phases II/III**  
**Cortile - P15/16**  
**Goodyear, AZ**

Report #: 9457-9  
Beginning: January 1, 2026  
Expires: December 31, 2026

**RESERVE STUDY**  
**Update "With-Site-Visit"**

August 26, 2025

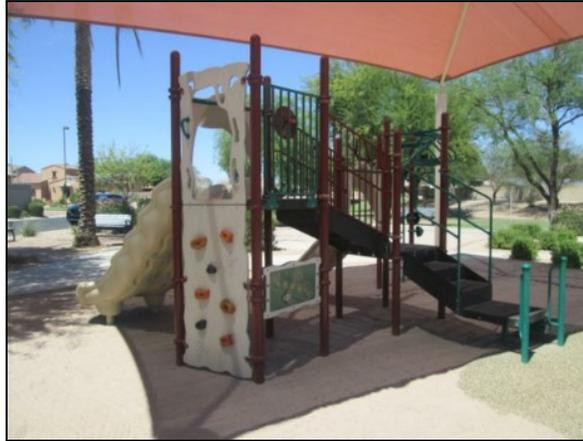
**Comp #: 910 Playground Equip - Replace**

**Comments:** Playstructure is old but still intact. Playground equipment was manufactured by Playworld Systems. Quantity includes (1) medium-sized structure and (1) swing set. Long life expectancy under normal circumstances. Replacement should be expected to update and modernize the equipment.

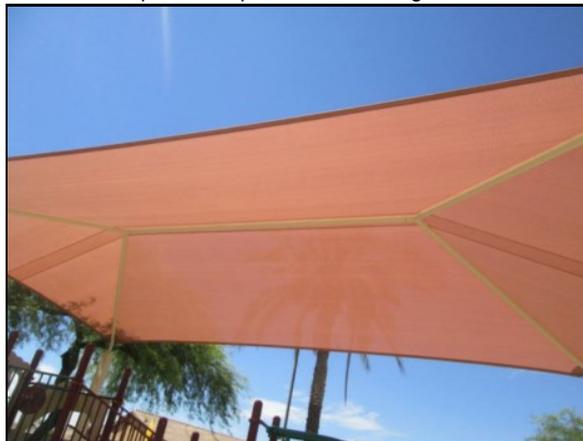
**Comp #: 914 Shade Screen - Replace**

**Comments:** Still appears in fair shape. This component funds periodic replacement of shade screen material. Shade screen structures have a long and unpredictable life span, so replacement funding has not been included.

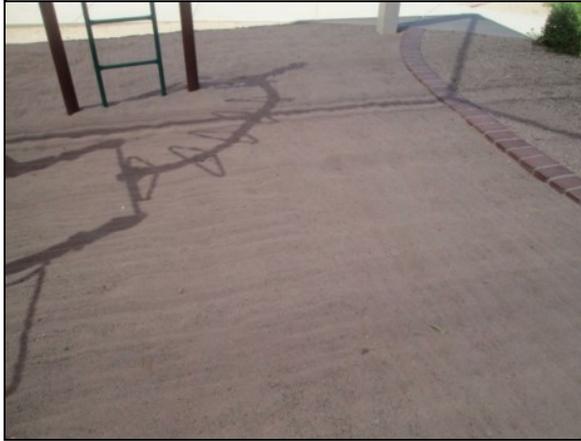
**Comments:** There is typically no expectancy to completely replace the sand. This component funds to periodically top-dress or replenish the sand to maintain proper depths.

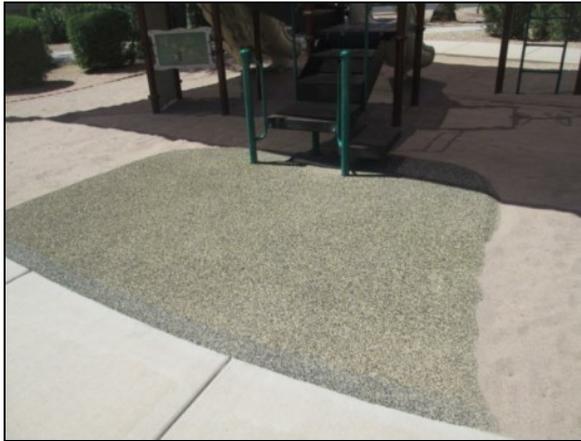
**Comp #: 917 Playground Turf - Replace**

**History:** Repaired in 2020 for \$1,000. Previously installed in 2006.

**Comments:** Still intact but feels very hardened. This is a poured-in-place rubberized surface. Life span will vary depending on the level of use and maintenance. It will need to be replaced with the play equipment, so timing is scheduled at the same time. There is potential the turf will not last that long due to lack of maintenance and vandalism. Combined cost with the coat component accounts for the total estimated replacement budget.

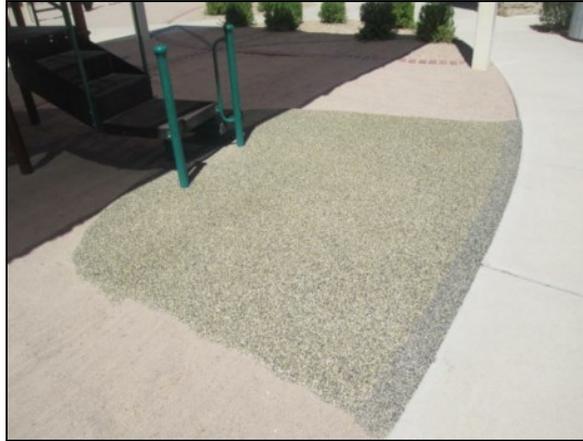
**Comp #: 918 Playground Turf - Coat/Repair**

**Comments:** Playground companies recommend regularly applying a urethane coating to the rubberized playground turf. This coating helps to bind the turf granules, prevent the turf from hardening prematurely, and reportedly helps extend the life span.

**Funded?:** No. Cost is below the Reserve expense threshold. Recommend periodically recoating/repairing as an Operating expense.

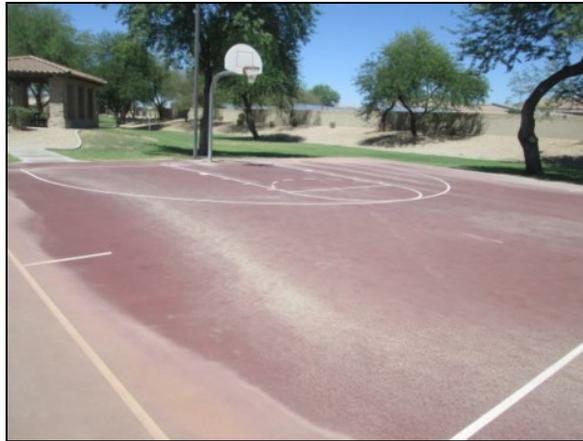
**Comments:** This is a concrete half-court with a coated surface. Coating still appears stained and discolored. This component funds to periodically resurface the basketball court.

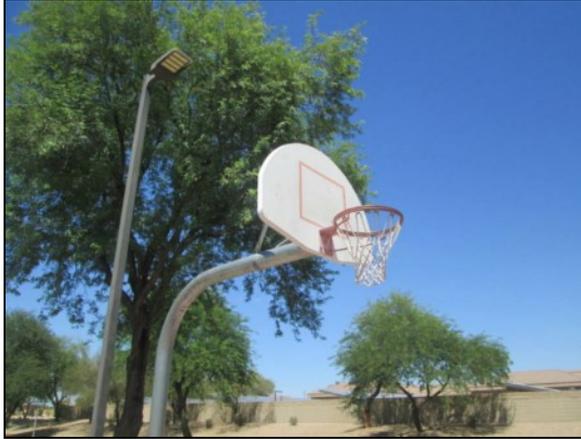
**Comp #: 932 Basketball Equip - Replace**

**Comments:** This is a heavy-duty backboard and goal mounted to a metal post. There is no expectancy to replace the metal post. This component funds to replace only the backboard and goal.

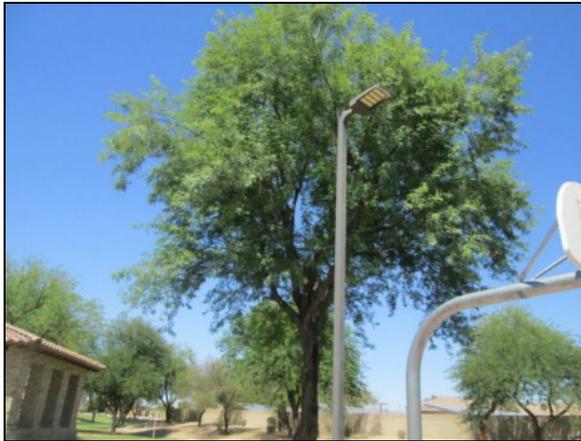
**Comp #: 934 Pole Light - Replace**

**Comments:** The metal light pole will last longer than the light fixture, but replacement should still be anticipated. This component funds to replace the pole in conjunction with a future light fixture project.
