## Scottsdale Springs Condominiums

### *Scottsdale, AZ*

## RESERVE STUDY

### Update "With-Site-Visit"

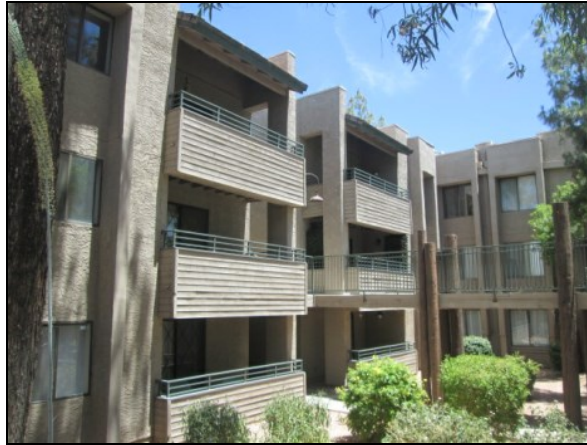
**Comp #: 1130 Bldg Exteriors - Repair****Quantity: (203) Units**

Comments: Building exteriors have wood, metal, and concrete surfaces that will require repair or replacement periodically. This includes the patio/balcony walls, stairway rails, stairway support posts, and stairway steps. There is no expectancy for complete replacement. This component funds an allowance for repairs and partial replacement as needed.

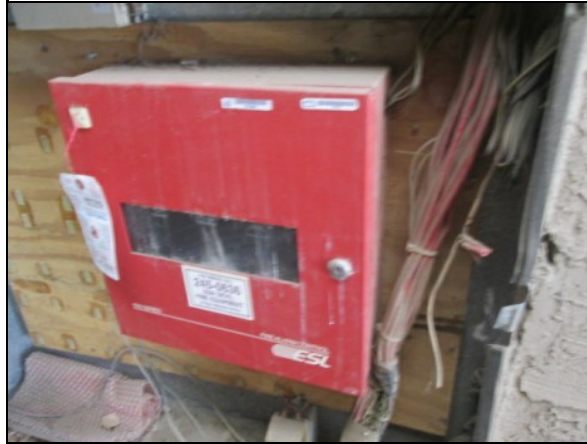
**Comp #: 1160 Fire Panels - Replace (A)****Quantity: (9) Panels**

Comments: We are not authorized to test or inspect fire alarm panels. HOA should professionally test and inspect as required by local laws. Panels are functional with no problems reported. Based on age, replacement should be anticipated soon to update and modernize the system.

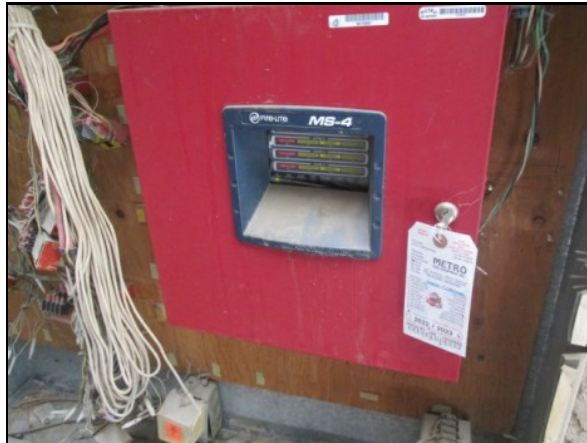
**Comp #: 1162 Fire Panels - Replace (B)****Quantity: (2) Panels**

Comments: We are not authorized to test or inspect fire alarm panels. HOA should professionally test and inspect as required by local laws. Panels are functional with no problems reported. Based on age, replacement should be anticipated soon to update and modernize the system.

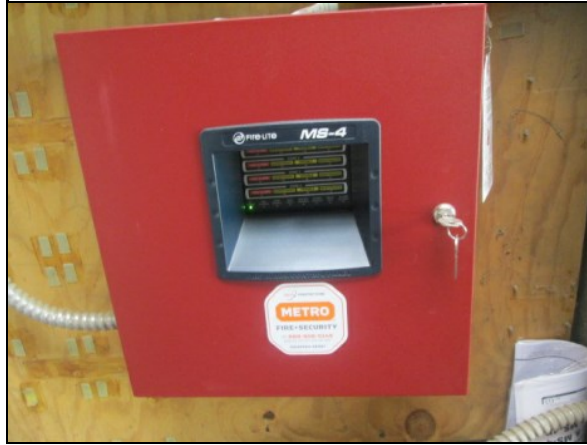
**Comp #: 1164 Fire Panels - Replace (C)****Quantity: (2) Panels**

Comments: We are not authorized to test or inspect fire alarm panels. HOA should professionally test and inspect as required by local laws. Panels are functional with no problems reported. Replacement should be anticipated.

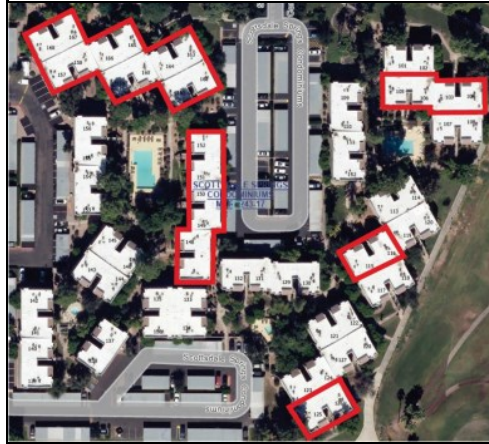
**Comp #: 1302 Foam Roofs - Replace (Ph1)****Quantity: Approx 30,000 Sq Ft**

Comments: No access to closely inspect. These roofs were replaced after the inspection, therefore they are assumed to be new and in good condition. Life span is based on periodically recoating the roofs. Combined cost with the recoat component accounts for the total estimated replacement budget.

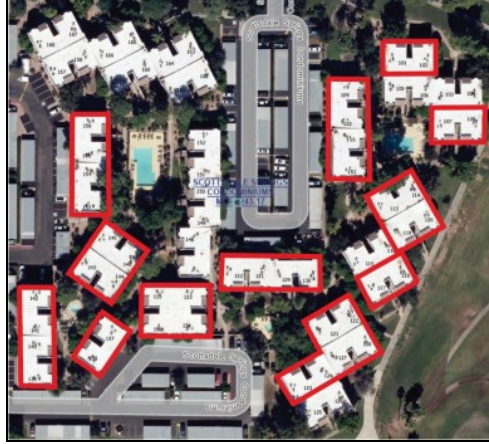
**Comp #: 1304 Foam Roofs - Replace (Ph2)****Quantity: 33% of ~49,000 Sq Ft**

Comments: No access to closely inspect. Assumed to be intact and in decent shape. No problems with leaking reported. Life span is based on periodically recoating the roofs. Combined cost with the recoat component accounts for the total estimated replacement budget.

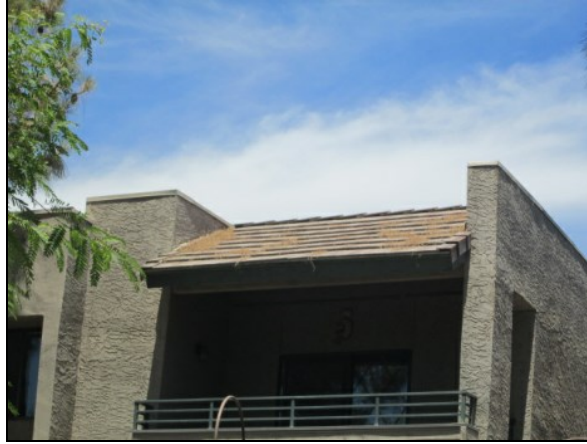
Comments: This is a concrete tile roof system. Underlayment is the true waterproofing component of this roof. Although it is not visible to inspect, replacement will be needed eventually. Tiles have a longer life span than the underlayment, but roofers recommend replacing them anyway with the underlayment. There are multiple reasons supporting complete replacement, and the cost differential is not that high. Life span will vary depending on the quality of underlayment installed as well as regular roof maintenance.

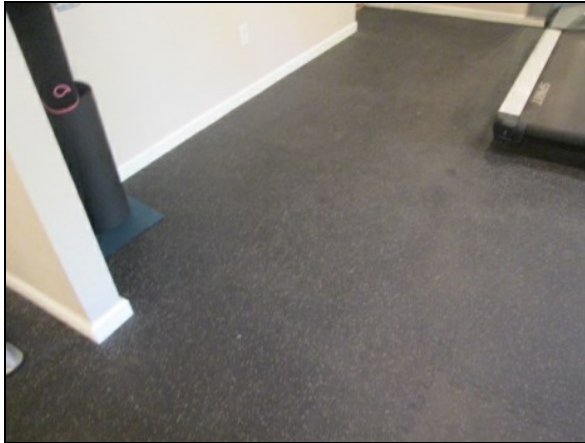
**Comp #: 907 Rubber Floor - Replace****Quantity: Approx 500 Sq Ft**

Comments: Floor appears in fair shape, with no problems reported. Replacement should be anticipated.

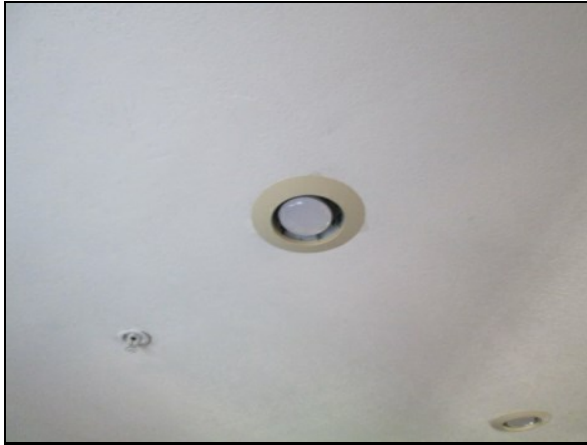
**Comp #: 910 Interior Lights - Replace**

Comments: Lights appear functional and in fair shape. Future replacement should be anticipated.

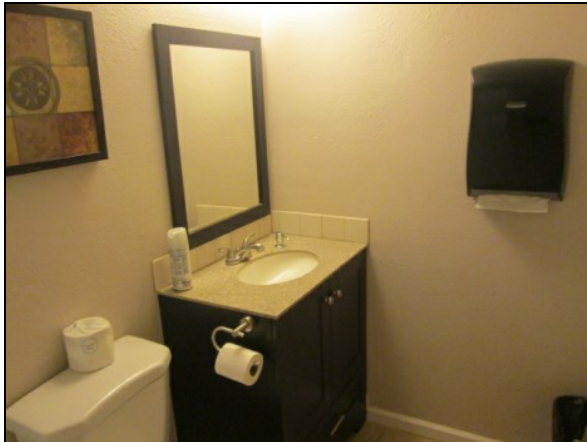
Comments: Restroom still appears in fair shape. Funding is provided for future replacement of the toilet, sink, mirror, and tile floor.

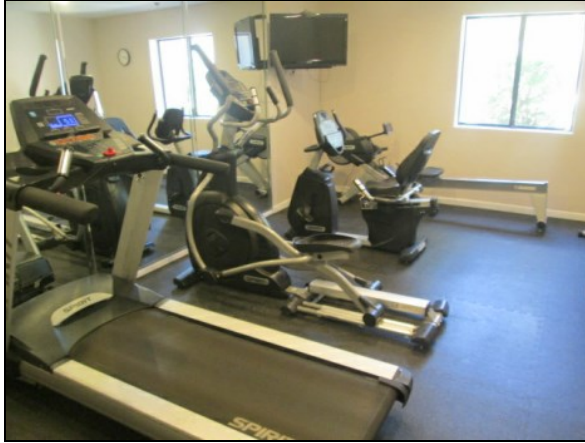
**Comp #: 930 Cardio Equipment - Replace****Quantity: (4) Spirit Fitness**

Comments: Pieces include (1) CT800 treadmill, (1) CRW800 rower, (1) CE800 elliptical, and (1) CR800 recumbent bike. Cardio equipment is in fair condition with no problems reported. Replacement should be anticipated.

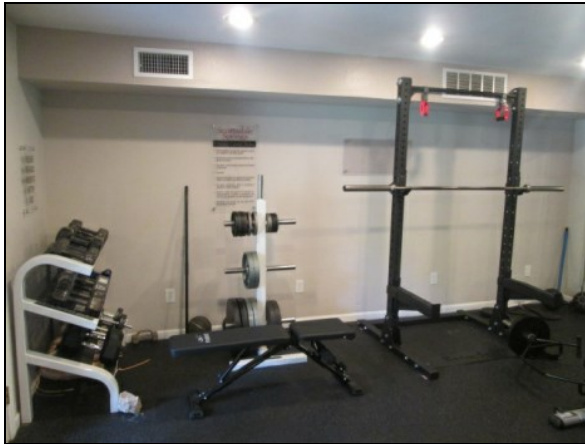
**Comp #: 935 Strength Equipment - Replace****Quantity: (4) Assorted Pieces**

Comments: Pieces include (1) multi-station machine, (1) dumbbell rack and weights, (1) plate rack and weights, and (2) benches. Strength equipment manufactured by Maxicam. Equipment appears in fair shape. Replacement should be anticipated.

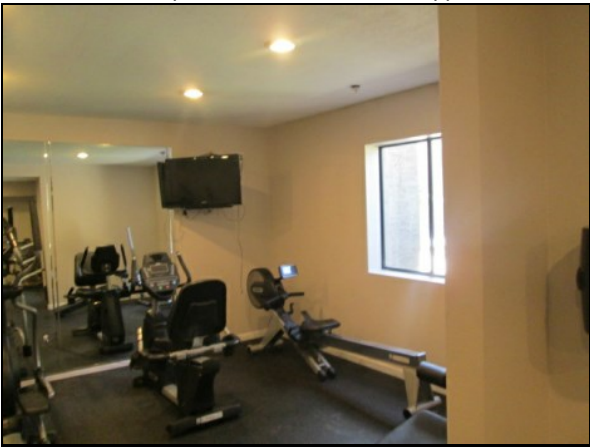
Comments: Surfaces exhibits scuffs and wear. Repaint soon to restore the appearance.

Funded?: No. Recommending repainting periodically as an Operating expense.

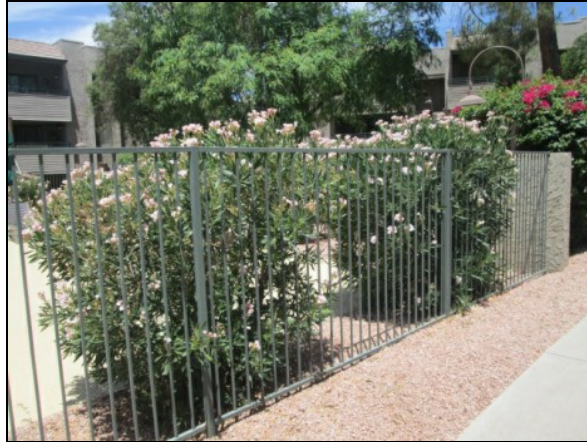
**Comp #: 503 Metal Fence - Replace****Quantity: Approx 260 LF**

Comments: Fence is still sturdy and in fair condition. Useful life was previously extended per the client's request. Replacement should be anticipated.

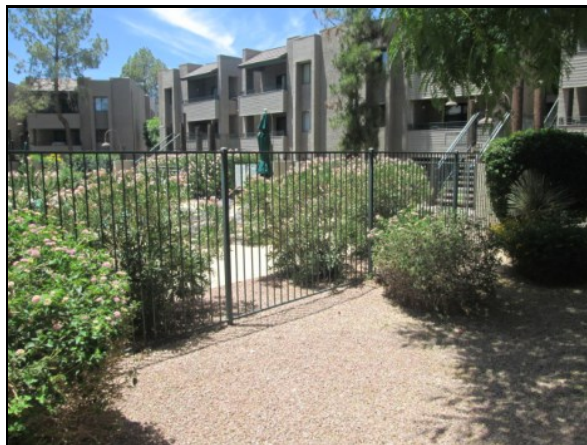
Comments: Surfaces appear oxidized and faded. Rust issues also evident. Recommend planning to repaint soon to restore the appearance and inhibit rust.

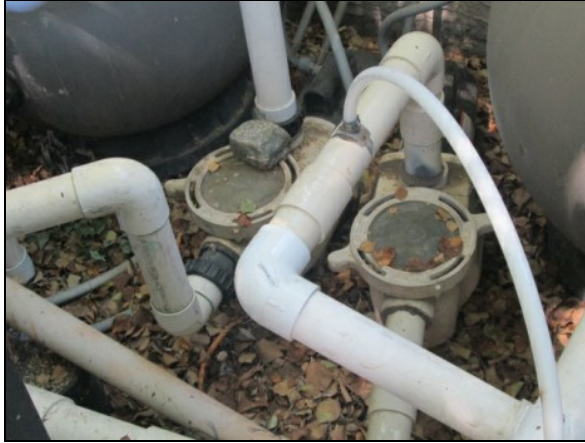
Comments: Appear older but functional with no problems reported. Periodic repair and motor replacement should be addressed as a maintenance issue. This component funds for replacement of the pump and motor assembly.

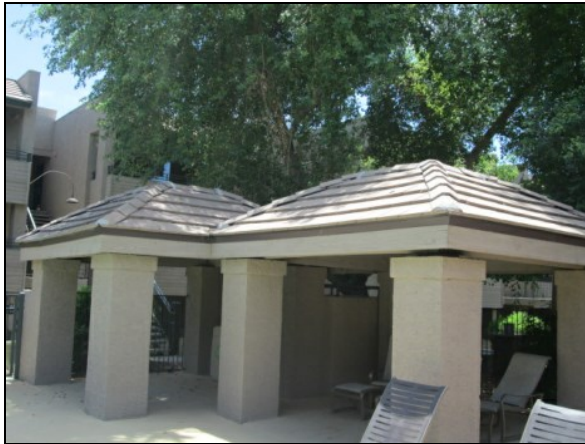
Comments: Appears in good condition with no problems reported. Complete replacement of the wood ramada roofs should be anticipated.

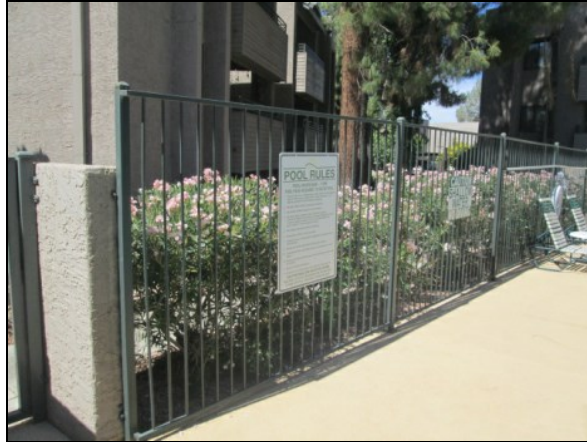
Comments: Fence is newer and in good shape. Useful life was previously extended per the client's request. Replacement should be anticipated.

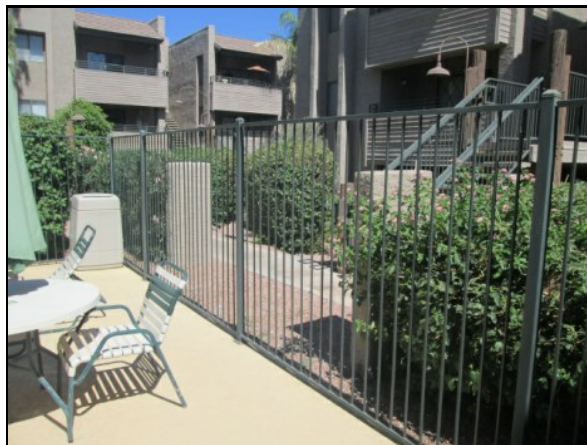
Comments: Surfaces appear oxidized with some minor rust. Recommend planning to repaint soon to restore the appearance and inhibit rust.

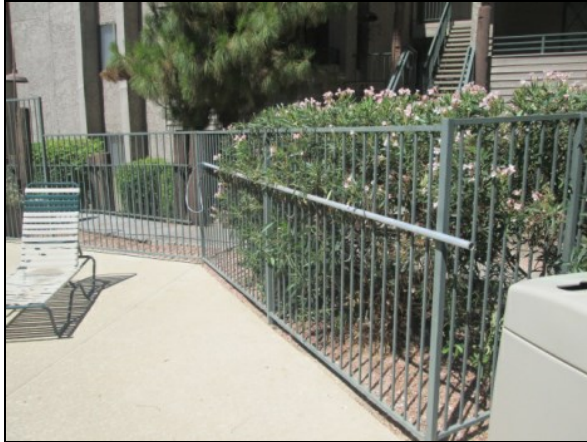
Comments: Still appears sturdy and in decent shape. Useful life was previously extended per the client's request. Replacement should be anticipated.

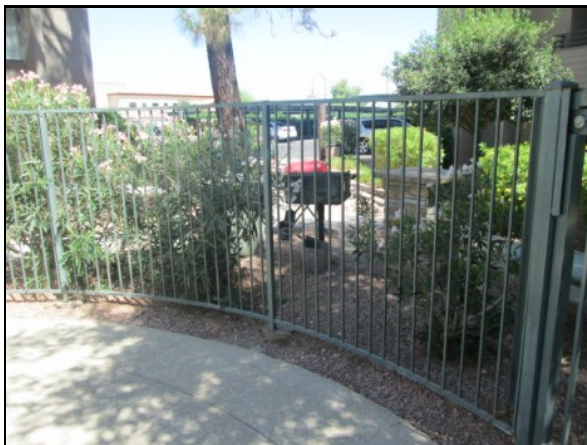
Comments: Surfaces appear oxidized with some minor rust. Recommend planning to repaint soon to restore the appearance and inhibit rust.

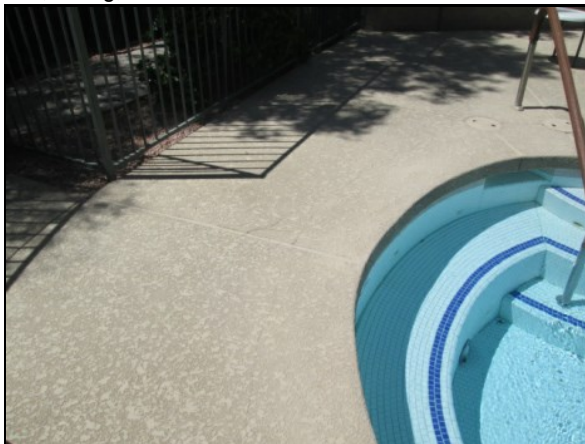
**Comp #: 1201 Spa Deck - Seal/Repair****Quantity: Approx 530 Sq Ft**

Comments: This component funds to periodically patch cracks and seal/paint the deck to cover stains and restore the appearance. Still some discoloration, fading, and cracks evident.

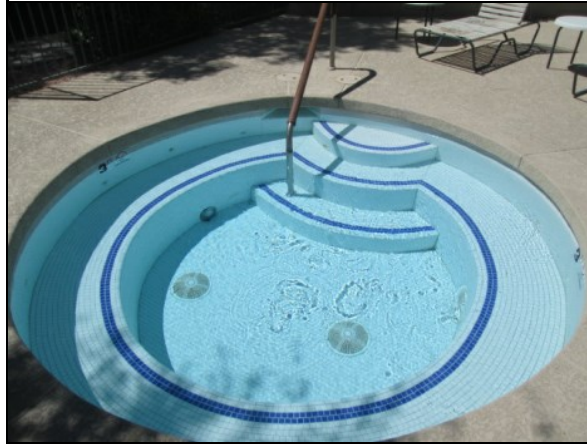
Comments: This is a tiled spa with (1) light fixture. Appears older but in fair condition. This component funds to replace the tiles and light fixture.

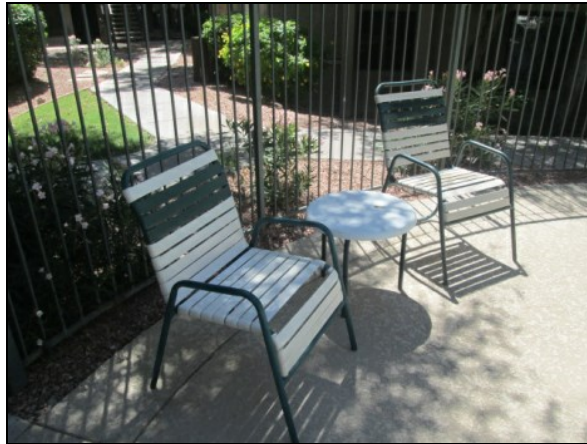
**Comp #: 1204 Spa Furniture - Replace****Quantity: (7) Assorted Pieces**

Comments: Pieces include (2) lounges, (2) chairs, and (3) side tables. Furniture appears in fair condition with no problems reported. Complete replacement should be expected periodically.

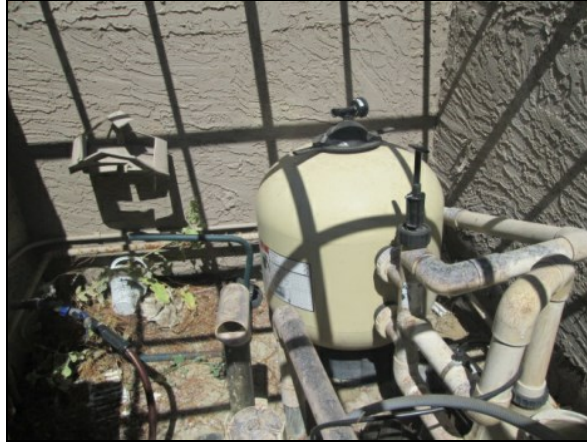
**Comp #: 1221 Spa Filter - Replace****Quantity: (1) Pentair, TR-60**

Comments: Filter appears functional with no problems reported. Replacement should be anticipated.

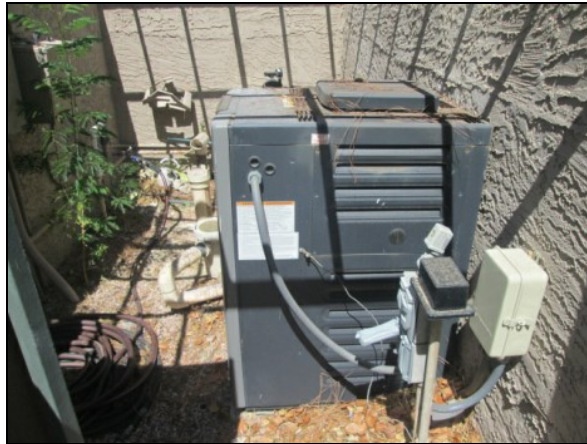
**Comp #: 1223 Spa Heater - Replace****Quantity: (1) Raypak 266,000 BTU**

Comments: Appears functional with no problems reported. Replacement should be anticipated.

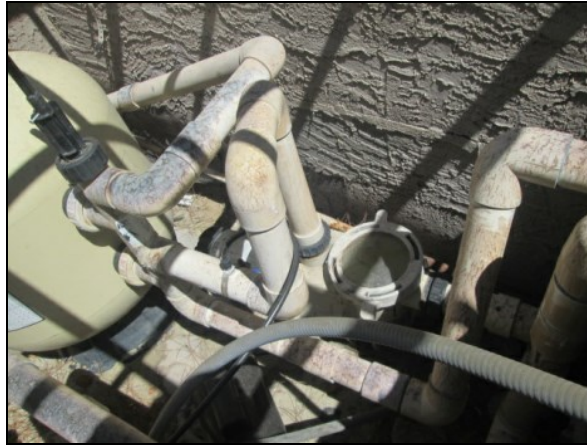
**Comp #: 1226 Filter Pump - Replace****Quantity: (1) Pentair**

Comments: Pump appears functional with no problems reported. Periodic repair and motor replacement should be addressed as a maintenance issue. This component funds for replacement of the pump and motor assembly. Based on age, replacement should be anticipated soon.

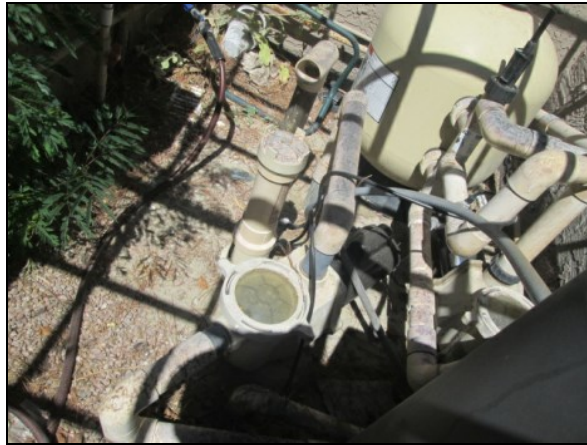
**Comp #: 1227 Jet Pump - Replace****Quantity: (1) Pentair**

Comments: Pump appears functional with no problems reported. Periodic repair and motor replacement should be addressed as a maintenance issue. This component funds for replacement of the pump and motor assembly. Based on age, replacement should be anticipated soon.

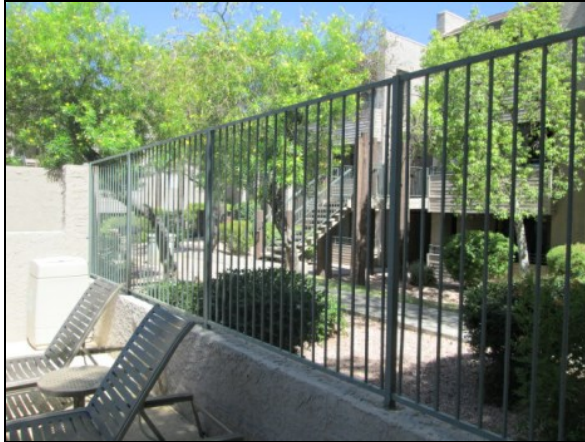
**Comp #: 503 Metal Fence - Replace****Quantity: Approx 160 LF**

Comments: Fence is still sturdy with no problems reported. Useful Life and remaining life were previously extended per the client's request. Replacement should be anticipated.

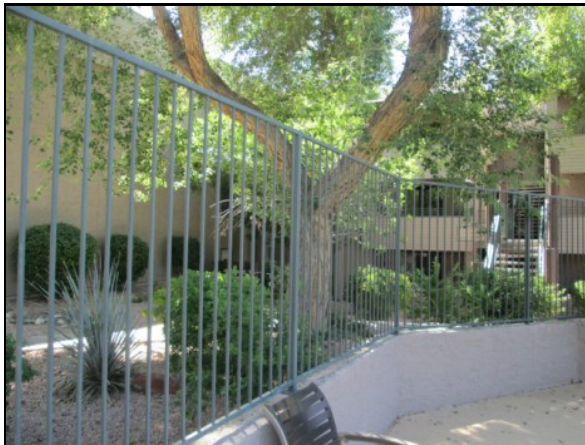
Comments: Surfaces still appear oxidized and faded. Rust issues also evident. Recommend planning to repaint soon to restore the appearance and inhibit rust.

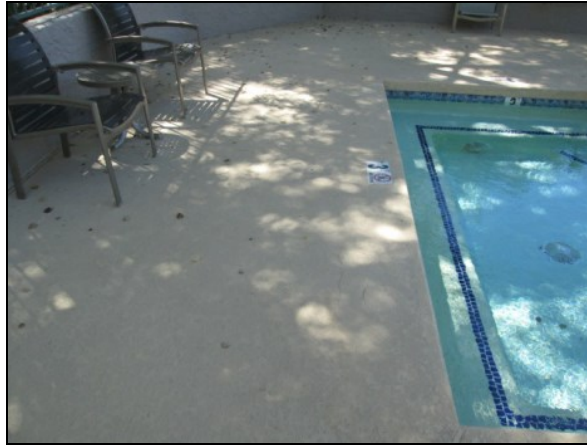
Comments: Deck still appears in fair condition with minor cracking. This is an acrylic coating applied to an underlying concrete deck. This component funds to periodically grind off the existing deck coating and re-apply a new surface. Combined cost with the seal/repair component accounts for the total estimated resurface budget.

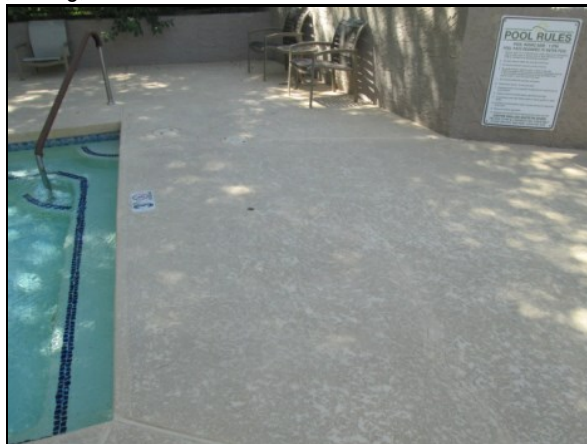
**Comp #: 1201 Spa Deck - Seal/Repair****Quantity: Approx 800 Sq Ft**

Comments: This component funds to periodically patch cracks and seal/paint the deck to cover stains and restore the appearance. Some discoloration, fading, and cracks evident.

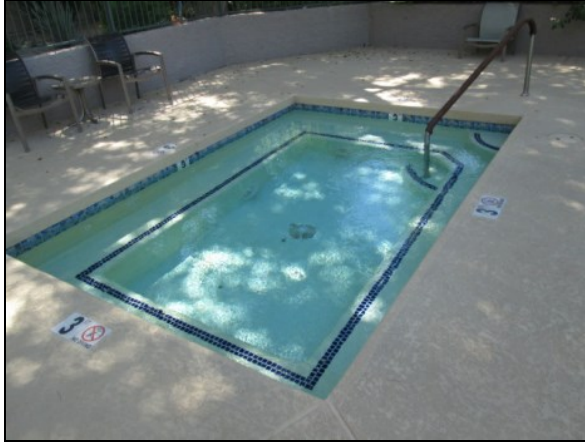
Comments: The spa has a pebble sheen surface with waterline tile and (1) light fixture. It appears in fair condition with no problems reported. This component funds to resurface the spa, replace the tile and light fixture.

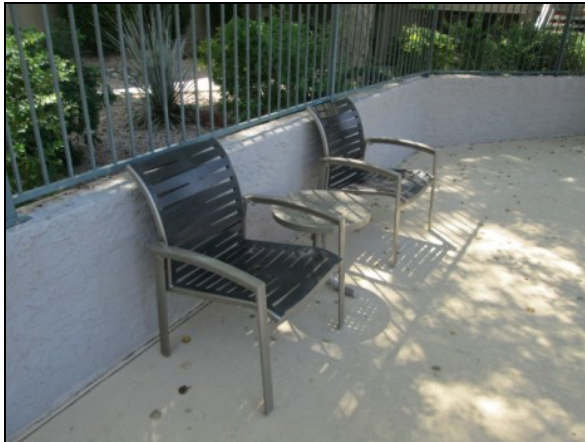
**Comp #: 1204 Spa Furniture - Replace****Quantity: (13) Assorted Pieces**

Comments: Quantity includes (4) lounges, (5) chairs, and (4) side tables. Furniture appears in fair condition. Replacement should be expected periodically.

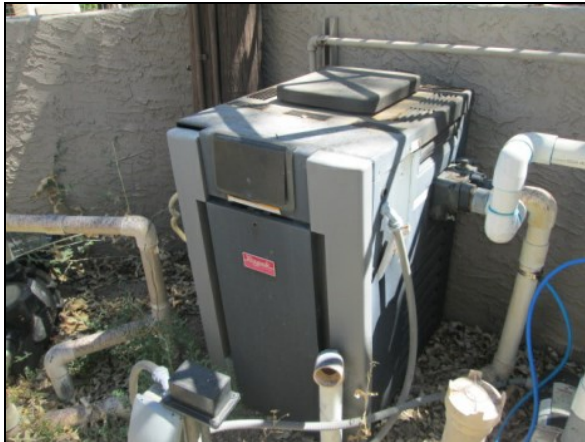
**Comp #: 1223 Spa Heater - Replace**

Comments: Appears older and worn. Heater should be nearing time for replacement.

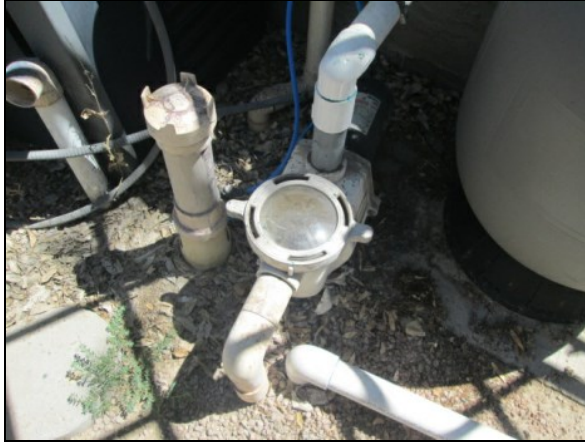
**Comp #: 1226 Filter Pump - Replace****Quantity: (1) Pentair**

Comments: Appears older, but functional with no problems reported. Periodic repair and motor replacement should be addressed as a maintenance issue. This component funds for replacement of the pump and motor assembly.

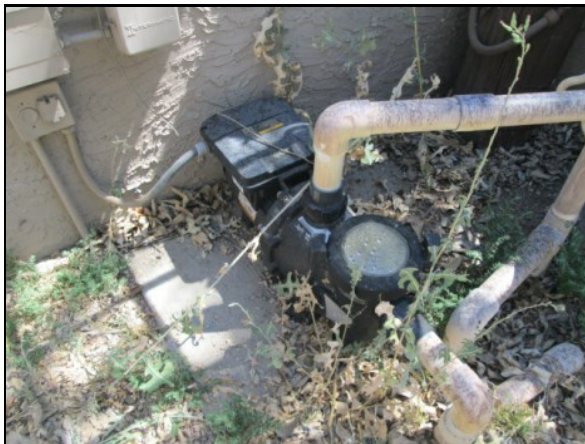
**Comp #: 1227 Jet Pump - Replace****Quantity: (1) Jandy, 2.7-HP**

Comments: Appears functional with no problems reported. Periodic repair and motor replacement should be addressed as a maintenance issue. This component funds for replacement of the pump and motor assembly.
