# Report of Findings

## Woodland Park Homeowners Association

Frank Civil Consulting

February 29, 2016

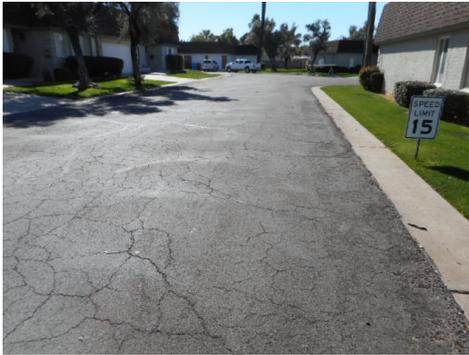
Exhibit 31

31st Way connects Coolidge Street with Hazelwood Street at the east side of the community (Exhibit 31). 31st Way exhibits the same asphalt conditions structurally and from a subterranean perspective with regard to instability and pavement failure (Exhibit 32).
