## Update “With Site-Visit” Reserve Study

### **Papago Ridge Condominiums** **Phoenix, AZ**

**Report #: 14506-1**  
**For Period Beginning: January 1, 2016**  
**Expires: December 31, 2016**

**Date Prepared: January 7, 2016**

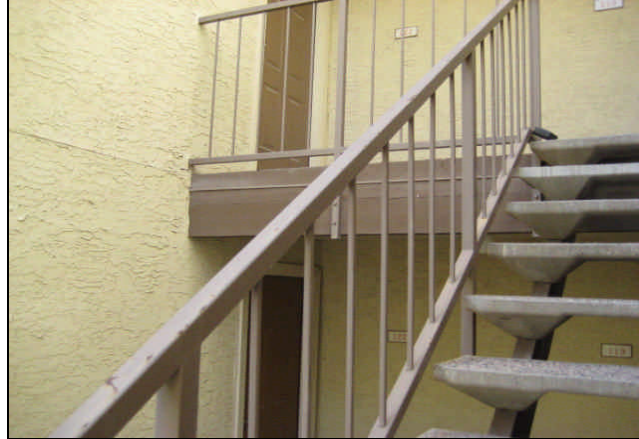
Evaluation : Chipping and oxidation evident. Repaint periodically to maintain appearance and to inhibit rust.

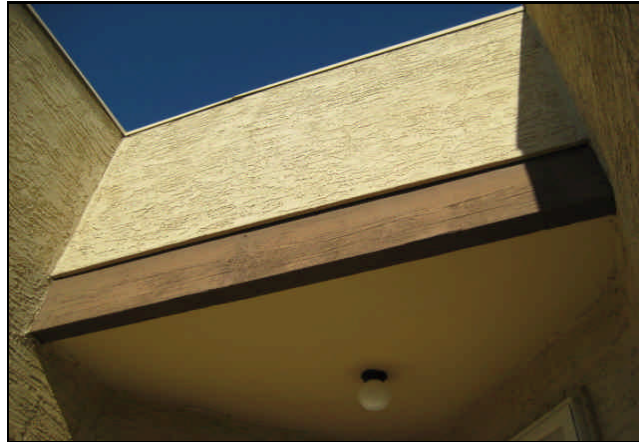
Evaluation : Fading and surface deterioration observed. Repaint regularly to maintain appearance and to protect the wood surfaces.

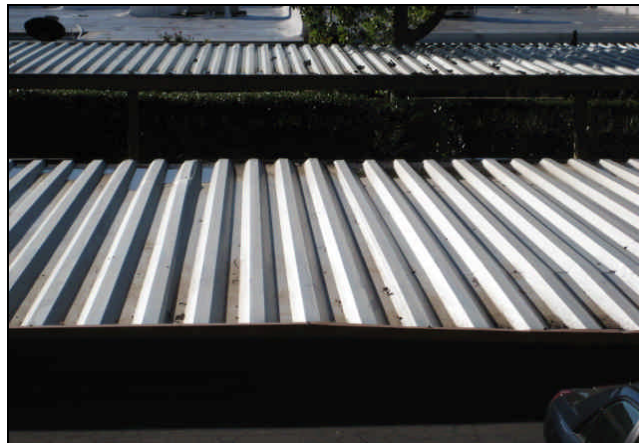
**Comp # : 1300 Carports - Repair**

Evaluation : Carports have corrugated metal roofs. There is no expectancy to completely replace them. This component provides an allowance to repair or replace sections as needed.

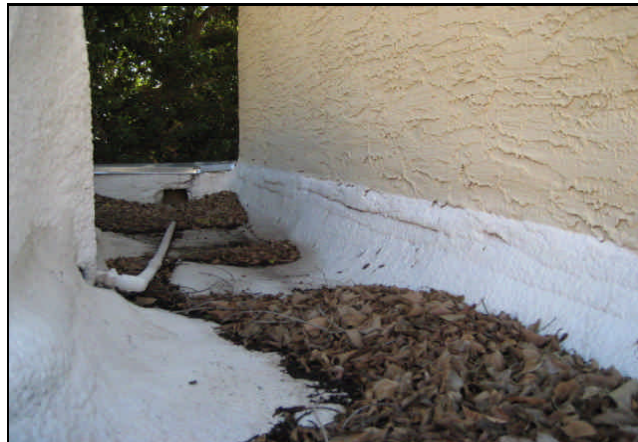
Evaluation : The association should plan to recoat the roofs every 5-years until replacement is needed.

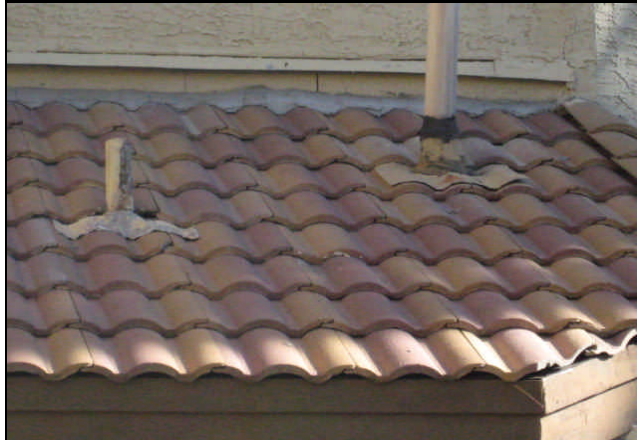
Evaluation : There is no expectancy to replace all of the tiles under normal circumstances. Replacement of the felt paper underlayment should be anticipated eventually. Life span will vary depending on the quality of underlayment installed. Based on age, tile roofs should be nearing the end of the typical life expectancy.

Estimate to remove tiles, replace underlayment,  
reinstall tiles

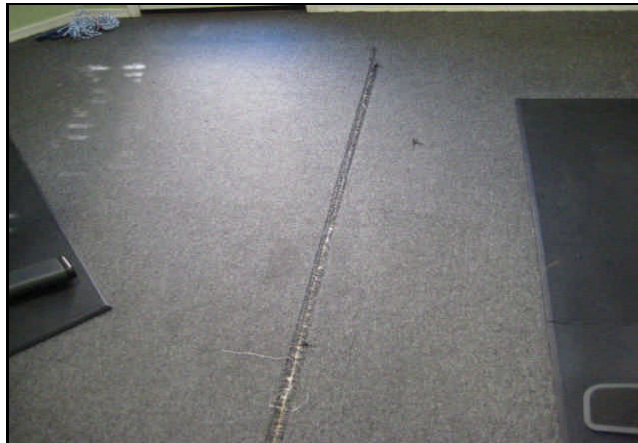
**Comp # : 901 Carpet Floor - Replace**

Evaluation : Carpet exhibits signs of wear. Life span will vary depending on the level of use. Based on age and appearance, replacement should be expected soon.

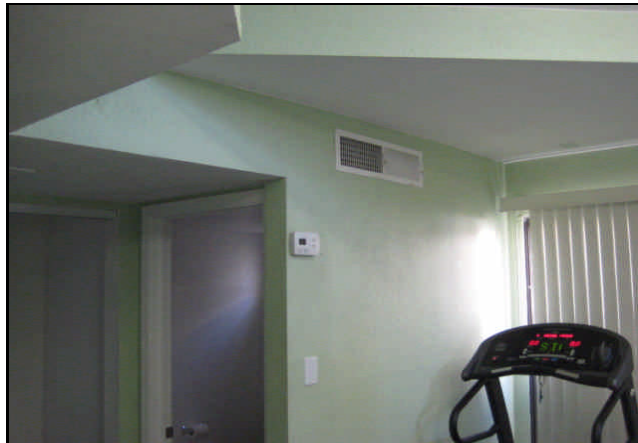
Evaluation : Fair conditions observed. Periodic repainting should be expected to maintain a uniform appearance.

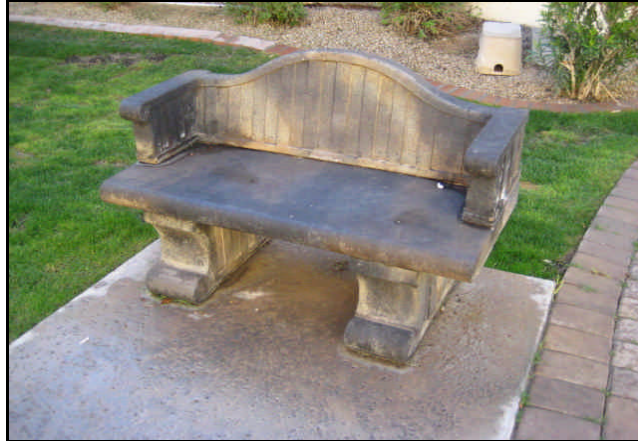
**Comp # : 405 Concrete Furniture - Replace** Quantity: (6) Assorted Pieces  
Location : Center of community - adjacent to the pool & walkway between buildings  
Funded? : Yes

Evaluation : Pieces include (2) benches, (2) table/bench sets and (2) trash receptacles. Concrete furniture appears to be in stable condition. Future replacement is expected to maintain and update the appearance.

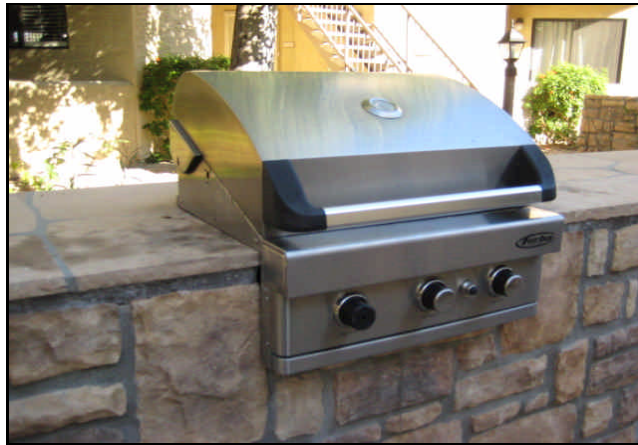
**Comp # : 407 BBQ Grills - Replace** Quantity: (2) Turbo Grills  
Location : Center of community - adjacent to the pool  
Funded? : Yes

Evaluation : Appear functional and in good shape. Future replacement should be anticipated.

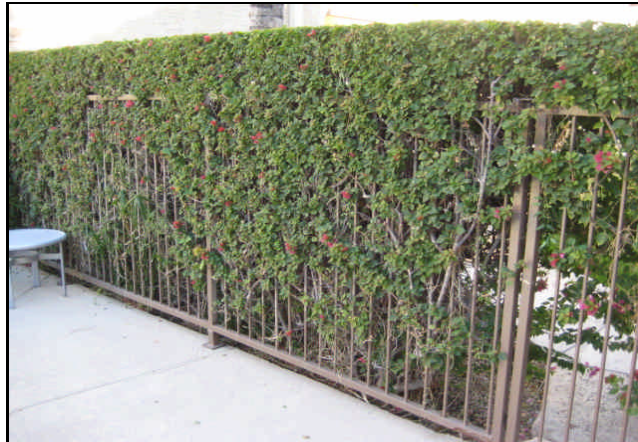
**Comp # : 504 Pool Fence - Replace**

History : Pool fence was repaired in 2006.

Evaluation : Overall fair conditions observed with some random rust, but no significant instability. Metal fencing is typically a long lasting material, but will require eventual replacement. Repainting is included with fences and gates under the common area section of this report.

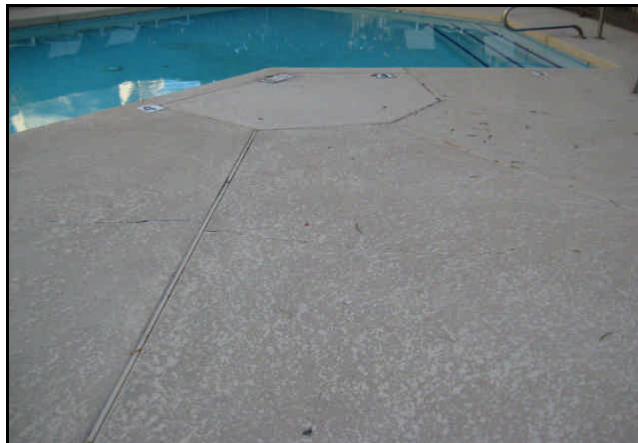
Evaluation : Observed to be in fair condition with random cracking, but no significant damage. Keep clean and properly sealed to reach full life expectancy.

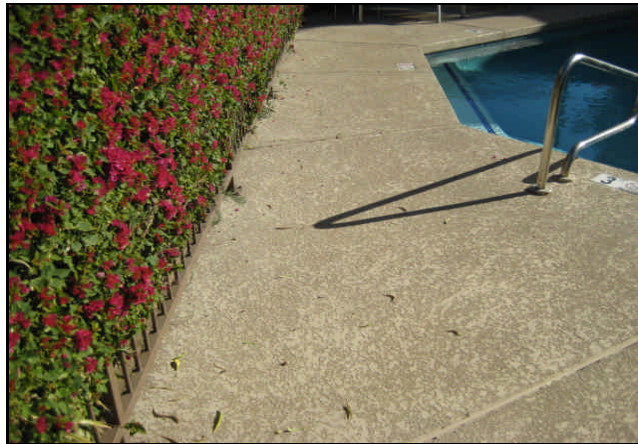
**Comp # : 1201 Pool Deck - Seal/Repair**

Evaluation : Some cracks and discoloration noted. This component funds to periodically patch cracks and seal the deck to cover stains and restore the appearance.

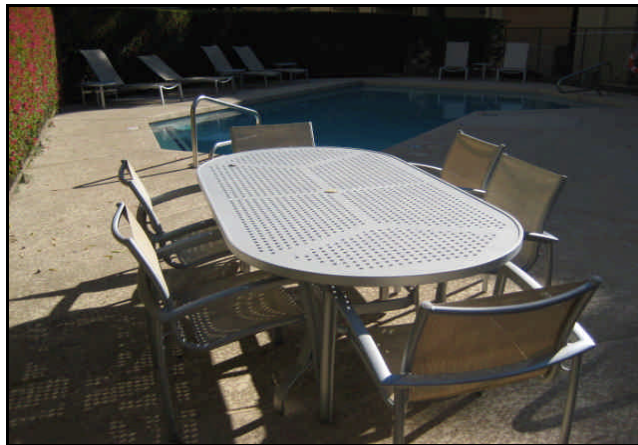
Comp # : 1204 Pool Furniture - Replace

Evaluation : Pieces include (2) dining tables, (6) tea tables, (10) chairs, and (9) lounges. Fair conditions observed. Periodic replacement should be expected.

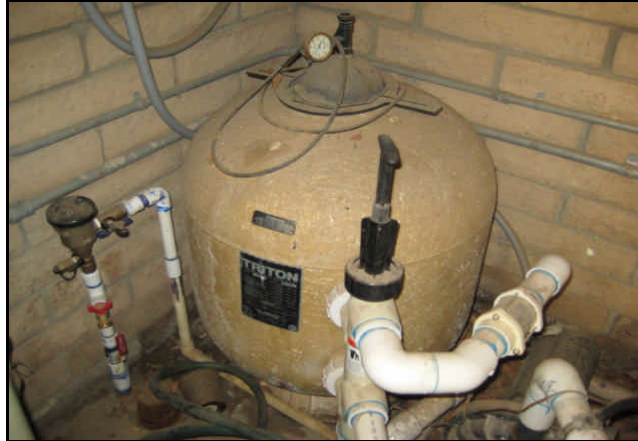
Comp # : 1220 Pool Filter - Replace

Evaluation : Based on age, it would be prudent to plan for replacement soon. Clean and service regularly to ensure efficiency and long life. Serial #TR-80436.

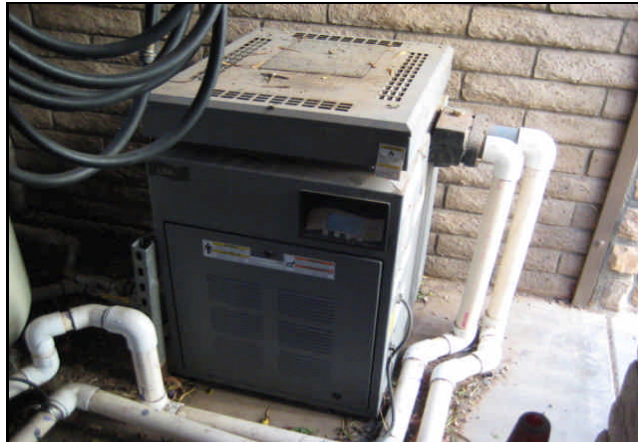
Comp # : 1223 Spa Heater - Replace

Evaluation : The spa heater is reported to be in functional condition. Some rust/corrosion was noted on unit, but no water leaks were observed. Service periodically to maintain efficiency and life expectancy. Clean periodically to prevent dirt/debris buildup.
