Update "No-Site-Visit" Reserve Study

Overlook II HOA

Scottsdale, AZ

Report #: 25455-2

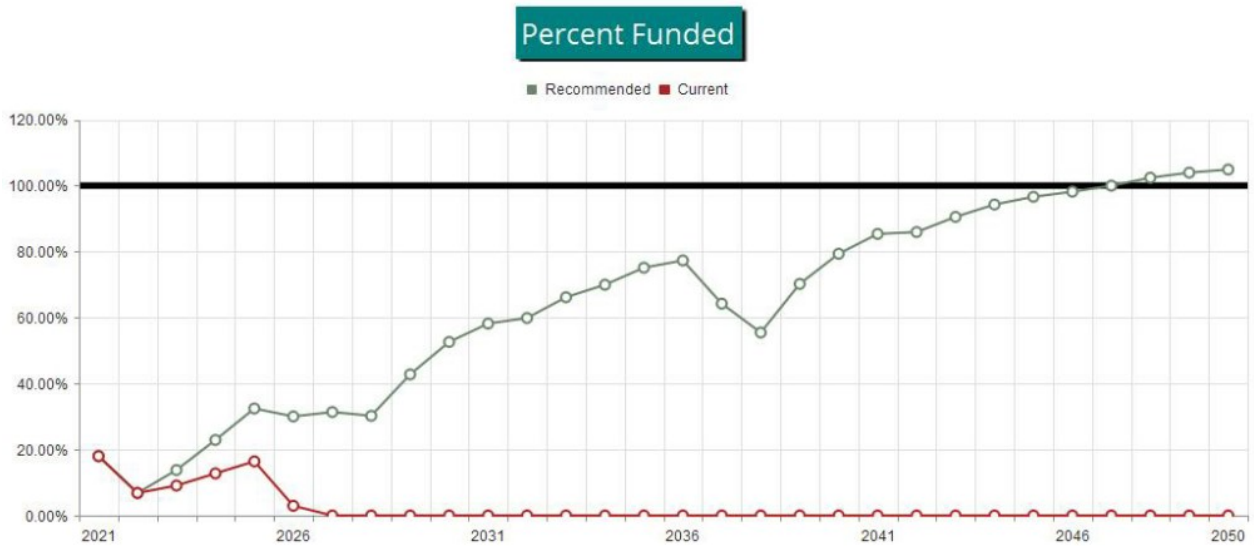
Figure 4

This chart shows the same information plotted on a Percent Funded scale. It is clear here to see how your Reserve Fund strength approaches the 100% Funded level under our recommended multi-year Funding Plan.
