Windsor Gardens HOA
Phoenix, AZ

Report #: 13342-1
Beginning: January 1, 2026
Expires: December 31, 2026

RESERVE STUDY
Update "With-Site-Visit"

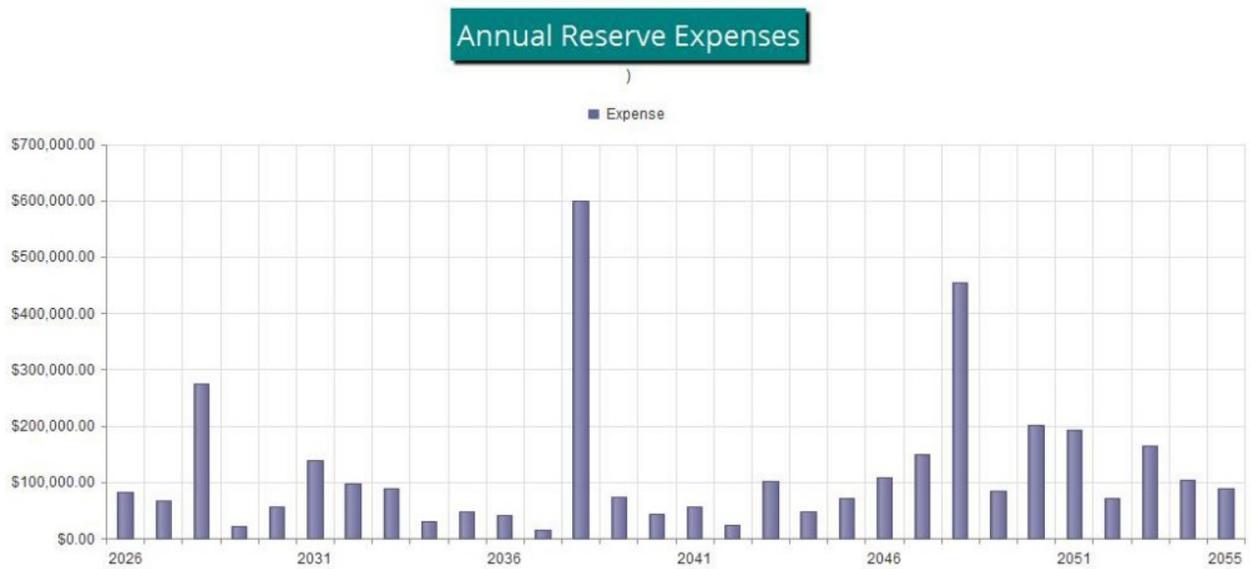
Figure 1

The chart below summarizes the projected future expenses at your association as defined by the Reserve Component List. A summary of these components is shown in the Component Details Table, while a summary of the expenses themselves is shown in the 30-yr Expense Summary Table.

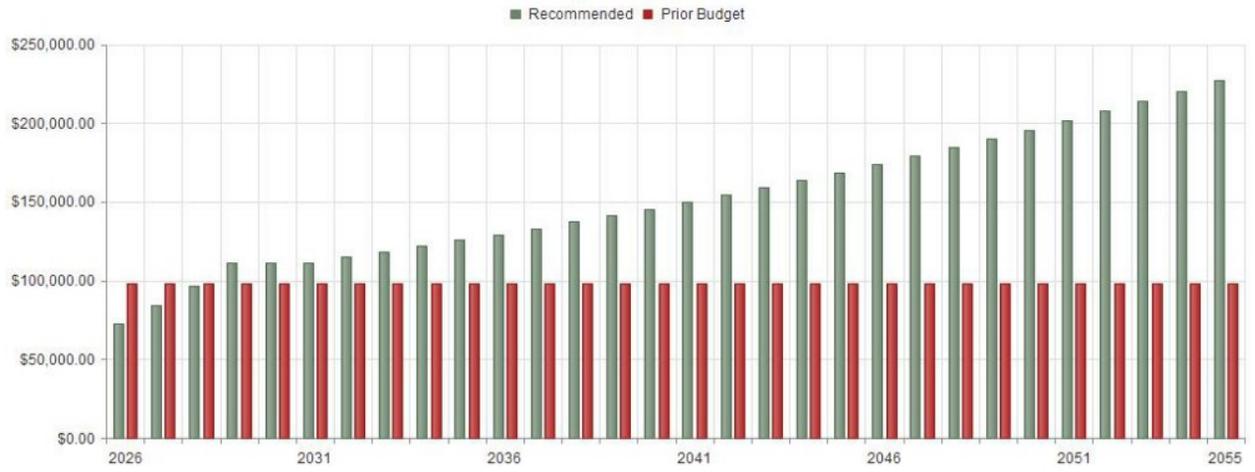
Figure 2

Annual Reserve Funding

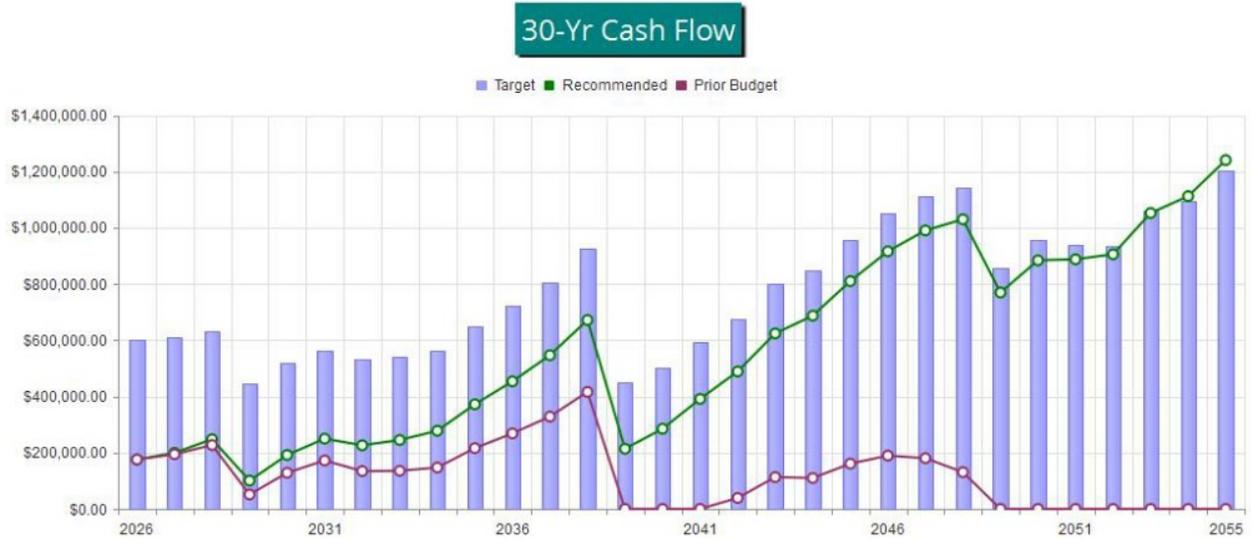
Figure 3

The following chart shows your Reserve balance under our recommended Funding Plan and at your current budgeted level of Reserve funding, compared to the always-changing Fully Funded Balance target.

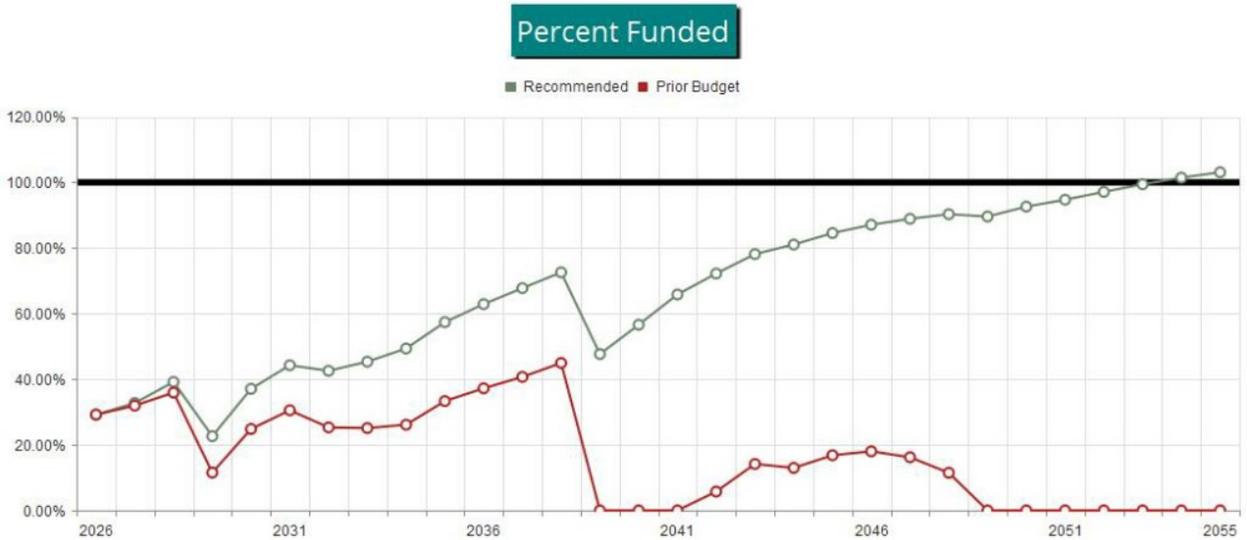
Figure 4

This chart shows the same information plotted on a Percent Funded scale. It is clear here to see how your Reserve Fund strength approaches the 100% Funded level under our recommended multi-year Funding Plan.

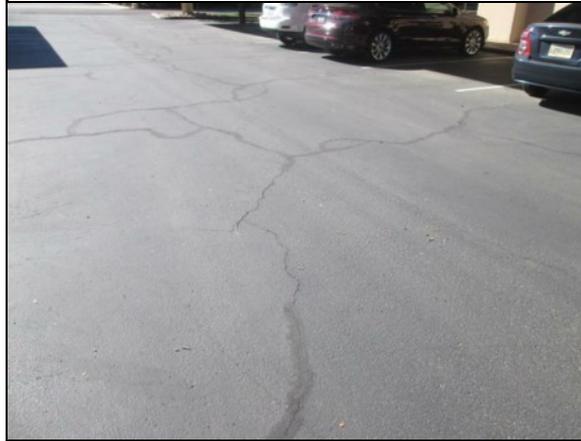
Comp #: 202 Asphalt - Seal/Repair

Useful Life:
6 years

Remaining Life:
1 years

Lower Estimate: \$ 18,000 **Higher Estimate:** \$ 22,000

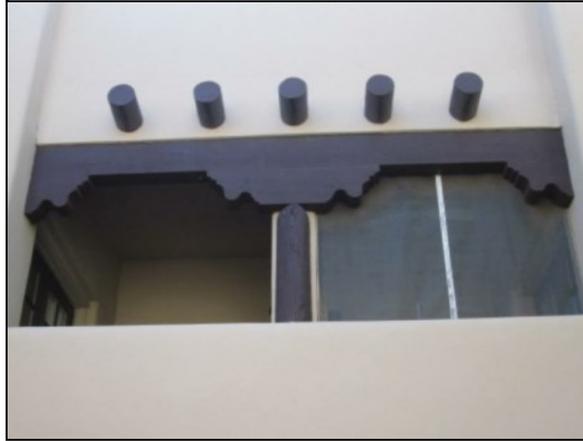
Comp #: 1065 Vigas - Partial Replace

History: Replaced (27) vigas on Building 5 during 2016 for ~\$13,700. Previously original from 1985.

Comments: Appear to still be intact and holding up well. No problems or issues observed. This component funds an allowance to partially replace the vigas as needed.

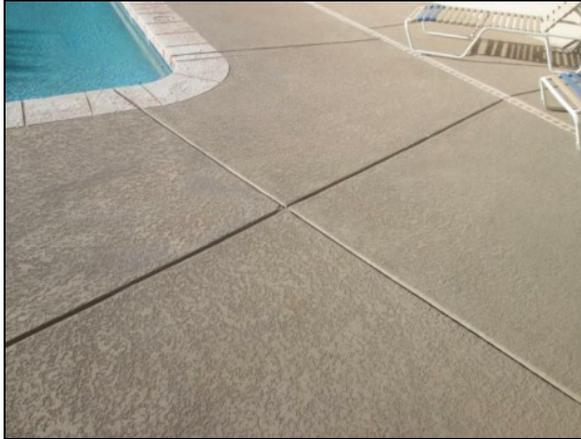
Comp #: 1200 Pool Deck - Resurface**Approx Quantity: 2,000 Sq Ft****Location:** Pool area**Funded?:** Yes.**History:** Resurfaced in 2010.**Comments:** Still appears to be in fair condition. No major wear or deterioration evident. This component funds to periodically grind off the existing deck coating and re-apply a new surface. Combined cost with the seal/repair component accounts for the total estimated resurface budget.**Useful Life:**
