# RESERVE ANALYSIS REPORT

## Vintage Ranch

Gilbert, Arizona

July 15, 2020

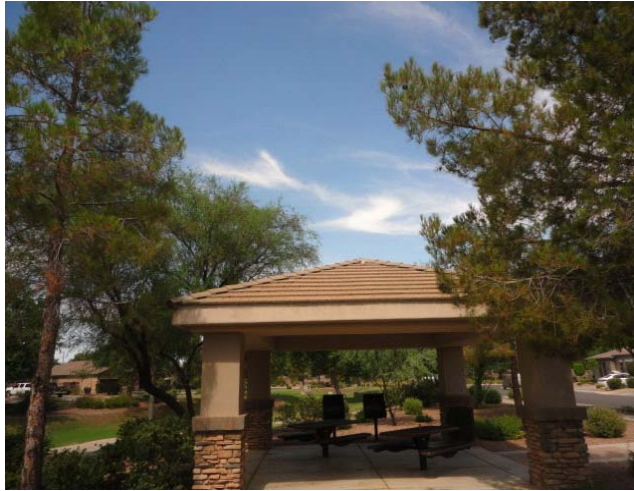
The following comments apply to the concrete tile roofs atop the four (4) community ramadas:

Tile roof systems are designed to last for the life of the project. However, the integrity of the tile roof is dependent on the condition of the roof underlayment. The tile can last indefinitely but will not keep the building watertight unless the underlayment is intact.

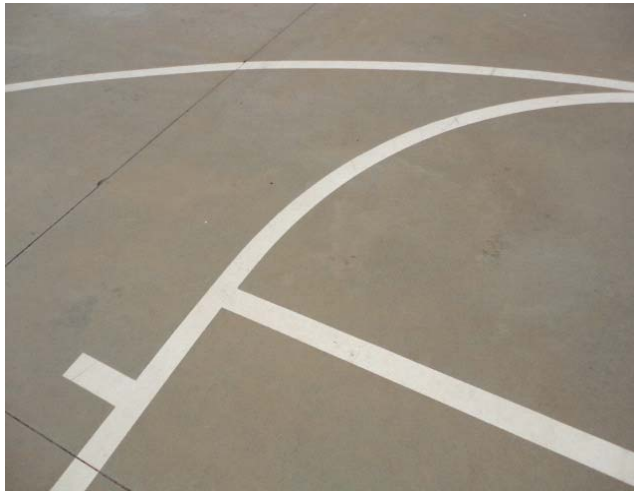
ARS Builders completed a project to re-paint the basketball court lines at all three (3) courts in late 2019 for \$2,750.

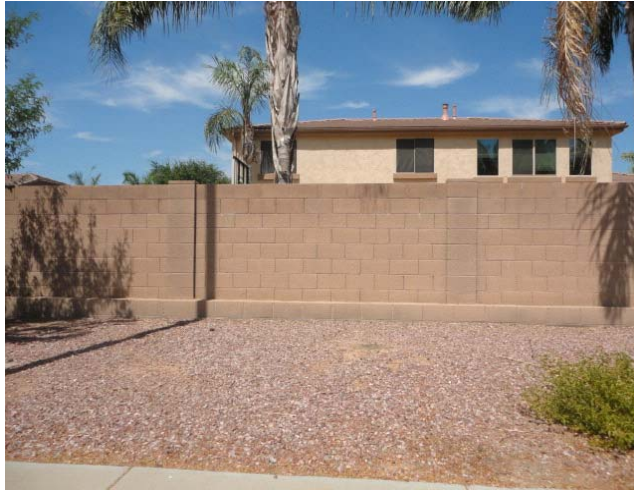
This is an estimate for painting the common area walls on an eight (8) year cycle located on the west perimeter, facing the interior of the community, including:

- between lots 128 & 149 (approximately 390 LF)
- south of lot 208 (approximately 450 LF)

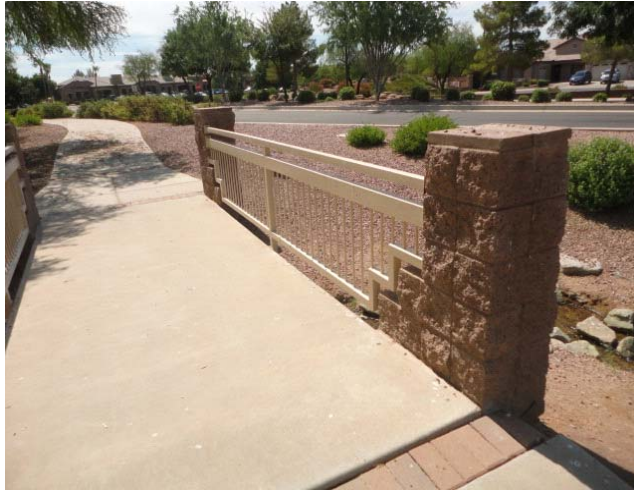
This is an estimate for painting the following metal components, next in 2018:

- 2" x 4" metal railings atop three (3) separate portions of the east perimeter wall along Lindsay Road (approximately 450 LF).
- metal bridge railing at the main entrance on the north side of East Saratoga Ave.
- steel split rail fencing scattered throughout the interior greenbelt at culverts
- meta light poles at three (3) basketball courts (6 poles)

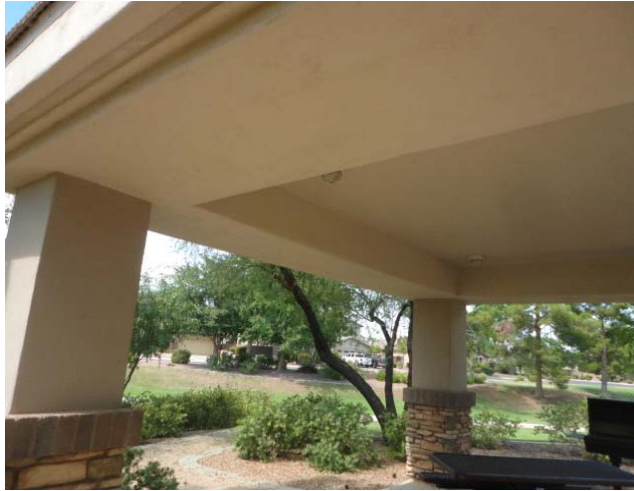
This is an estimate for painting the stucco ramada and mailbox structures.

The actual date this component was placed into service is not available. For budgeting purposes, this date has been estimated based on its condition at our most recent site visit.

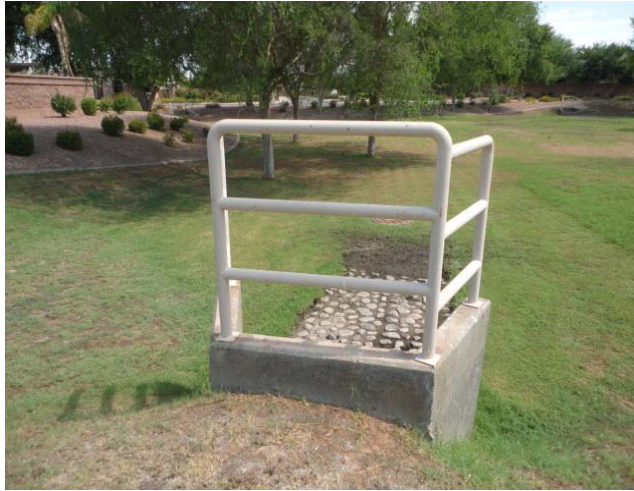
We are not budgeting to replace the steel split rail fencing because it has an indefinite life, and should last for the life of the community if properly maintained. Any repairs should be handled on an as needed basis and the expense paid for out of the annual operating budget.

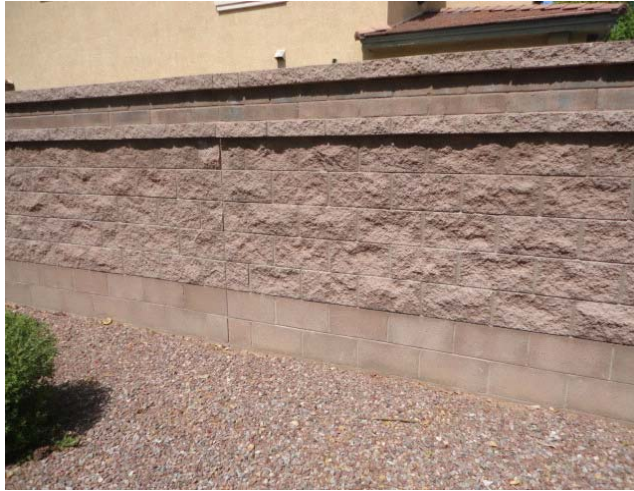
This component will accumulate funds for 25 years, and then on a continuous 10 year cycle, for the major repair/replacement of a percentage of the common area walls. The accumulate funds should be used as needed, and the percentage budgeted for repair/replacement should be adjusted over time as conditions dictate.

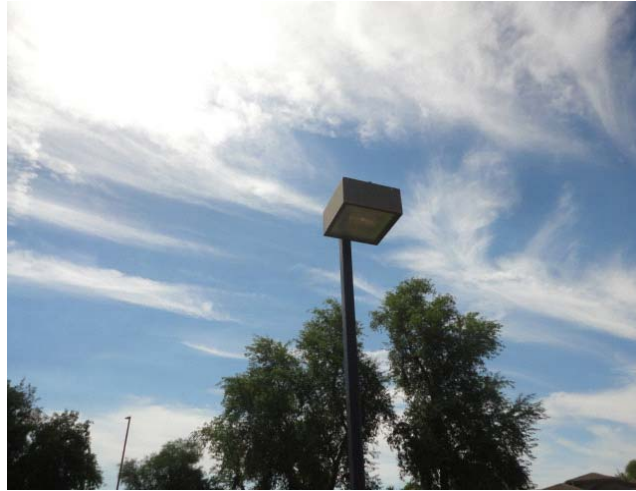
These are pole mounted, box style fixtures at the three (3) basketball courts. The cost does not include the replacement of poles or mounting brackets.

Note that we have not included budgeting for replacement of the pole mounted, box style light fixtures within the interior greenbelt. We were previously advised that these poles/fixtures are not owned by the Association.

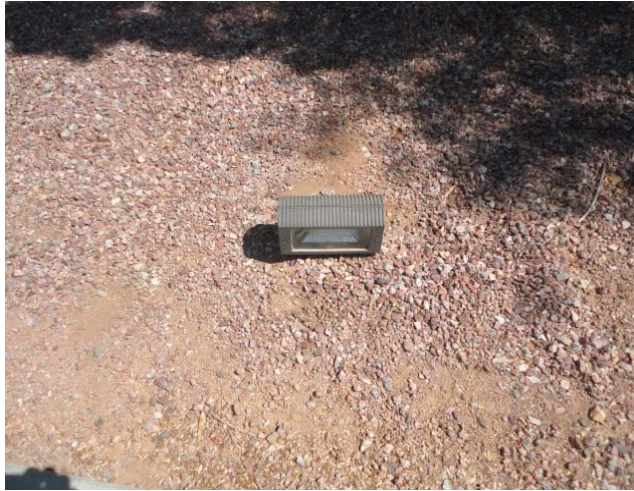
We are not budgeting to replace any ground level landscape, monument or pathway lighting systems. Individual light fixtures are most often replaced as needed using operating funds due to frequent damage by pedestrians, landscape personnel, and/or weather conditions. Should complete replacement of the lighting system(s) be required, expert evaluation will be necessary to provide replacement cost information.

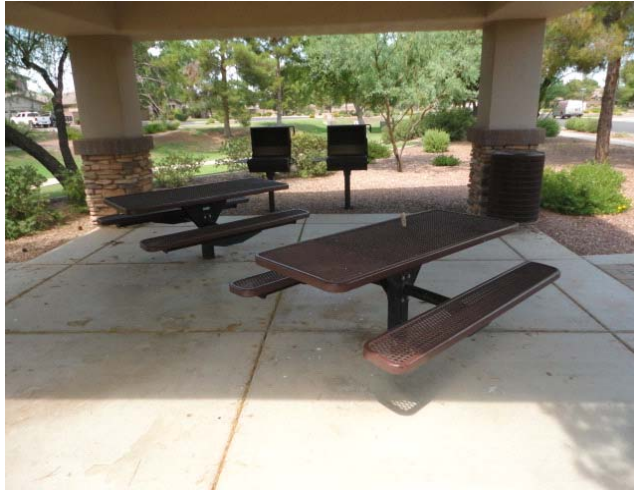
This component budgets for replacement of the following park equipment:

8 6' picnic tables (in ground, center post)	@	\$1,250.00	=	\$10,000.00
10 6' benches w/back (in ground)	@	\$900.00	=	\$9,000.00
4 trash receptacles	@	\$600.00	=	\$2,400.00
8 Pilot Rock charcoal grills	@	\$600.00	=	\$4,800.00
		TOTAL	=	\$26,200.00

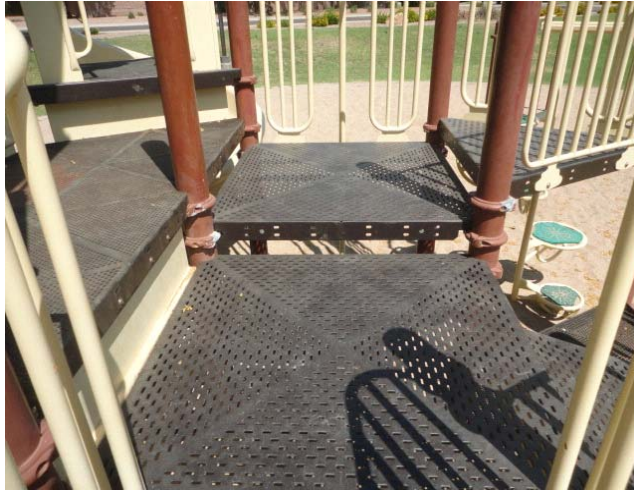
HOA Playground Services completed a project to repair the three (3) playstructures in 2018 for approximately \$20,000. It is not anticipated that this level of repairs will be need again prior to replacement of the playstructures. Therefore, we have included budgeting of \$10,000 in 2026 as a one-time expense.

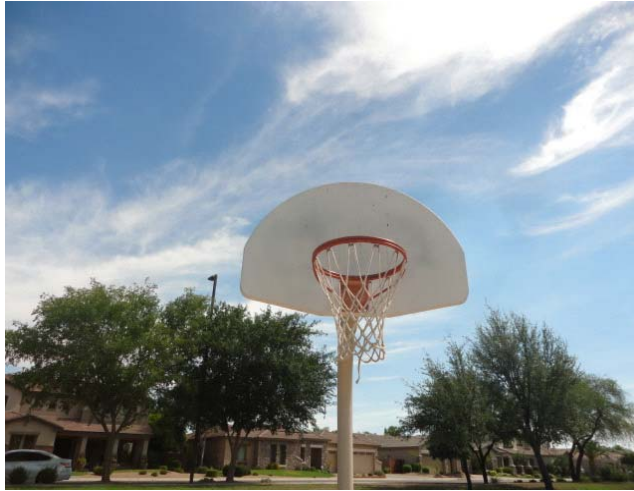
This is an estimate for replacement of the basketball backboards and rims at the east play area basketball court.

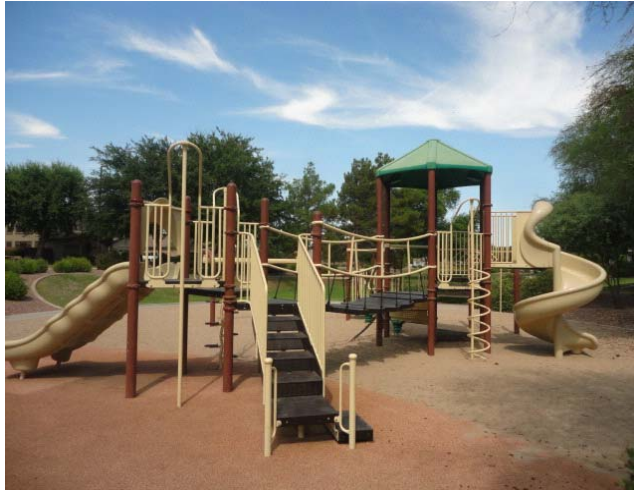
This component budgets to replace the playstructure located on the east side of the community near the East Saratoga Street. The cost includes a provision for sand replenishment on an "as needed" basis.

Repairs to the playstructure were completed in 2018.

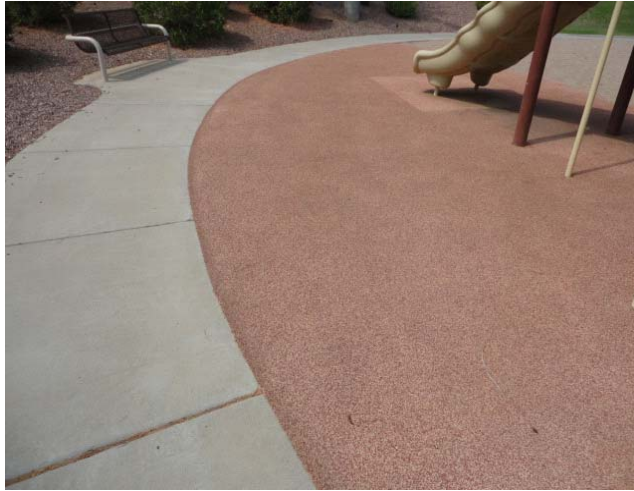
This component budgets for replacement of the rubber safety surface (Tot Turf) at the play area on the east side of the community near the East Saratoga Street entrance.

Interim repairs or flexcoats should be handled as needed using funds from the operating budget.

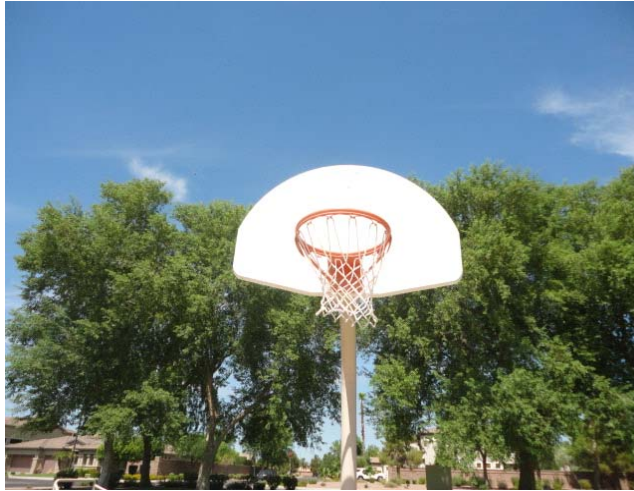
This is an estimate for replacement of the basketball backboards and rims at the north play area basketball court.

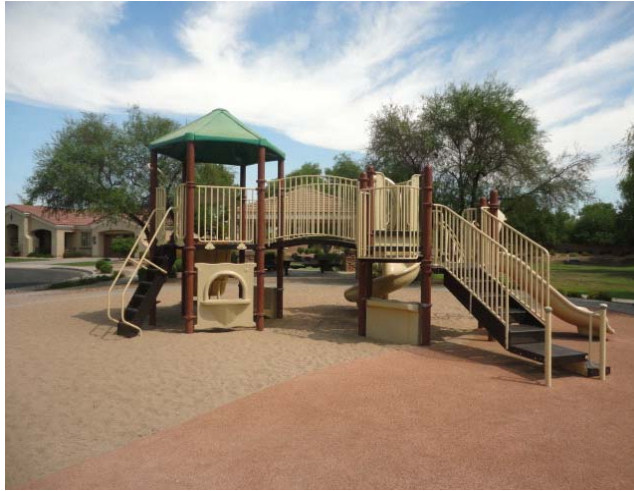
This component budgets to replace the playstructure located on the north side of the community near the East Frye Road entrance. The cost includes a provision for sand replenishment on an "as needed" basis.

Repairs to the playstructure were completed in 2018.

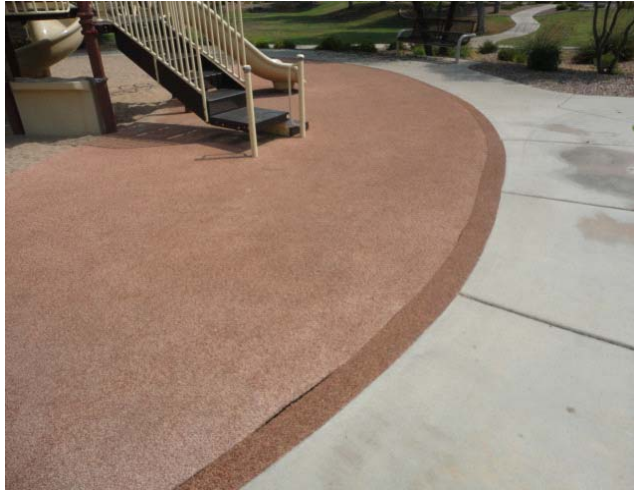
This component budgets for replacement of the rubber safety surface (Tot Turf) at the play area on the north side of the community near the East Frye Road entrance.

Interim repairs or flexcoats should be handled as needed using funds from the operating budget.

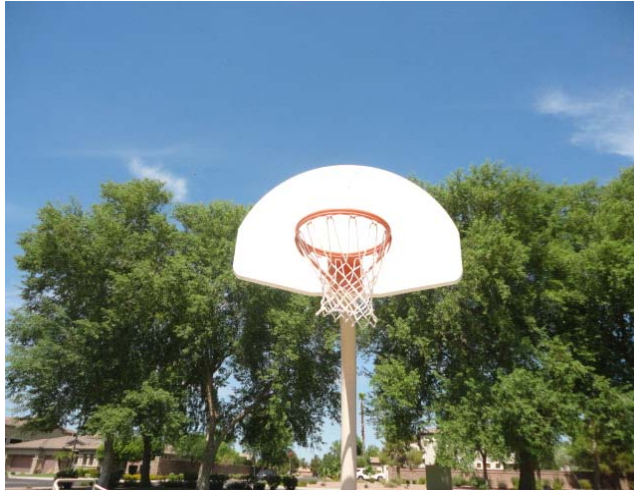
This is an estimate for replacement of the basketball backboards and rims at the south play area basketball court.

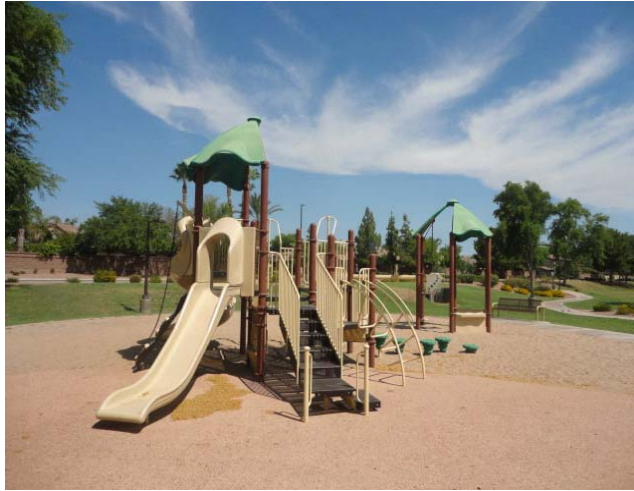
This component budgets to replace the playstructure located on the south side of the community near the Pecos Road entrance. The cost includes a provision for sand replenishment on an "as needed" basis.

Repairs to the playstructure were completed in 2018.

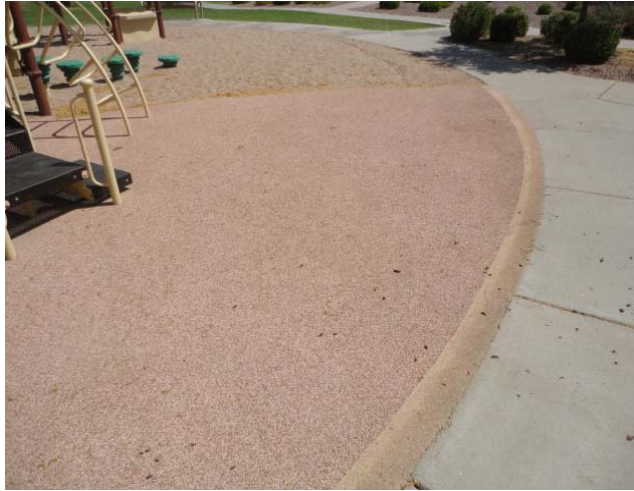
This component budgets for replacement of the rubber safety surface (Tot Turf) at the play area on the south side of the community near the Pecos Road entrance.

Interim repairs or flexcoats should be handled as needed using funds from the operating budget.

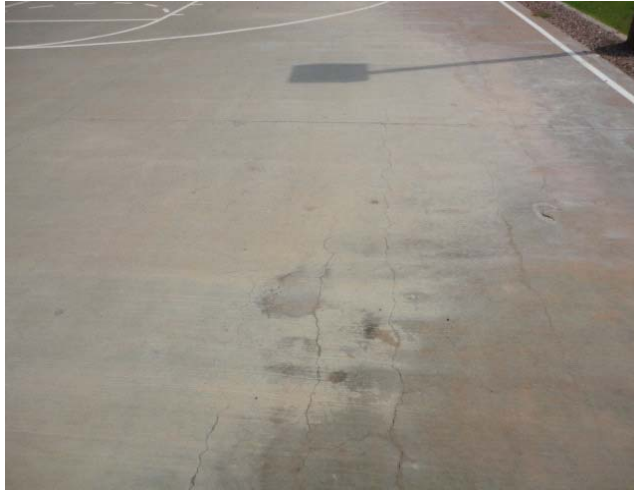
We are not budgeting for repair or replacement of concrete components in this analysis. It is anticipated that any repairs/replacements required will be addressed immediately due to safety concerns. There should not be a need for complete replacement at a single point in time, and good maintenance practice won't allow the need for repairs to accumulate to a point of major expense. We recommend that a line item be set up in the annual operating budget to account for potential concrete repairs/replacements on an as needed basis. However, should the client wish to include budgeting for concrete components as a reserve expense, we will do so at their request (cost and useful life to be provided by client).

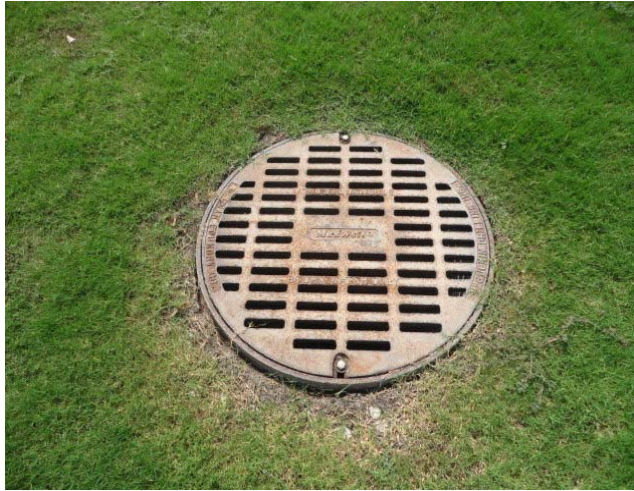
We have been advised that drywells are maintained using funds from the annual operating budget.

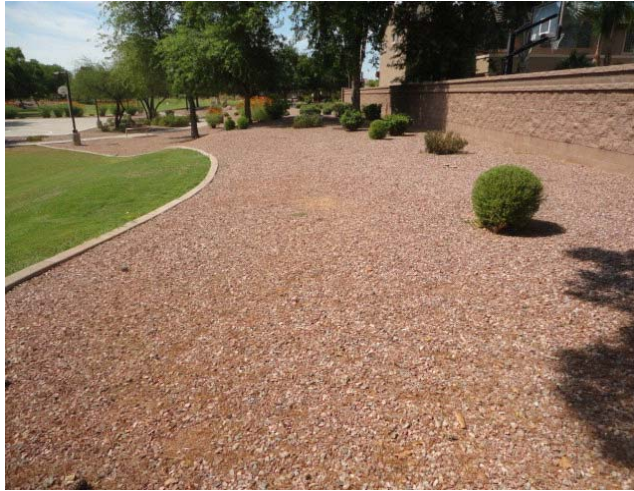
There are 4,350 tons of common area granite landscape rock.

2,175 tons were replenished in 2010. The Board previously requested that we budget to replenish every 15 years. We have been advised now that the Board would like some granite replenishment to bare areas completed in 2021. Based on what we saw on-site, we have estimated that about 25% of the common areas are a bit bare.

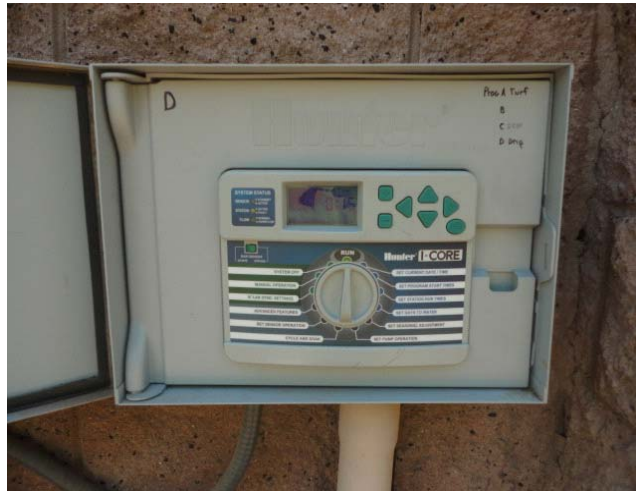
4	Hunter ICC 42 station controllers	@	\$800.00	=	\$3,200.00
			TOTAL	=	<u>\$3,200.00</u>

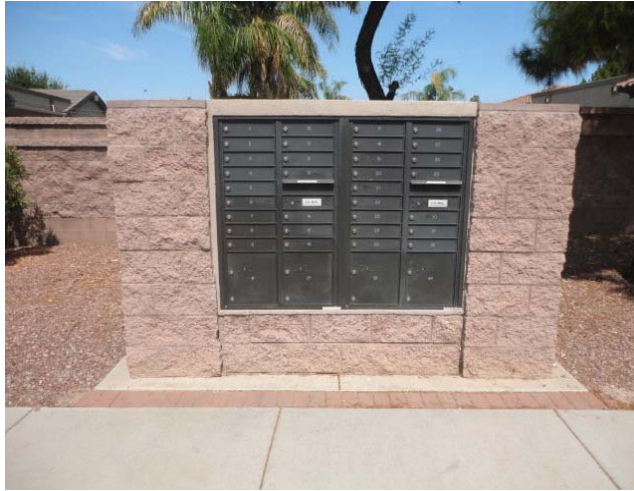
Express Mailbox completed a project to replace the community mailboxes in late 2015 for \$22,876.79. We are budgeting to replace the mailboxes on a 15 year cycle.

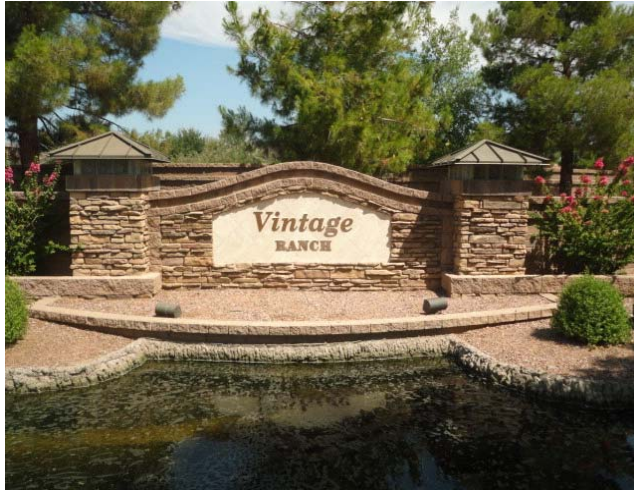
The monuments signs are made up of steel letters mounted on stone tile signfaces. Back in 2008 the Board requested that we budget \$5,000 for sign refurbishment. No changes to this component have been requested. Therefore, we have adjusted the cost to account for inflation and have continued to budget for monument signs in a similar manner.

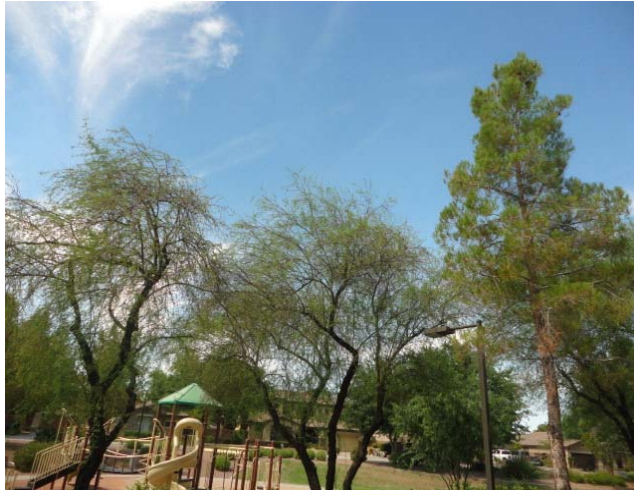
We have been advised by arborists that major tree trimming is usually required every 3 – 5 years and could be considered a reserve expense. However, the cost for a major tree trimming project depends on the size, type, maturity and number of trees at the community – all of which call for expert evaluation, but fall outside the scope of a reserve study.

Should the Board obtain a proposal and trimming schedule we will include budgeting for tree trimming in a revision or future update of this analysis at the Board's request.

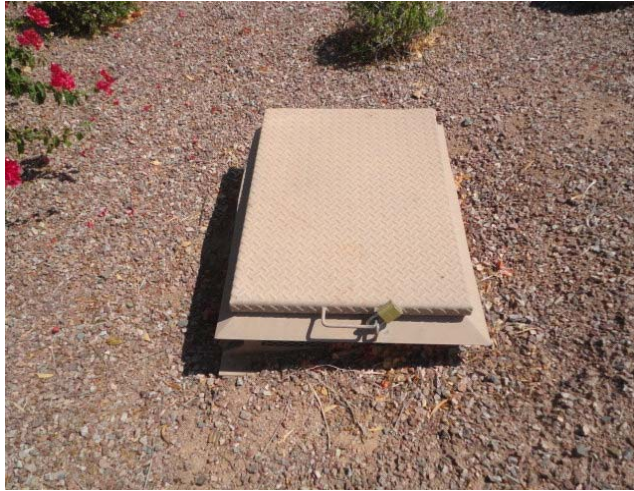
Clearwater Engineering has performed major repairs to the water feature vault, pumps, valves, and mechanicals over the past 9 months totalling \$23,000. We have included provision of \$25,000 every 10 years to be used as needed for water feature repairs.

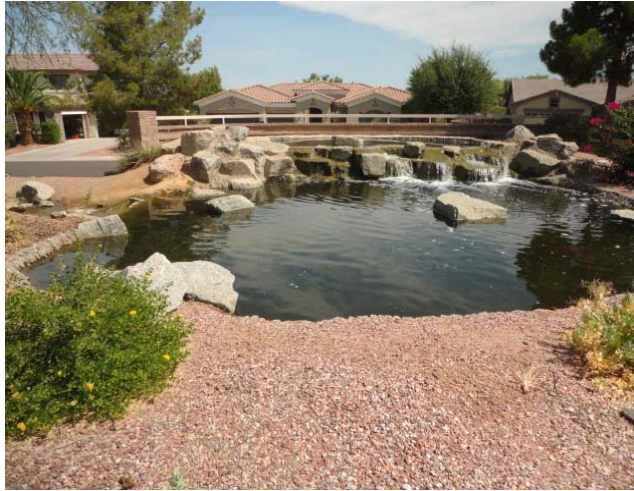
Clearwater Engineering completed a project to pump out and then clean the water features in mid 2016 for \$6,000. We are budgeting for a similar scope of work every eight (8) years.
