**RESERVE STUDY UPDATE  
FOR  
CIRCLE G RANCHES 4 HOMEOWNERS  
ASSOCIATION**

January 12, 2026

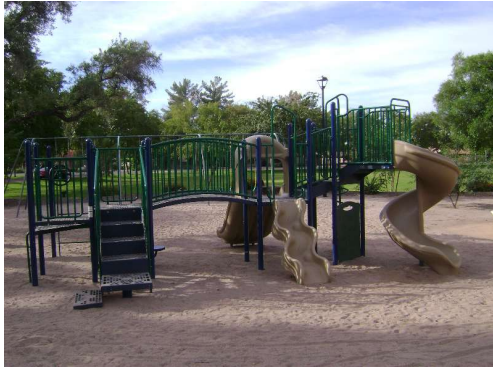
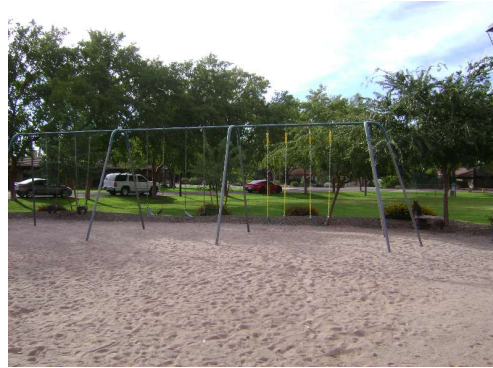
Good condition. Budget to paint play structure and swing set.

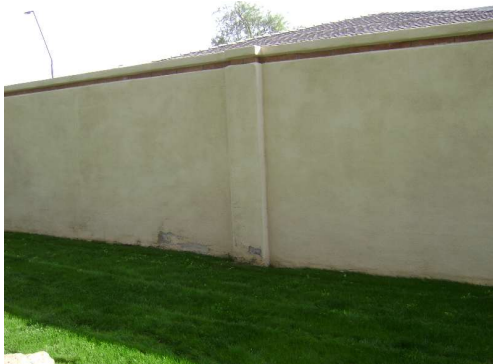
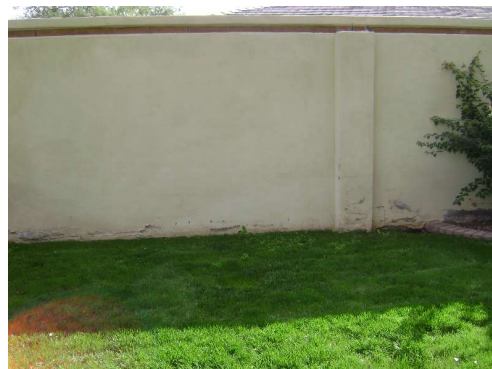
Poor condition. Budget to paint masonry block stucco walls. Locations include entrance,

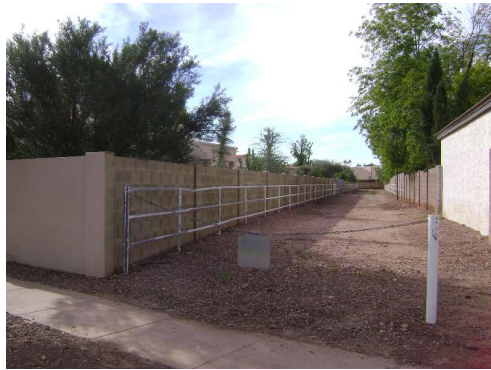
**Bridle Path Chains & Posts (A) - Replace**

Fair condition. Budget to replace bridle path chains and posts. Low priority - life adjustment.

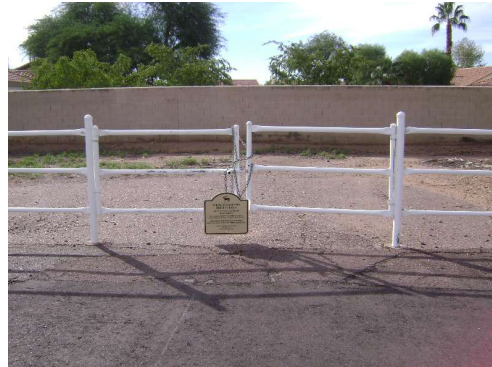
**Bridle Path Fencing & Gate (B) - Replace**

Fair condition. Budget to replace approximately 40 LF of split rail fencing/gates. Location South end of Fairfield Dr. Low priority - life adjustment.

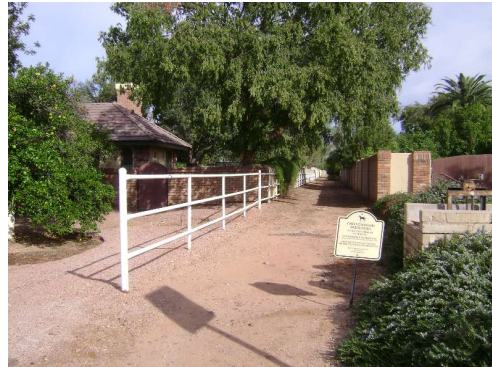
#### Bridle Path Rails - Replace/Paint

Unfunded. Prior report stated owner's responsibility. Various conditions. All need paint.

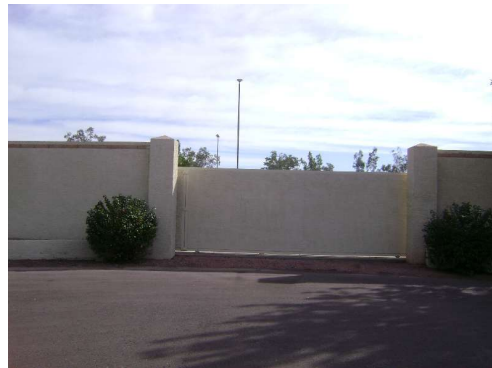
**Emergency Gate - Replace**

Good condition. Budget to replace emergency fire gate with block wall. Approximately 25 LF.

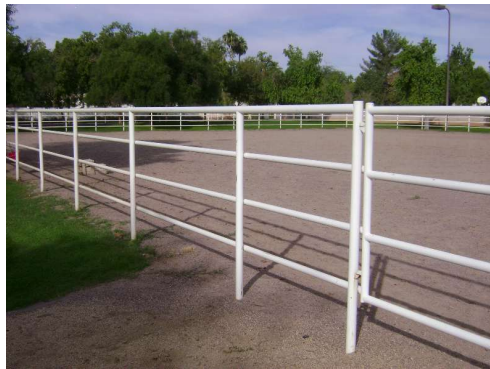
**Horse Arena Split Rail Fence - Repair/Replace Footings**

Poor condition. Budget to repair and/or replace footings where needed. Reportedly footings are failing. Approximately 670 LF of split rail fencing.

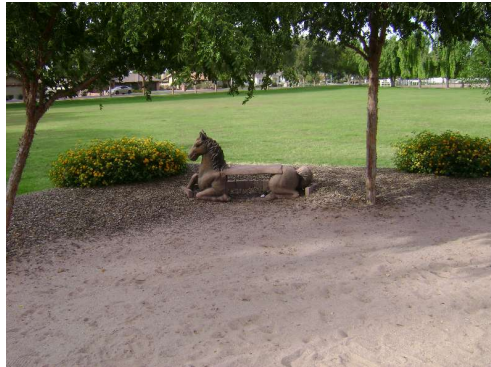
**Horse Benches - Replace**

Unfunded. No anticipation to replace.

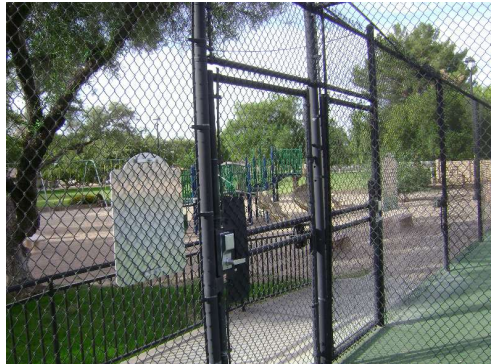
### Tennis Fence - Paint

Fair condition. Budget to paint chain link tennis fencing. Approximately 600 SF. Life adjustment due to condition.

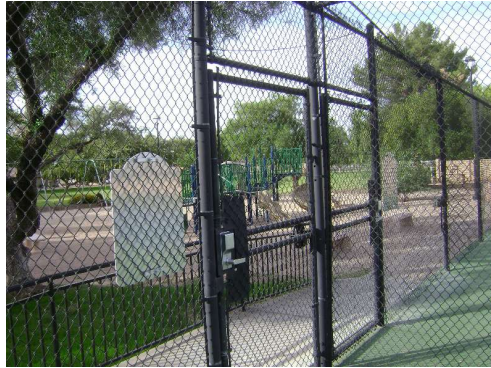
### Tennis Fence - Replace

Good condition. Budget to replace chain link tennis fencing. Approximately 540 LF.  
2018 - Replaced fence total \$10,800.

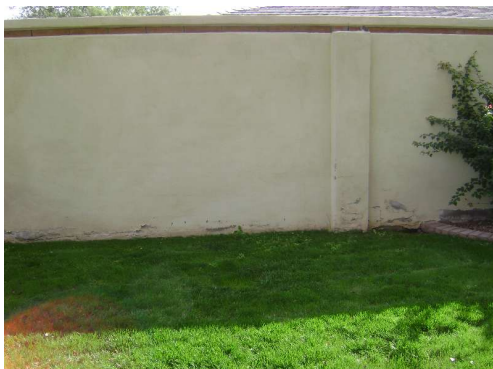
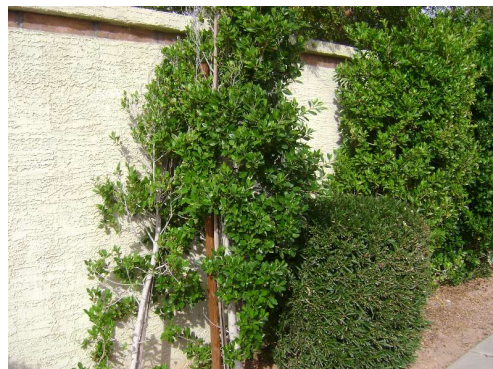
### Walls (Stucco) A - Repair

Various conditions. Budget to repair painted stucco walls. Location entrance Warner Rd &

Fairfield Dr. and North of lots 157 & 158 along Warner Rd. Recommend paint with minor stucco repair soon to preserve and aesthetics. In conjunction with wall paint, see asset ID 1008. Approximately 7,800 SF of wall.

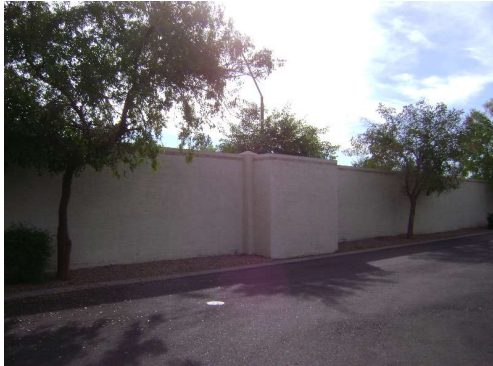
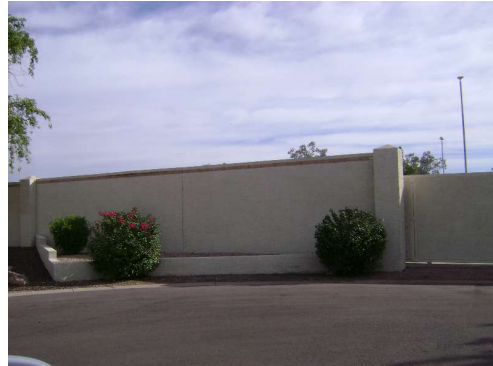
**Walls (Stucco) B - Repair**

Various conditions. Budget to repair painted stucco walls. Location along Price Rd. Recommend paint with minor stucco repair soon to preserve and aesthetics. In conjunction with wall paint, see asset ID 1008. Approximately 17,000 SF of wall.

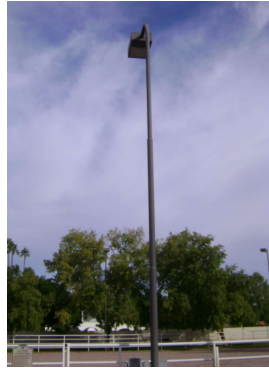
Poor condition. Budget to paint horse arena light poles.

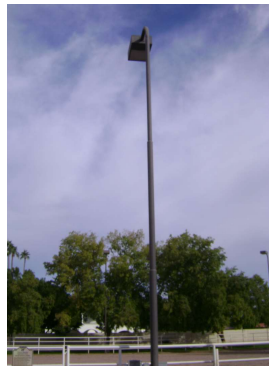
**Horse Arena Lights - Replace**

Assume working condition. Budget to replace horse arena lights including heads and poles.

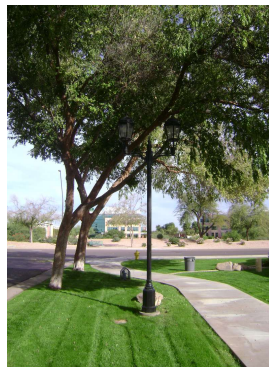
**Pole Lights (Entrance) - Replace**

Condition (working) unknown. Budget to replace (5) entrance pole lights. Location on Fairfield Dr.

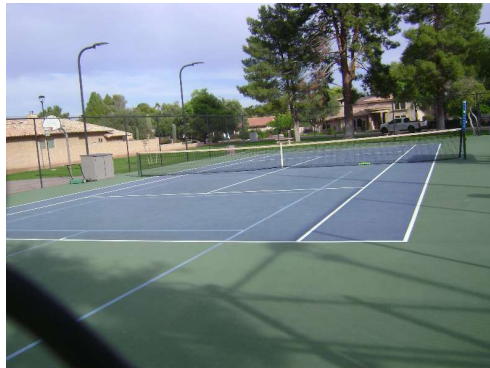
**Tennis Lights - Replace Heads**

Working condition. Budget to replace (12) LED heads. Does not include pole replacement.  
2024 - Convert to LED heads total \$4,930.

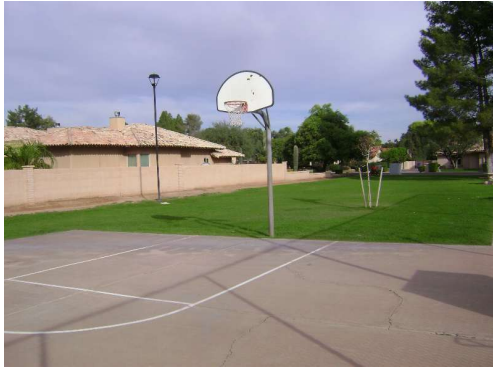
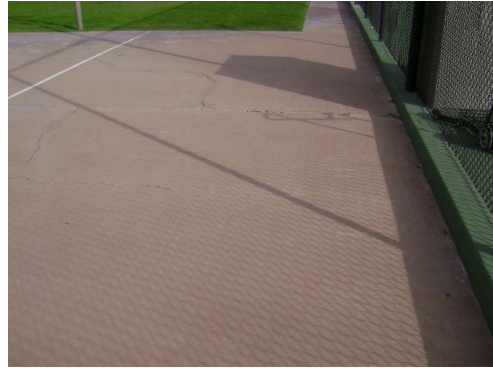
**Basketball Court Concrete - Replace**

Poor condition. Budget to replace the 1/2 court basketball with full court basketball in conjunction of removing the racquetball structure.

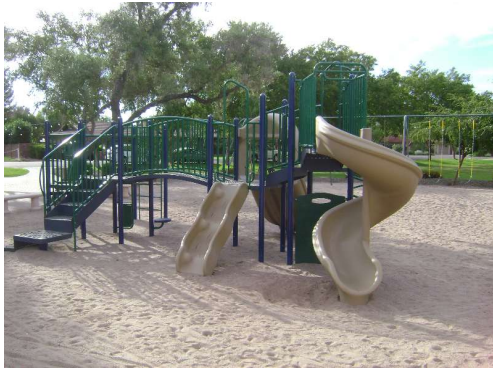
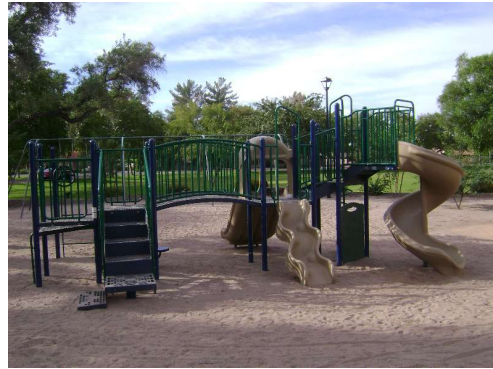
**Play Structure - Replace**

Good condition. Budget to replace large play structure.

2018 - Installed total \$52,500.

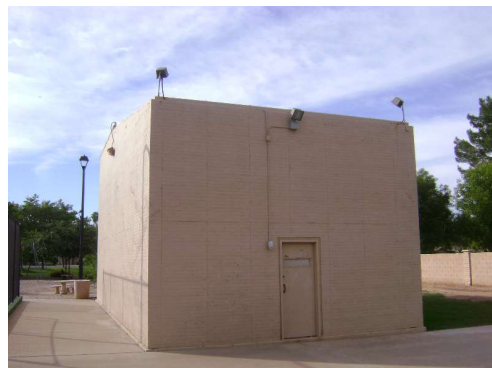
Non use. Budget for one time demo of racquetball structure.

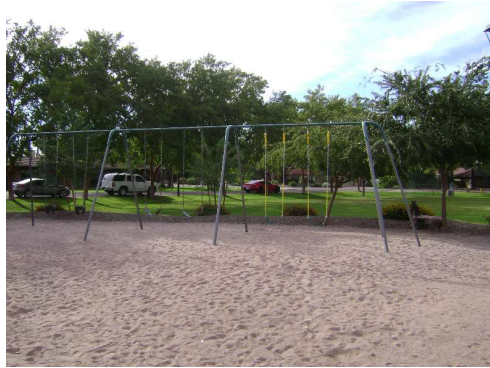
**Swing Set Poles - Replace**

Old but sturdy condition. Budget to replace swing set poles. Operating budget for swing hardware and seats replacement.

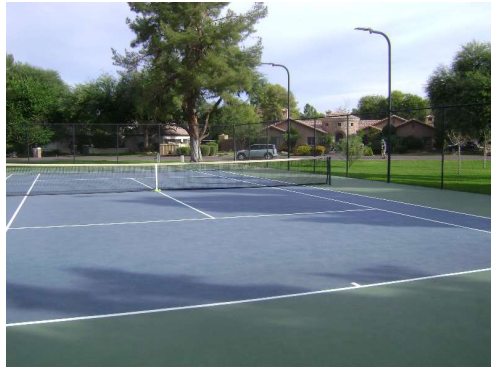
**Tennis Courts - Resurface**

Good condition. Budget to resurface two tennis courts. No anticipation to replace courts. Replaced in 2018 with post tension concrete total \$86,000. Noted no cracking. Resurfaced approximately 2-3 years ago.

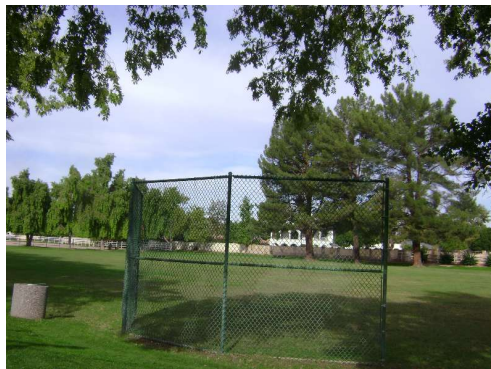
#### Baseball Backstop - Replace

Fair condition. Budget to replace chain baseball backstop. Noted bent out of shape but sturdy.

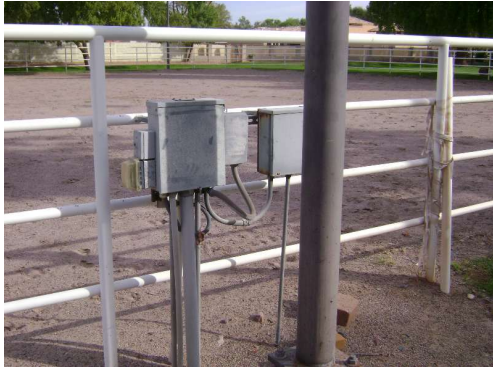
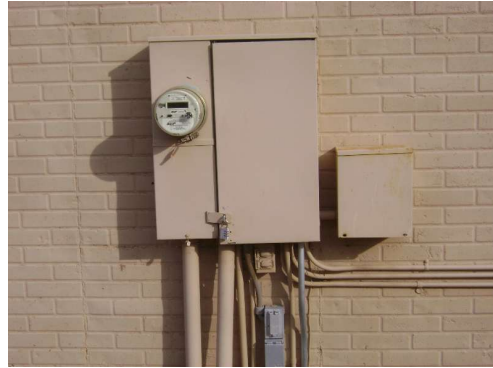
### Electric Panel - Replace

Budget to replace electric panels assume 100 amp panels. Located on raquetball and horse arenas. One will be replaced when building is torn down and replaced with full basketball court.

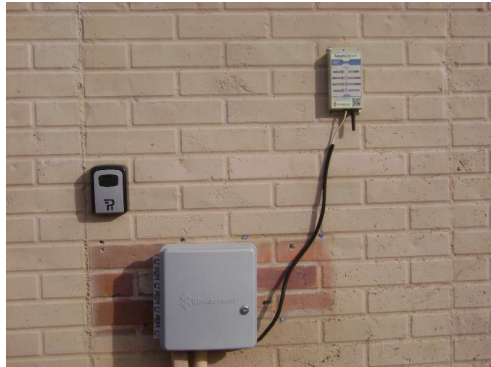
### Irrigation Controllers - Replace

Unfunded, under threshold. Budget to replace Weathermatic w/smart link irrigation controllers. Approximately, \$350 each.

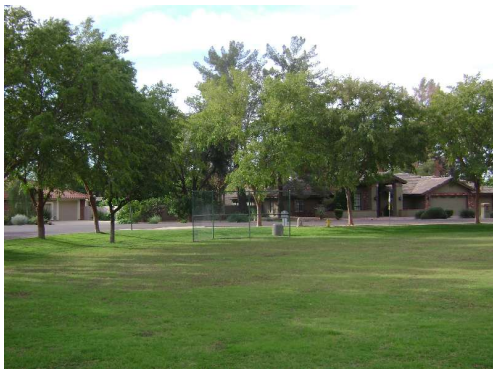
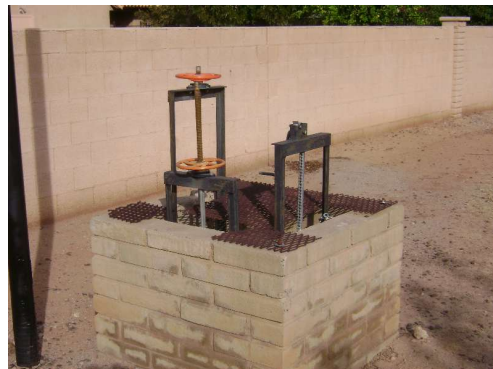
#### Irrigation System (Flood) - Refurbish

Budget to refurbish flood irrigation system. Location near baseball and basketball areas. Noted (2) irrigation lift stations these are unfunded and have a long life.

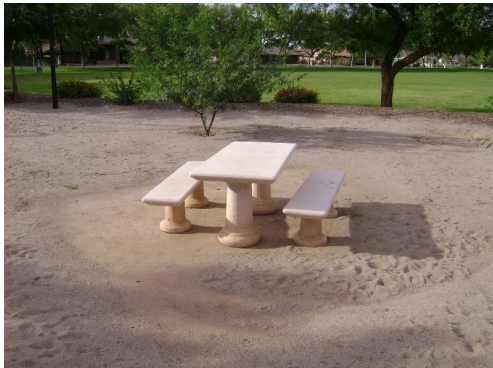
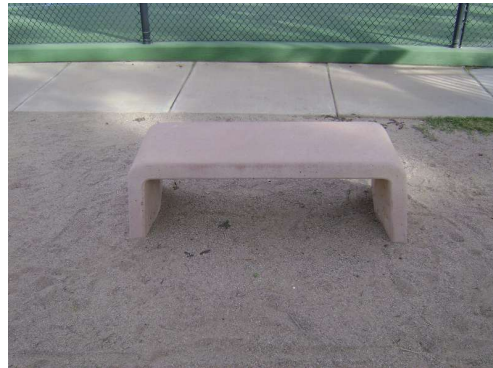
### Park Furnishings - Replace

Fair condition. Budget to replace park furnishings including rectangle concrete tables, benches and trash cans.

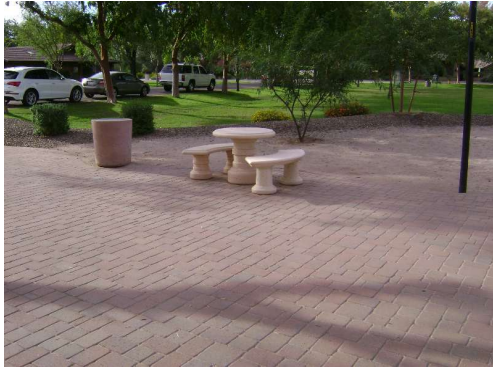
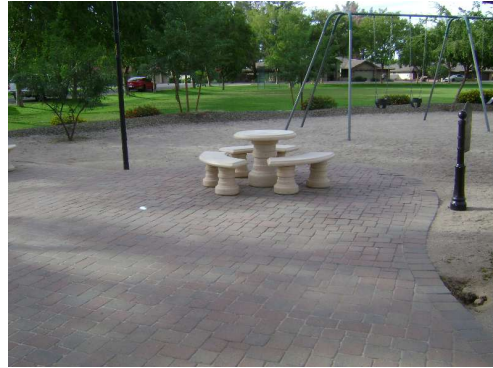
### Playground Furnishings - Replace

Fair condition. Budget to replace park furnishings including round concrete tables with benches.

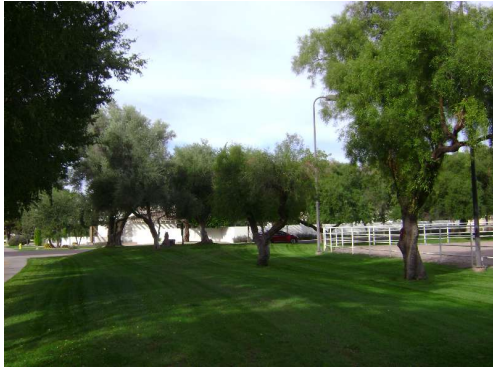
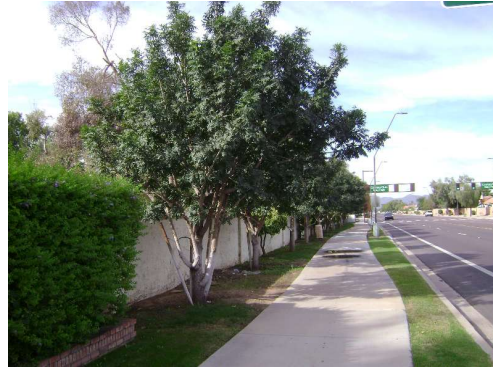
Budget to remove and/or replace trees and plantings throughout the community.

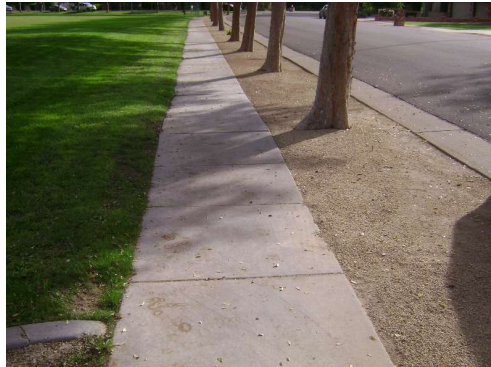
### Concrete Components - Repair/Replace Sections

Fair condition. Budget to repair and/or replace sections of concrete walkways or landscape curbing when needed. Noted lifting of sidewalk due to tree roots.

2022 - Concrete remove & replace total \$6,800.

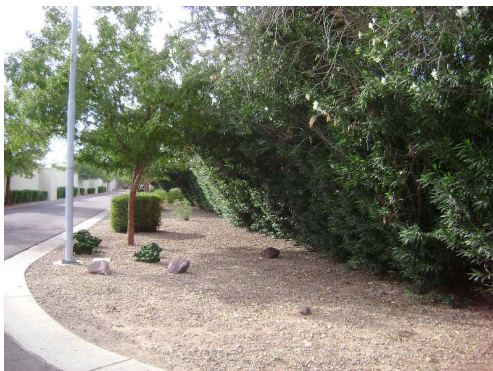
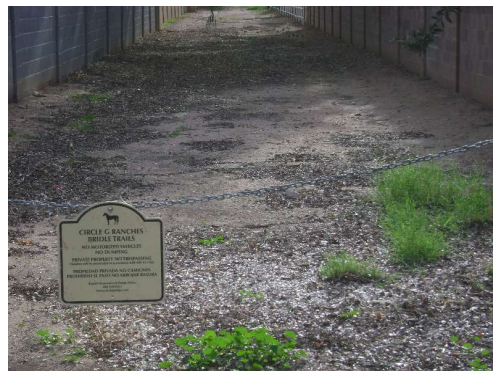
Good condition overall. Budget to replenish granite located on Price Rd. & Caroline Ln., along recreation area sidewalk, bridal path entrances and horse arena walkway where needed. Approximately 2,200 SF.

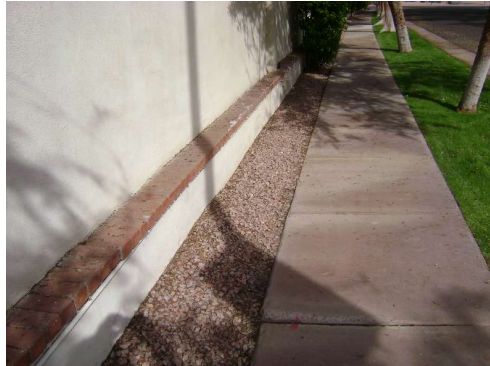
Good condition. Budget to replenish granite located on Warner Rd. & Fairfield Dr. and along Price interior areas where needed. Approximately 40,000 SF.

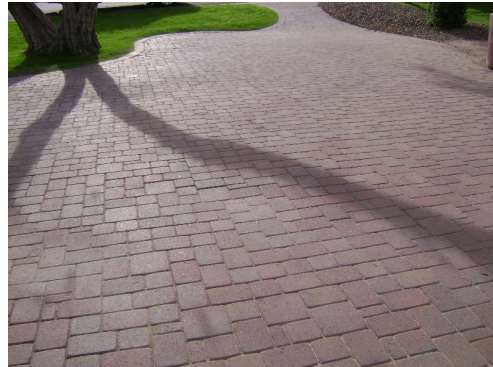
**Pavers (Concrete) - Repair/Replace Pieces**

Good condition. Budget to repair and/or replace sections of concrete pavers. Located near tennis and play structure.

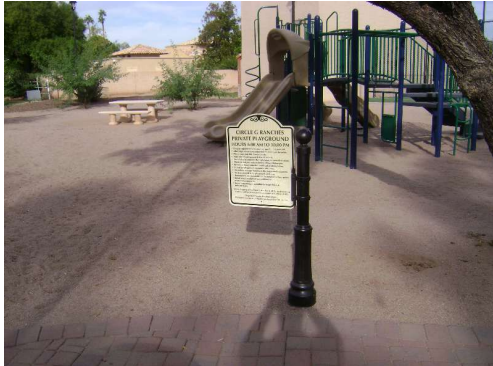
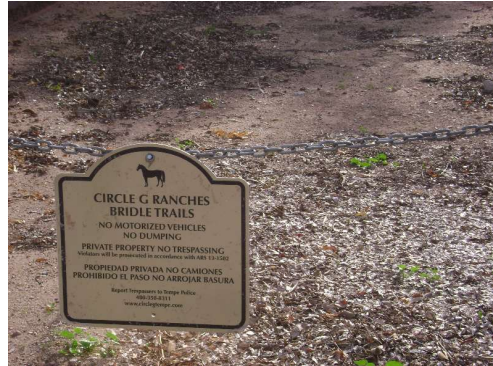
### Directional Signs - Refurbish/replace

Good condition. Budget to refurbish and/or replace signs as needed. Located at the recreation area and grounds. Placed in service date unknown, based on condition.

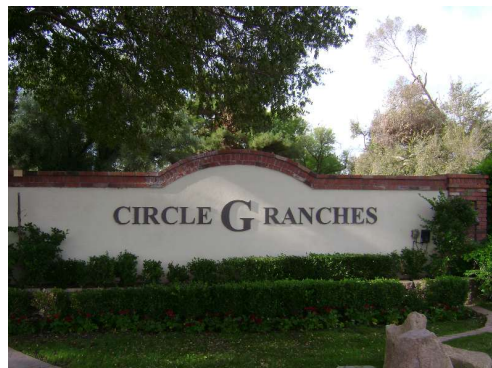
### Monuments - Refurbish

Fair condition. Budget to repair stucco cracks, paint stucco, and paint metal lettering and horse

busts. No anticipation to remove & replace. Location entrance off Warner Rd. In conjunction with wall repairs, see asset ID 1006.
